# PHASE 2 GROUND INVESTIGATION

Lidl Great Britain Ltd  
Great North Road, Milford Haven

Client: Lidl Great Britain Ltd

*798.02.01*  
*January 2021*

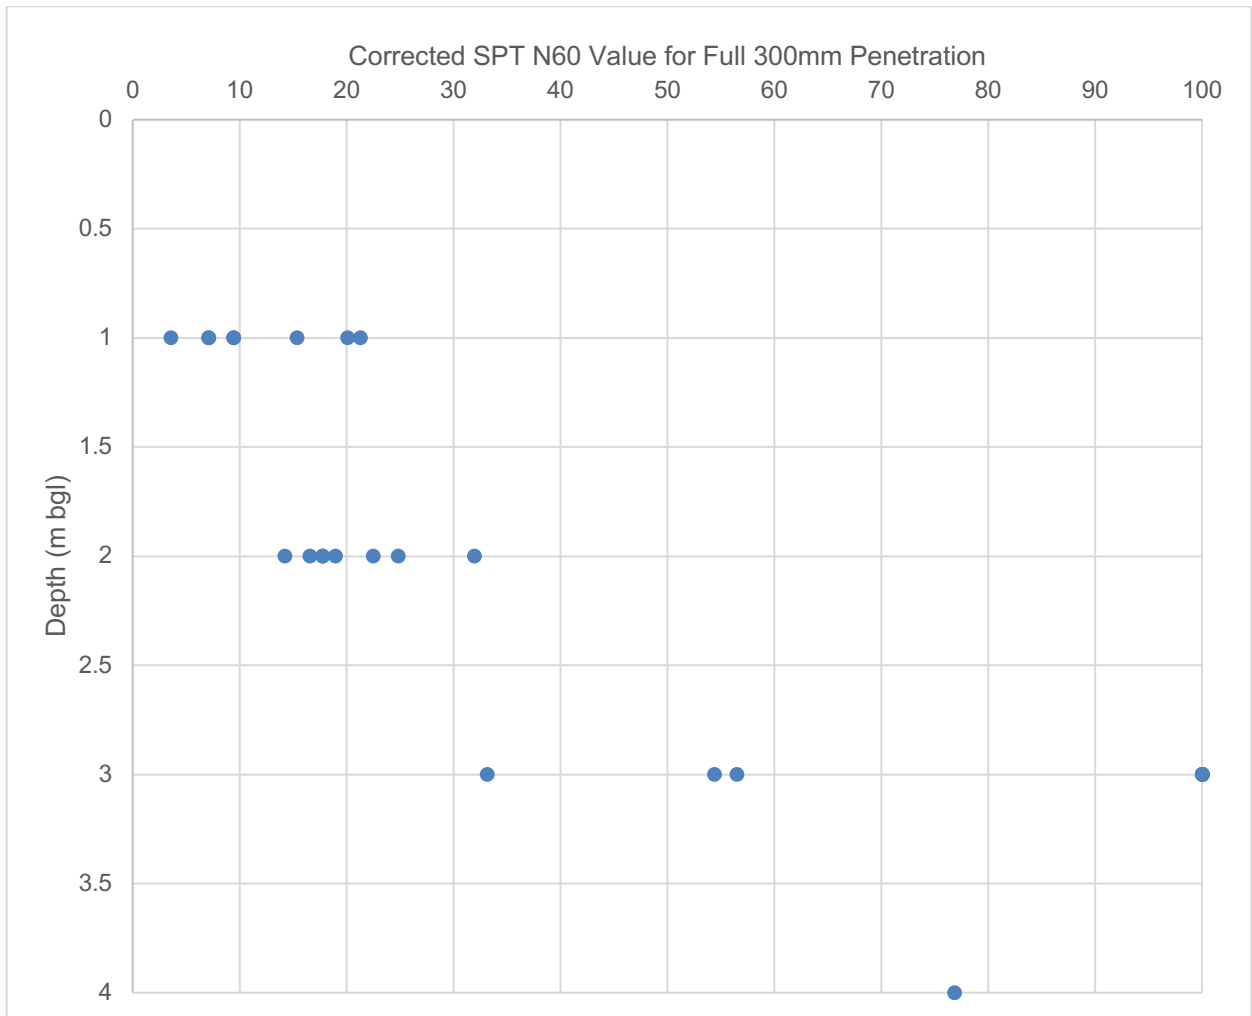
**Graph 1: Plot of Corrected SPT N-Values Versus Depth**

In-situ SPTs were undertaken to assist with the interpretation of strata encountered. The SPT N-values have been corrected based on the Energy Ratio of 71% for the SPT hammer on the window sampling rig. The SPT Hammer Energy Test Reports, undertaken in accordance with BS EN ISO 22476-3:2005 are included in **Appendix D**. An arbitrary value of 100 has been used where the corrected SPT N-60 value was recorded in excess of this value. The results of corrected N-values versus depth are plotted in the graph below:

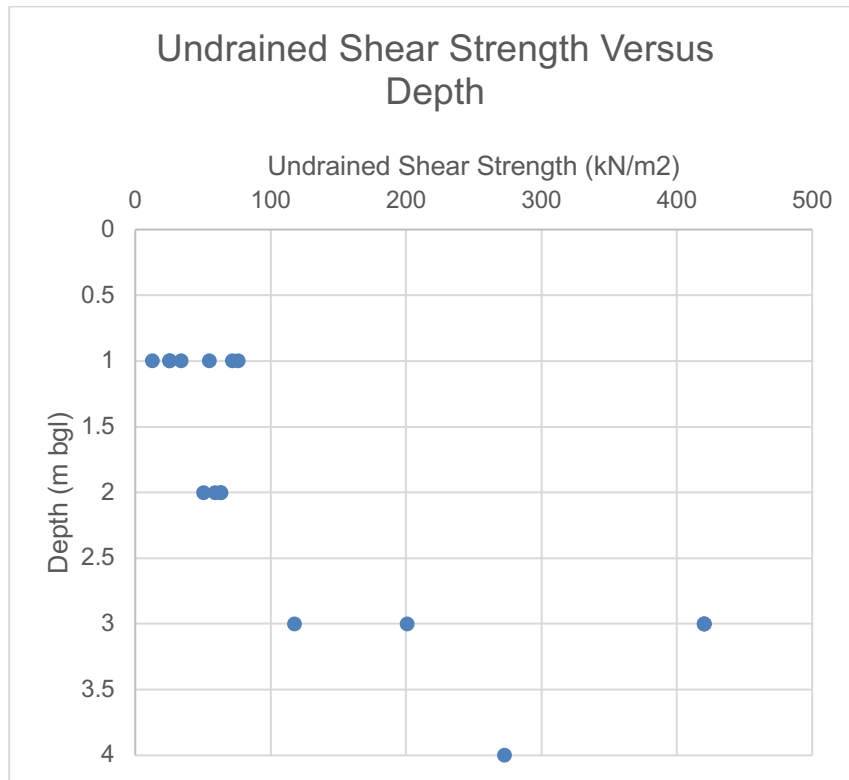
**Graph 2: Plot of Mass Shear Strength Versus Depth**

A Plasticity Index of 20% has been assumed (based on geotechnical laboratory testing) which equates to an  $f_1$  factor of 5. An arbitrary value of 420kN/m<sup>2</sup> ( $4.2 \times N60$  value of 100) has been used where the undrained shear strength is interpreted to be in excess of this value.
