1290 – Broughton Shopping
Park North

BS 5837:2012 Arboricultural
Report and Impact
Assessment

Site: Broughton Shopping Park, Broughton, Chester, CH4 0DH
 Report: BS 5837:2012 Arboricultural Report and Impact Assessment
 Reference: 1290
 Client: CPC Project Services Ltd
 Issue Date: 22/01/2026

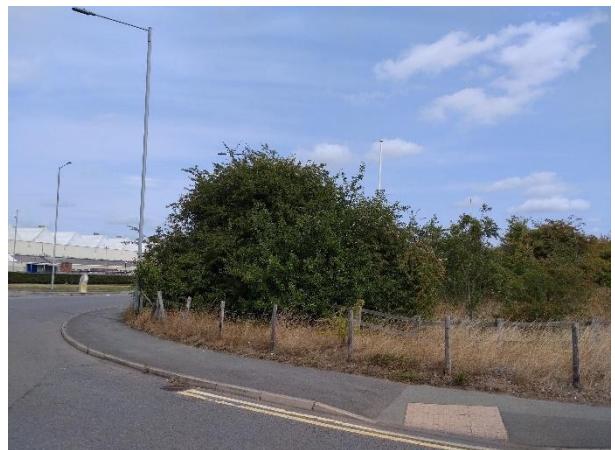
Photo 4: T017, G018 and western extent of G020 from the south

G020	Blackthorn (<i>Prunus spinosa</i>) Hawthorn (<i>Crataegus monogyna</i>) Alder (<i>Alnus glutinosa</i>) Cherry (<i>Prunus avium</i>)	6.0	>10	50 avg	See Plan				0.0	Semi Mature	40+ Years	Good	Dense group of trees & shrubs. Largely inaccessible. Predominantly hawthorn with occasional other species throughout. Several alder in SW area. Surrounded by dense brambles & undergrowth.	Removal of much of group required for new attenuation basin and vehicle parking	C2	-	-

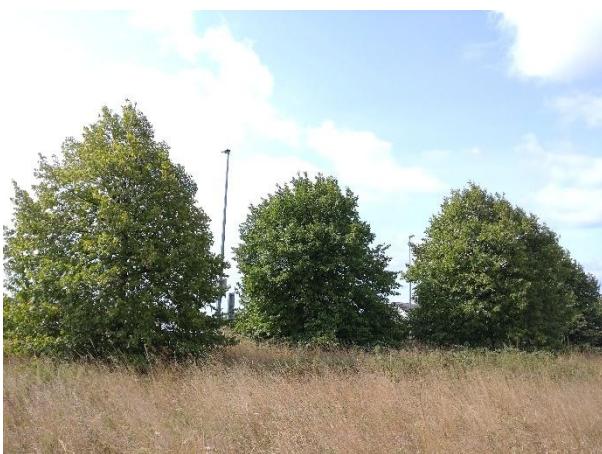
Photo 2: T004 to T007 from the north west

T006	Lime (<i>Tilia x europaea</i>)	7.5	1	270	3.0	3.5	4.0	3.5	0.5	Semi Mature	40+ Years	Good	Epicormic growth at base.	Removal required for new footpath	B1	3.2	32

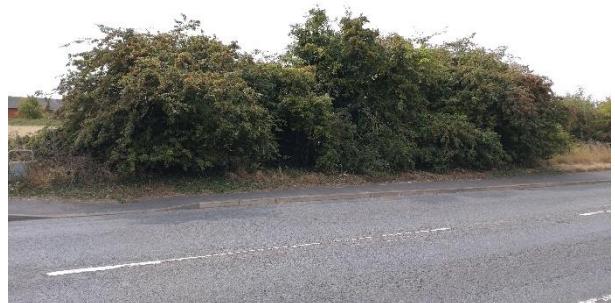
Photo 5: G021 from the north

Tree No.	Species	Height (m)	No. of Stems	Stem Dia. @ 1.5m (mm)	Crown Spreads (m)				Height of Crown Clearance (m)	Age Class	SLE	Overall Condition	Comments	Management	Category	RPA Radius (m)	RPA Area (m ²)
					N	E	S	W									
G021	Hawthorn (<i>Crataegus monogyna</i>)	6.0	>10	140 avg	See Plan				0.5	Semi Mature	40+ Years	Fair	Linear group of approx 10 multi-stemmed trees forming a single canopy. Dense ivy on majority of stems & into lower canopy. High proportion of minor deadwood low in canopy. Sparse canopy where ivy has become more established.	Removal of western section required for new attenuation basin	C2	-	-
T022 #	Hawthorn (<i>Crataegus monogyna</i>)	4.5	6	90 avg	3.5	3.0	3.0	2.5	0.5	Semi Mature	40+ Years	Fair	Multi-stemmed at base. All stems growing against & through fence. Occasional minor deadwood throughout, particularly low in crown. Smaller hawthorn W.		C2	2.6	21
G023	Blackthorn (<i>Prunus spinosa</i>) Hawthorn (<i>Crataegus monogyna</i>)	5.0	>10	50 avg	See Plan				0.0	Semi Mature	40+ Years	Good	Dense mass of young to semi mature trees & shrubs. Wholly inaccessible due to dense surrounding brambles, nettles & various creepers.	Pruning back of W canopy and removal of several western trees for various new design elements	C2	-	-

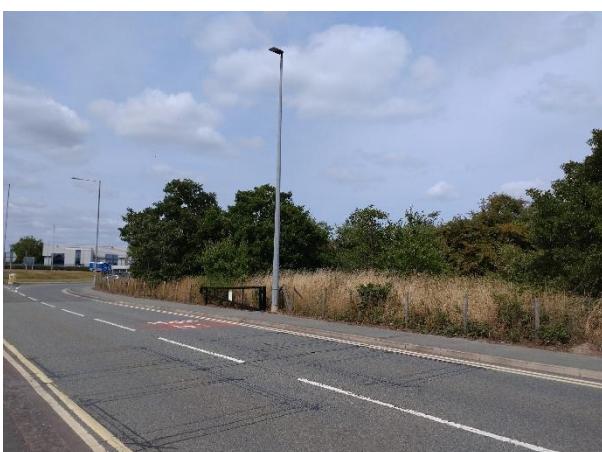
Photo 3: T012 to T016 and southern extent of G020 from the south east

T015	Alder (<i>Alnus glutinosa</i>)	7.0	1	290	3.5	5.0	4.5	4.0	0.5	Semi Mature	40+ Years	Good	Large & dense epicormic growth at base. Occasional minor deadwood low in crown.		B1	3.5	38

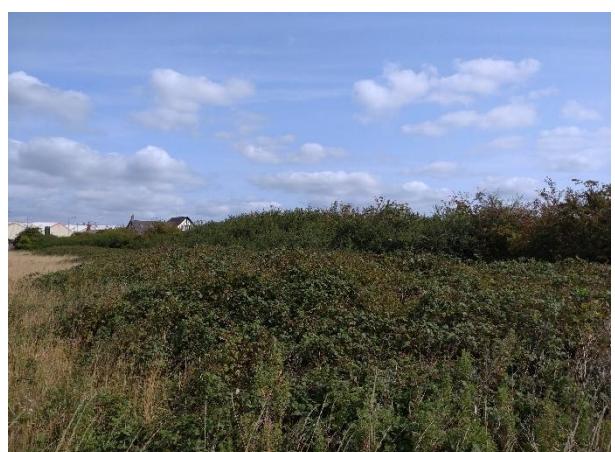
Photo 6: G023 from the south west

5.9 The westernmost retained trees within G023 will need to be pruned back from several if the new design elements, to allow for their construction.
