Bro Tathan (former RAF St Athan, East Camp)

Vale of Glamorgan

Historic Building Recording

Bro Tathan East (former RAF St Athan, East Camp), Vale of Glamorgan

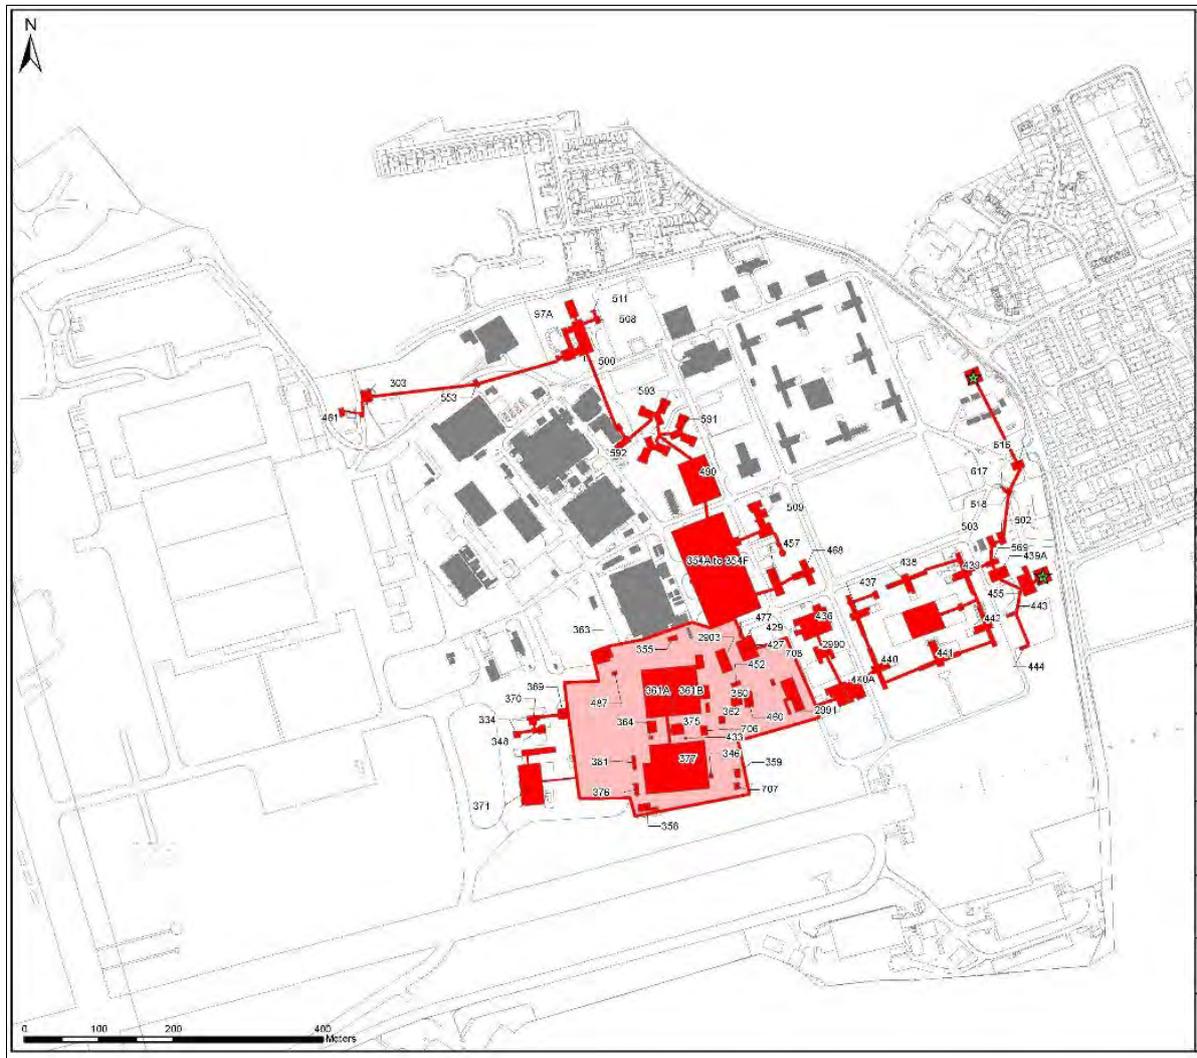
Figure 2. Plan indicating buildings for demolition and groundworks (Red - buildings to be demolished. Grey - previously demolished. Pink - area of fill and regrading).

Previous works to the Bro Tathan site have seen several phases of demolition. This application would mark the final phase of demolition to prepare the site for future redevelopment. To clear the site, buildings, infrastructure, foundations and areas of hardstanding are to be removed (Rio Architects 2023). The proposed demolition area includes additional buildings to those subject to historic survey.

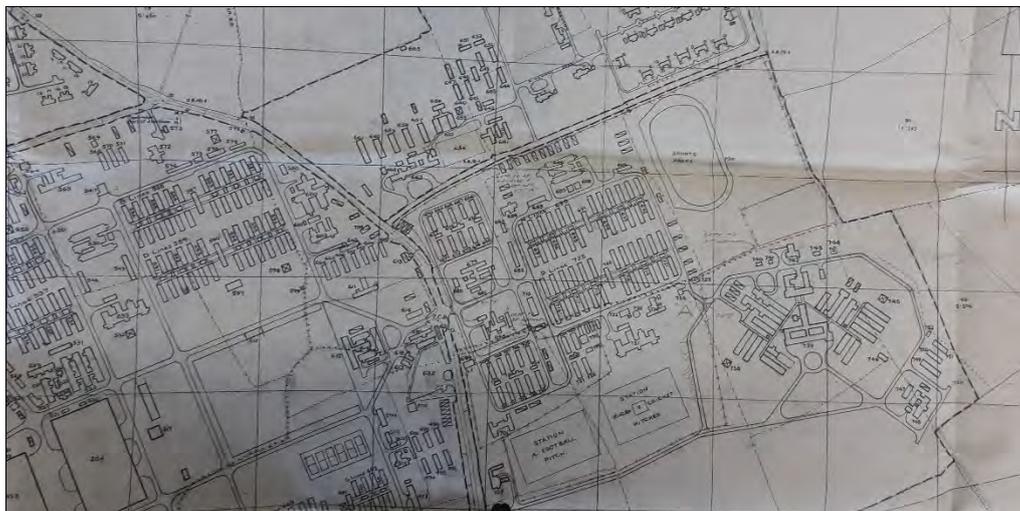
The athletes were accommodated within a fenced area to the east side of the Station and fenced to maintain a degree of separation from the operational base. The 1957 plan (Plate J) indicates the Sports Village (AIR 2/13294).

Plate J. Bldg. 354, the swimming pool and gymnasium in the lower left of the plan. The hutted accommodation in the centre north of the pitches

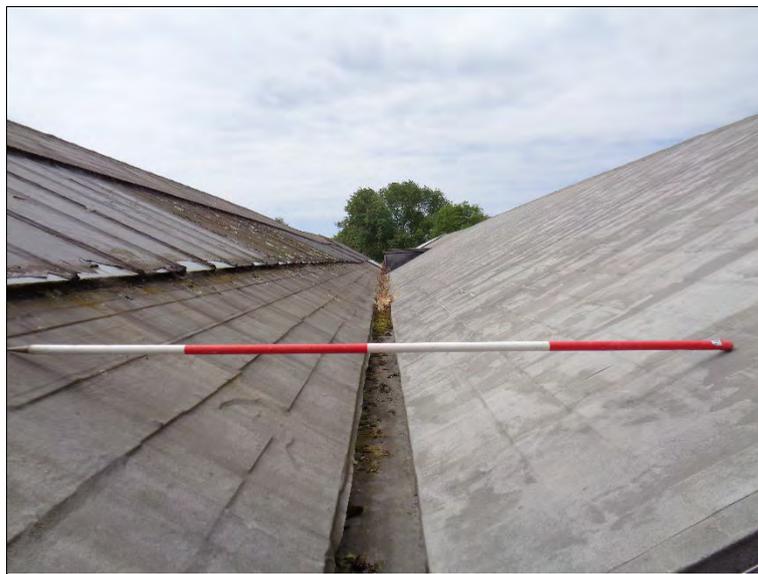
Plate K. Roof detail showing lights gutter and tiles covered in 'bituminous felt'

This brick building orientated 17 degrees west of grid north was the largest of all the buildings in East Camp measuring 138m (453 feet) in length by 74.1m width (243 feet) with a height of 7.52m (approx. 24.5 feet) to the parapet (0.33m wide) and 9.83m (approx. 32 feet) to the roof ridge of which there were 15 pitched roofs transverse to the building's length, with skylights facing north, ranged between the hipped roofs. A slightly splayed U-shaped metal gutter with a flat base (0.32m wide, 0.15m high) collected runoff from each roof leading to downpipes below parapet level and of which the greater number were internal; gutter height to parapet level 0.45m (Plate K).

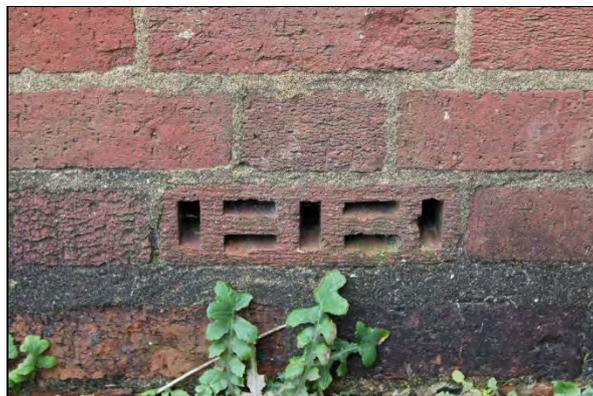
The north and south elevations were similar with 14 windows each, on the west there were 15 and, on the east, originally 13, but reduced to 12 with adaption (this elevation unique in that it hosted the cinema entrance); glazing was again consistent with 9 panes in each with their frame set back 30mm from the elevation line. Smaller window reveals (1.37m high by 2.74m wide) their top flush with the lintel were also consistent on all elevations, and present over the original main doorways. Other standard fabric features of note were air bricks present above the lintel central to each window including over the cinema doors and at ground level integrated with the first course of brick above DPC level (Plate M).

Plate M. Original air brick detail

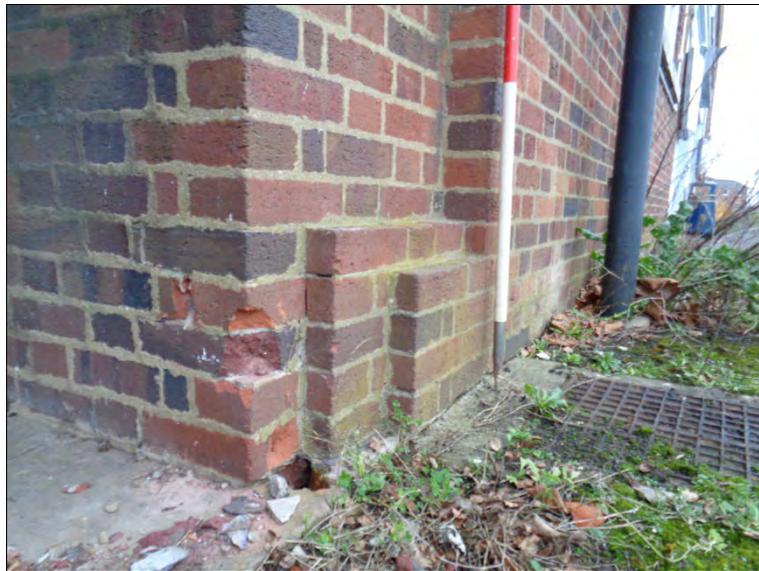
Plate N. Decorative brickwork common to pedestrian entrances for the cinema, pool and Church

The entrances were 2.89m high to underside of canopy, with 2.2m high doors, and along the face of the elevation 2.3m wide reducing over 0.45m to 1.52m wide at the door. In addition to stepping in, the brick stepped up in two lifts, the outer 0.29m (four brick courses) and the inner 0.37m (five brick courses) from ground level and it was this lower-level architectural brickwork that suggested an art deco influence (Plate N).

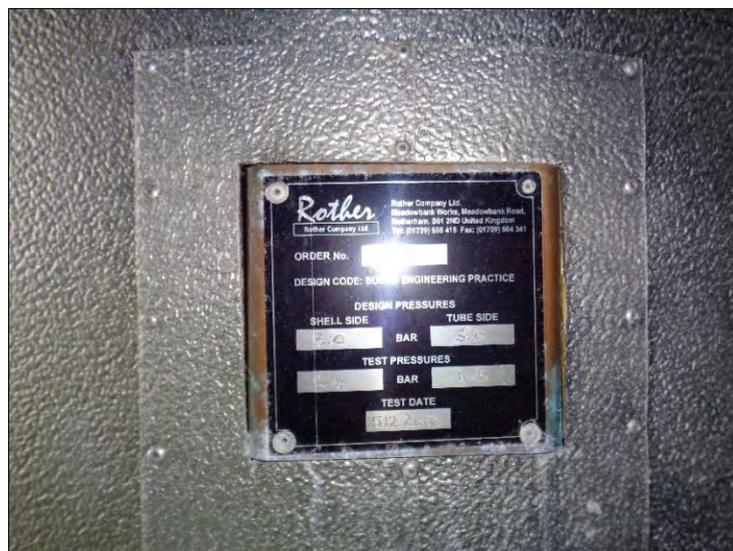
Plate O. Rother Company Limited plate in swimming pool plant room.

The plant room comprised two 1.1m diameter by 1.93m high cylinders (heat exchangers or calorifiers supplied by Rother Company Limited, Meadowbank Works, Rotherham (Plate O). A website indicates that all RAF camps were supplied by the firm, as well as many hospitals and holiday camps) and extensive lagged piping which provided heated water for the pool and for which a protective cover over electrical wiring was present just off the external west elevation corner. The filtration system is contained in the Pool Plant room.

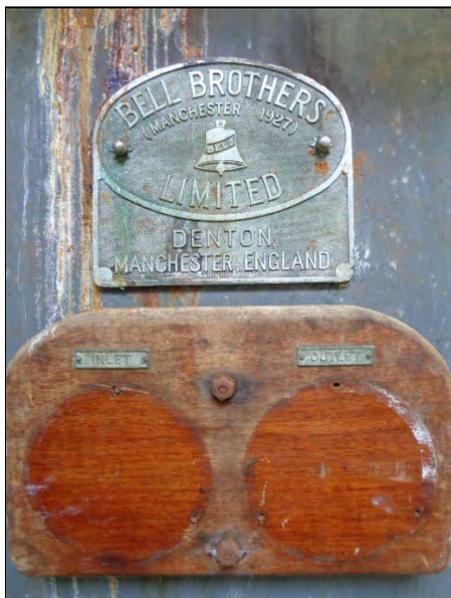
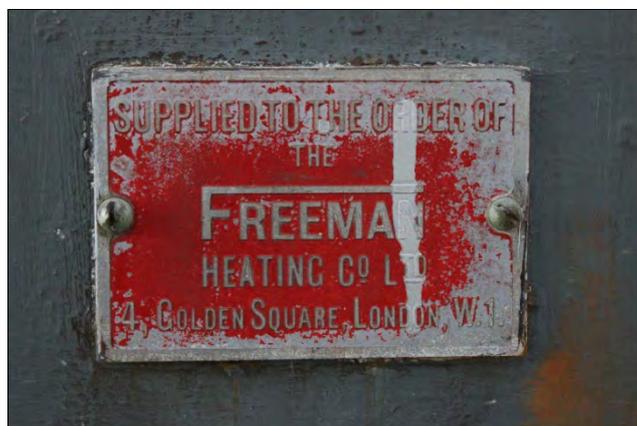
Plate P. Bell Brothers and Freeman plates on the tanks

Manufacturers plates on the end of the cylinders bore the name 'Bell Brothers Limited (Manchester 1927), Denton Manchester England' and along its length 'Supplied to the order of the Freeman Heating Company limited, 4, Golden Square, London W1' (Plate P).

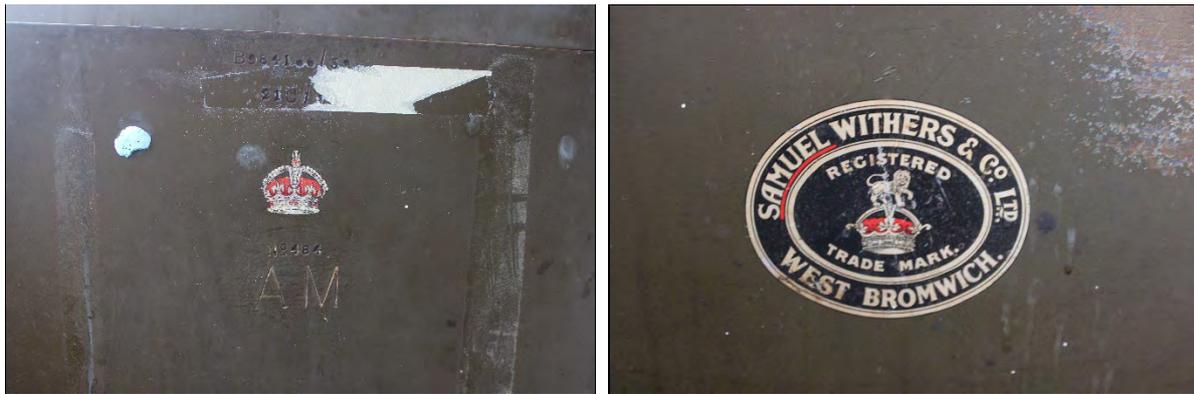
There were two rooms to the left (south) of the kiosk, the first via a single door opposite an auditorium entrance led via a short flight of steps downward to an office room (5m by 3.5m) that housed a safe supported on a stand positioned in the opposite corner of the room to the door and adjacent to the single window (Plates 63, 64); the assumption is that cinema takings were kept in the safe. The safe was manufactured by Samuel Withers and Co. Ltd, West Bromwich was inscribed AM (probably Air Ministry) No 484 with further numbering reading B984166/39 over 21c/1050 and the supporting stand supplied by Roneo Ltd, Steel Office Furniture, Romford, England (Plate R).

Plate R. Photos showing detail of the incised numbering and manufacturer of the Safe

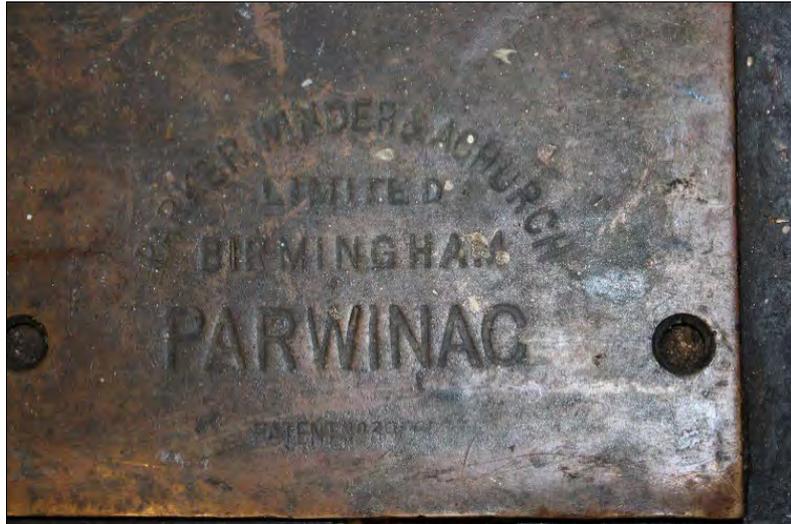
A pair of similarly sized double doorways (1.37m wide, 2.12m high with a small art-deco style viewing window in each door, on each side of the kiosk gave access to the auditorium (Plate 67). The manufacturers name stamped into the brass base plates on the pivot points for these doors and the front doors was PARWINAC (Parker. Winder & Achurch) Limited Birmingham (Plate S).

Plate S. Floor plate showing manufacturer of the foyer and auditorium doors

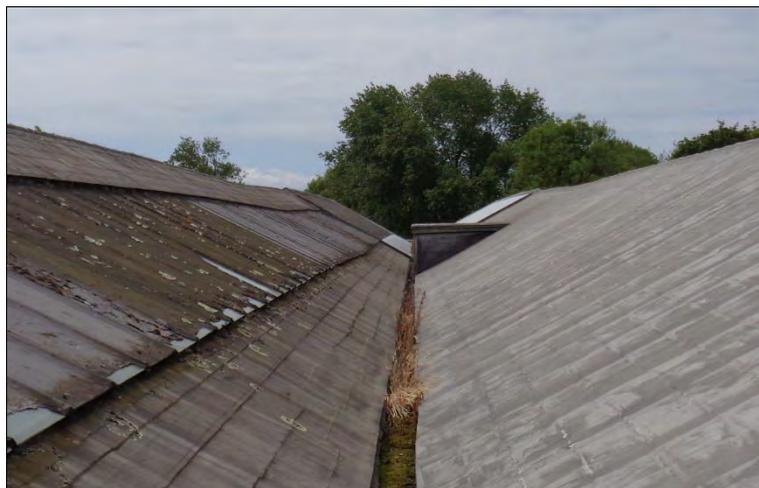
Plate U. External view to west of the dormer over the stage.

Roofing comprised cream-coloured wooden planks matching the pitch however an unusual feature, positioned almost central to the structural pillar along the east elevation was a wooden dormer style roof arrangement 1.95m wide with its flat roof 5.2m off floor level and of unknown purpose. A similar dormer roof was observed above the cinema stage (Plates 80, 81 and Plates T and U).

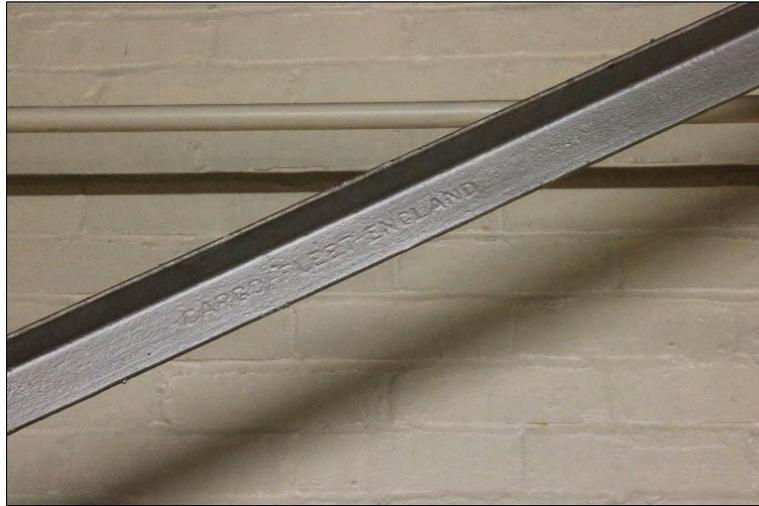
Plate V. Cargo Fleet manufacturers stamp in the cinema backroom

A manufacturers stamp on the bracing rail over the windows read Cargo Fleet England (Plate V). This is Cargo Fleet Iron Co Ltd, iron and steel manufacturers, Middlesbrough, England (1883-1970).

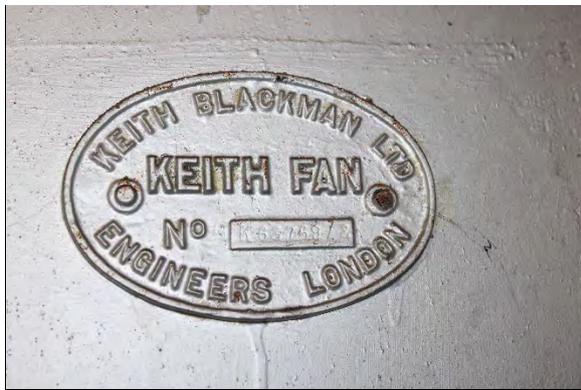
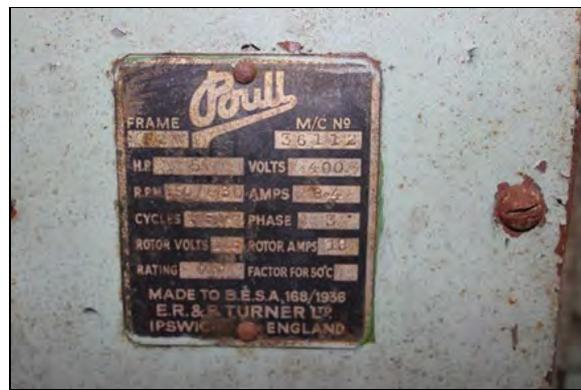
Plate W. Keith Blackman plate on fan housing and Bull on the motor

The 1.8m high fan housing ('Keith Fan' manufactured Keith Blackman Ltd, Engineers London (Plate W) was bolted to a low 1.62m by 1.22m long concrete base was central to the north half of the room with its attendant motor on dampeners, central to it on a low plinth (0.88 by 0.48m) 0.17m to its south (Plate 90).

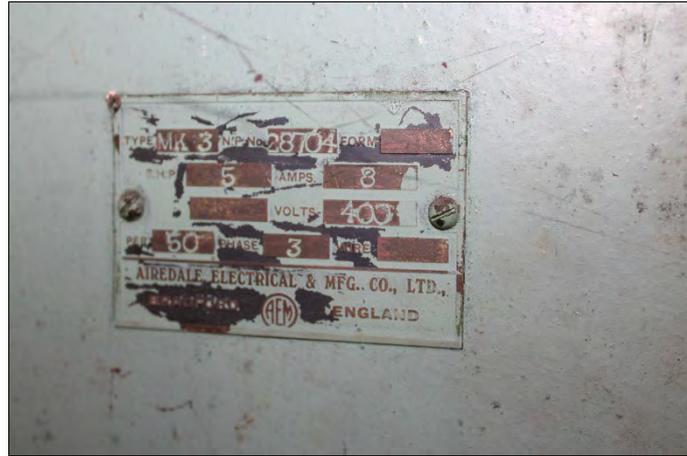
Ducting aside and a downpipe in the northeast corner, the west, north and east walls were plain. Attached to the south elevation however was an electrical voltage control box manufactured by AEM (Airedale Electrical & MFG. Co., Ltd., Bradford, England) (Plate X). These manufactures were all in existence in the latter 1930s and it is considered that these were perhaps original fittings.

Plate X. Airedale Electrical & MFG. Co., Ltd plate

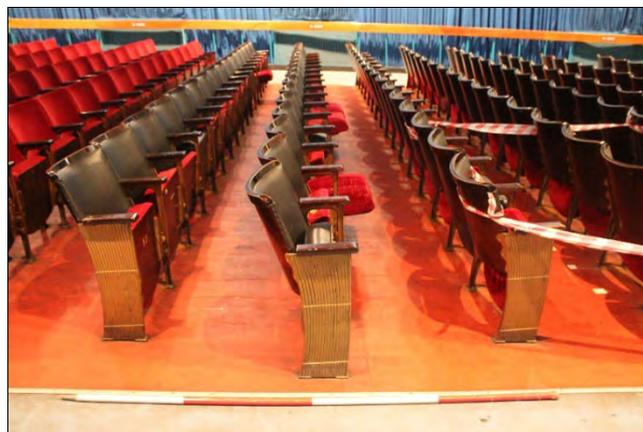
Plate Y. Reeded cast iron seating end panels

Three different styles of curved back seats were present with 8 rows of leather or leather effect seating at the front, nine rows of dark red soft fabric seats in the centre and five rows of soft fabric blue coloured seats at the back; repairs noted were where several red cushions had replaced the original black cushion. Of the two different cast iron aisle end panels recorded, the greater number were circa 1920's gold painted art deco style curving vertical reeded line decoration (Plate Y), and the others circa 1930s art deco plain style (plausibly original but reset onto the present lino flooring), and all with wooden arm rests.

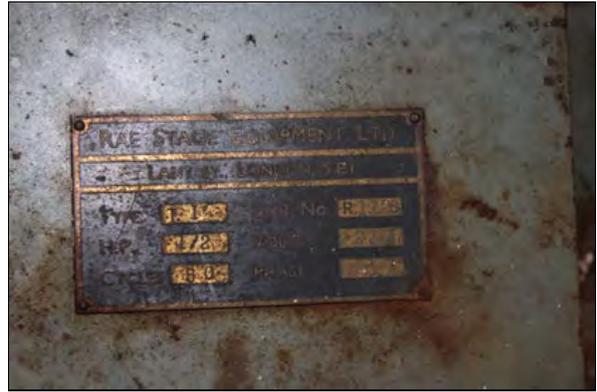
In line with the seating 2.85m back from the edge, the stage supported a large curving screen (8.8m wide screen by 5m drop (4.45m high visible screen height). Plate 100) tied to and supported by a tubular metal framework (10.65m overall length) on four small solid roller wheels. A motor, manufactured by RAE Stage Equipment Ltd. Lant St., London SE1, attached to the framework at the north operated the screen curtains with options for wide screen (1950s on), cinemascope (in use from 1953) or side masking (Plate Z).

Plate Z. Screen curtain motor and RAE manufacturers plate

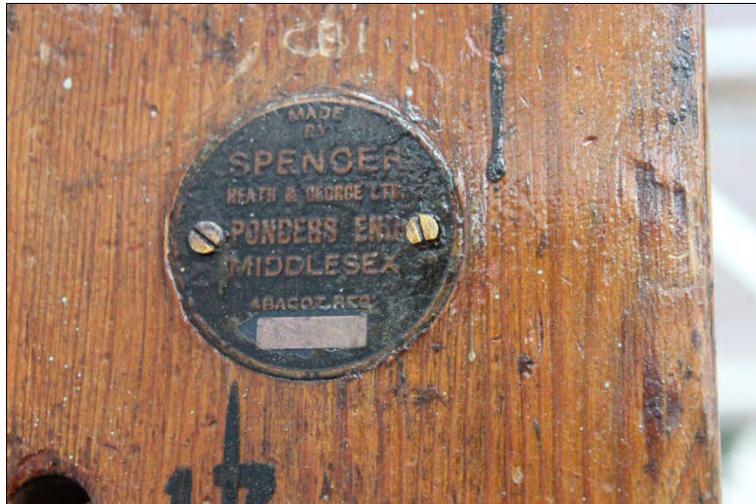
Plate CC. Spencer, Heath & George Ltd plate on gymnasium equipment

woodwork supporting horizontal beams (4.42m off the wall) manufactured by Spencer, Heath and George Ltd, Ponders End. Middlesex (Plate CC): In addition, the trusses of the four intermediate steelwork columns were used to support climbing ropes which were suspended from a secondary rail and which extended out to match the beams (Plates 178, 179).

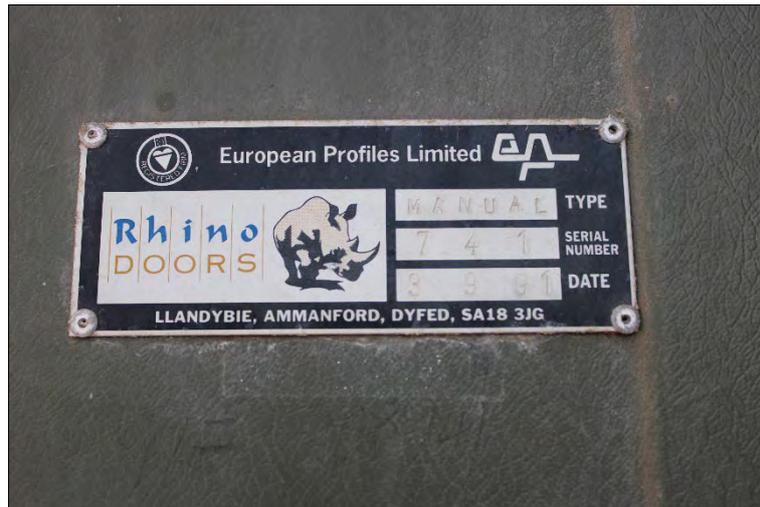
The infilled south hangar opening (17.2m between two lattice girder stanchions) was plain except for a single central fire door. In the centre arranged over 36m and again between lattice girder stanchions were three pairs of large windows with entrances between the pairs. The south entrance (2.75m wide) was fitted with a metal 3 panel folding door (Plate 198) with overhead external plate and rail guides (the doors dated 03 September 1991 manufactured by Rhino Doors LLandybie, Ammanford, Dyfed. Plate DD)).

Plate DD. Door manufacturer plate for the west elevation south doors

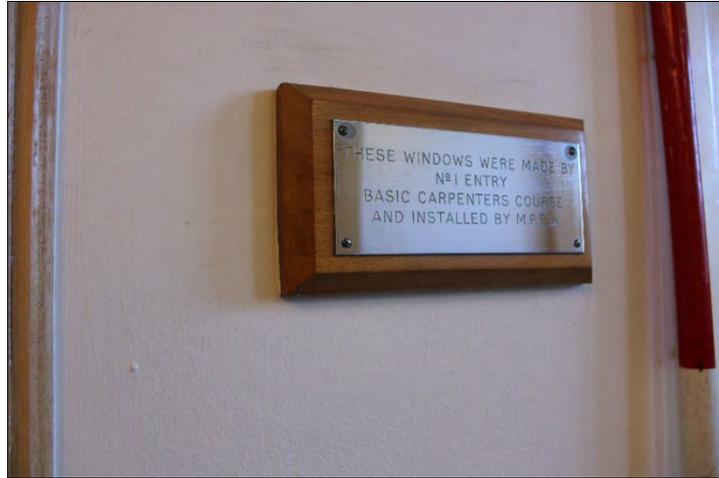
The east wall from the chancel had a double door at 2.5m along it leading to a Font Seating Area, and beyond that were the two Gothic windows starting at 0.6m and 4.9m respectively from the door. A plaque on the wall between the door and window stated that 'these windows were made by No. 1 Entry Basic Carpenters Course and installed by M.P.B.W'. Plate EE).

Plate EE. No. 1 Entry Basic Carpenters Course plaque in church

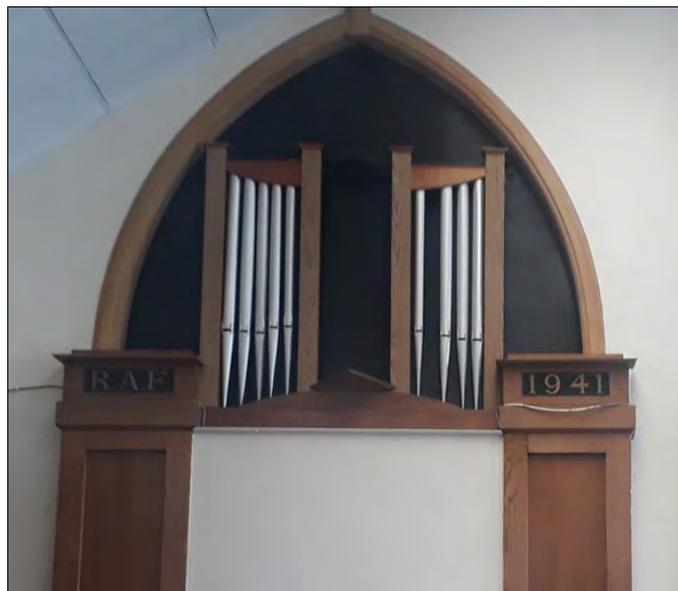
Just north of the window (0.8m) and 1.9m from the north wall was a single door 0.84m wide by 2m high to the Font Storeroom. This door and its plasterboard surround were a replacement for the church organ of which flanking oak panel columns, with the head of the north column carved with the letters RAF and the head of the south column the date 1941, were in situ below a Gothic arch inset with two wooden vertical frames each providing support for 5 small diameter imitation organ pipes: originally 10 pipes but one now missing (Plates 212, 213).

Plate FF. Detail showing the 1941 dated organ surround wood columns and imitation pipes

The overall height was just under 5m, width 2.56m, the columns were 3.13m high by 0.58m wide (the lettering panel itself 0.19m high) and the top of the pipe frame, 4.23m (Plate FF). As with the windows the organ surround was reputedly made by one of the earlier carpentry school intakes.

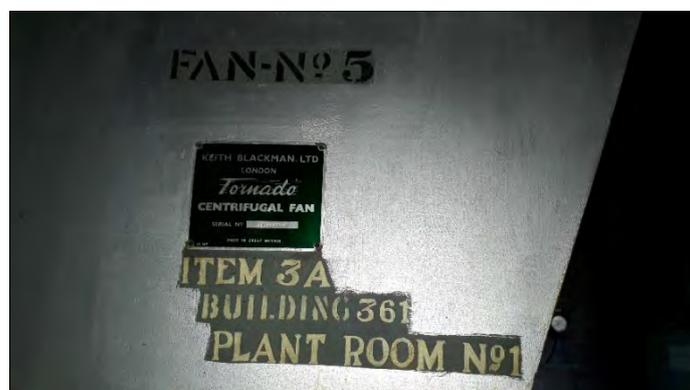
Plate II. Annotated detail on the side of the fan unit

Adjacent to the north and south elevations (1.82m off the elevation) were related fan houses (Keith Blackman Ltd., London. 'Tornado' centrifugal fans), with ventilation ducting that entered the building at high level through bricked in window reveals (Plate II). These are post 1945 fittings evidenced by aerial photos.

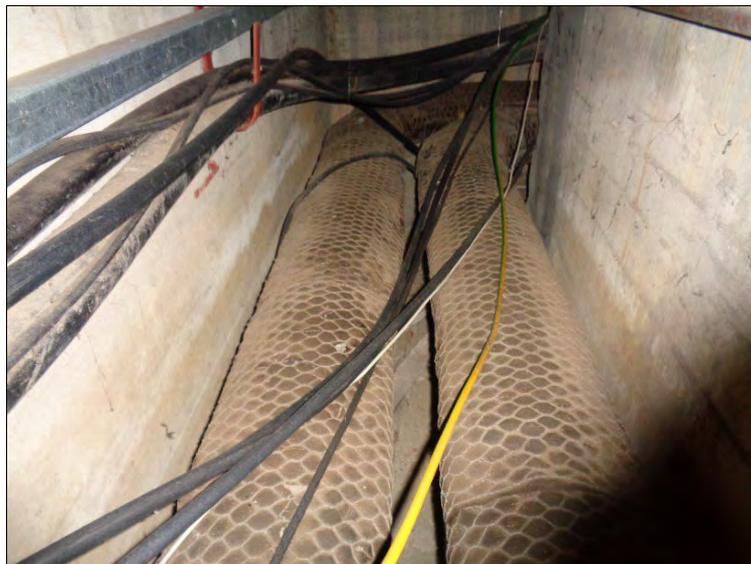
Leaving a four-metre gap for the vehicle route the wider channel restarted in line with the other, again with a right angle turn and continued to the south elevation where a right-angle branch headed to the Office 19 doorway meeting it halfway along the doorway. At the angle change the channel had been filled with concrete, and two narrow branches extended toward the inset electrical switchboxes.

Plate OO. Pipes in floor channels below plating

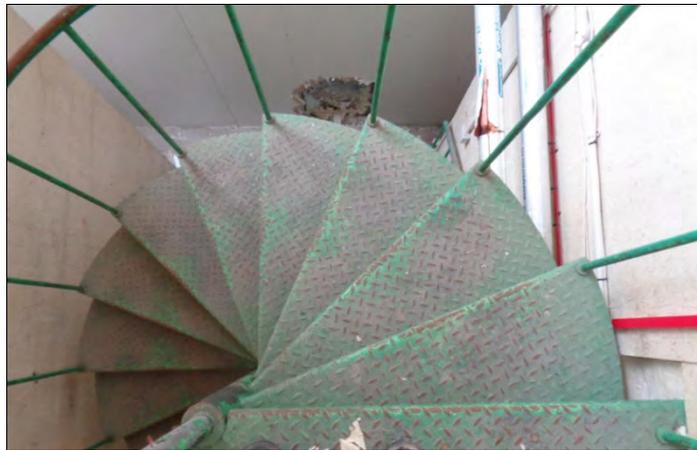
The 1m radius staircase (Plate PP) with a short platform leading to the first step fitted into a rectangular space 2.7m by 2.2m adjacent to the south elevation and rose 3.44m to a single room to its west (over the storeroom in the southwest corner) that from discarded paper appeared to have been a casual rest room 'for the boys' as indicated by pin ups on a wall.

Plate PP. View to the east looking down onto the spiral staircase

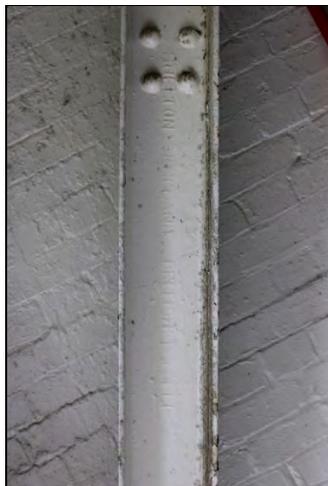
Underlying the rest room was a storeroom (7m maximum by 8.4m, ceiling 3.2m) with several structural features. In the southwest corner and like that in all corners of the building, was a vertical X-frame (Shelton England British Steel maker's mark. Plate QQ) parallel to its west elevation.

Plate QQ. Shelton stamped into the X-frame steelwork

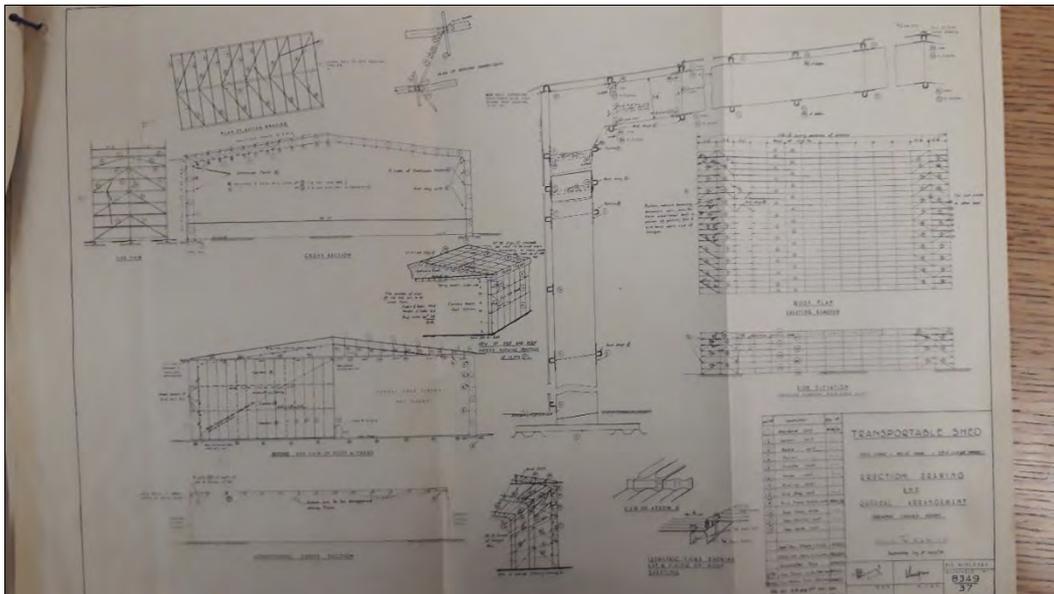
Plate WW. General arrangement drawing (Work 44/37 and work 44/38)

The framework matched that of the original design drawings (Work 44/37 and work 44/38) of which a selection follow (Plates WW to ZZ).

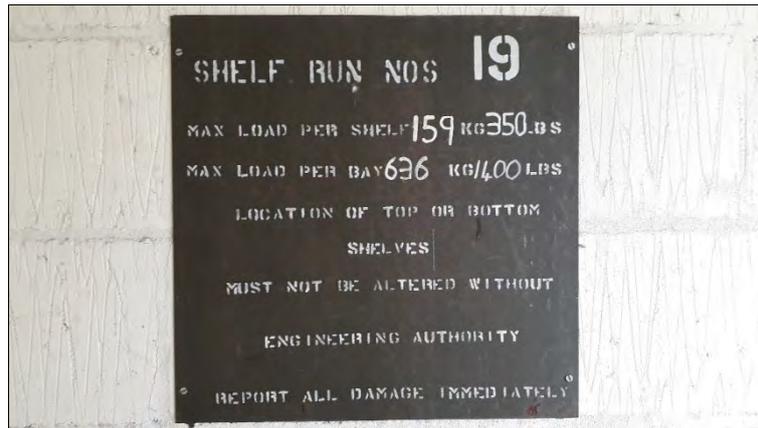
The lean-to was divided into two rooms with the east room the smaller (2.67m by 1.1m east, 3.23m by 1.1m west). Signage in the east room included loading information (Plate BBB).

Plate AAA. Weight loading signage in the lean-to

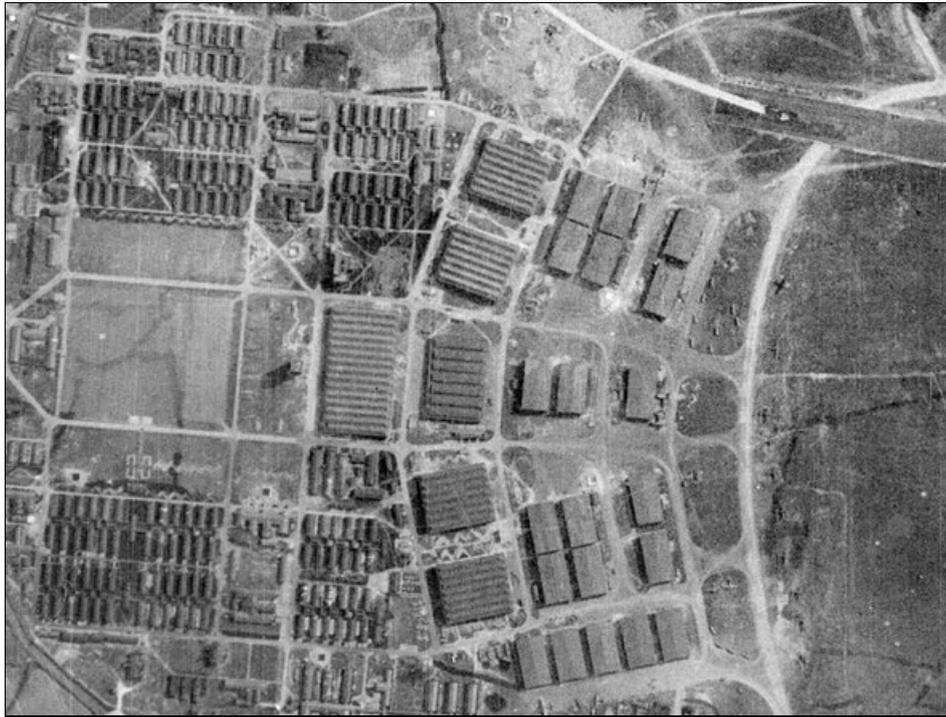
Plate BBB. 1942 photograph clearly showing the workshops, Bellman hangar and Bldg. 354

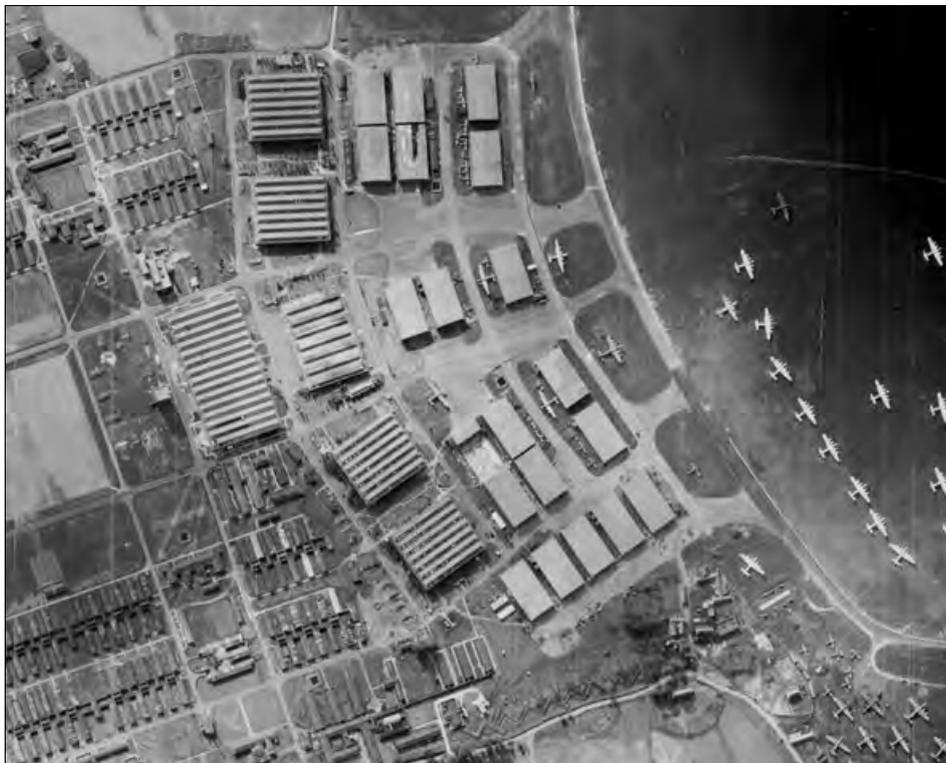
Plate CCC. 1945 photograph with no real change to the layout to that seen in 1942

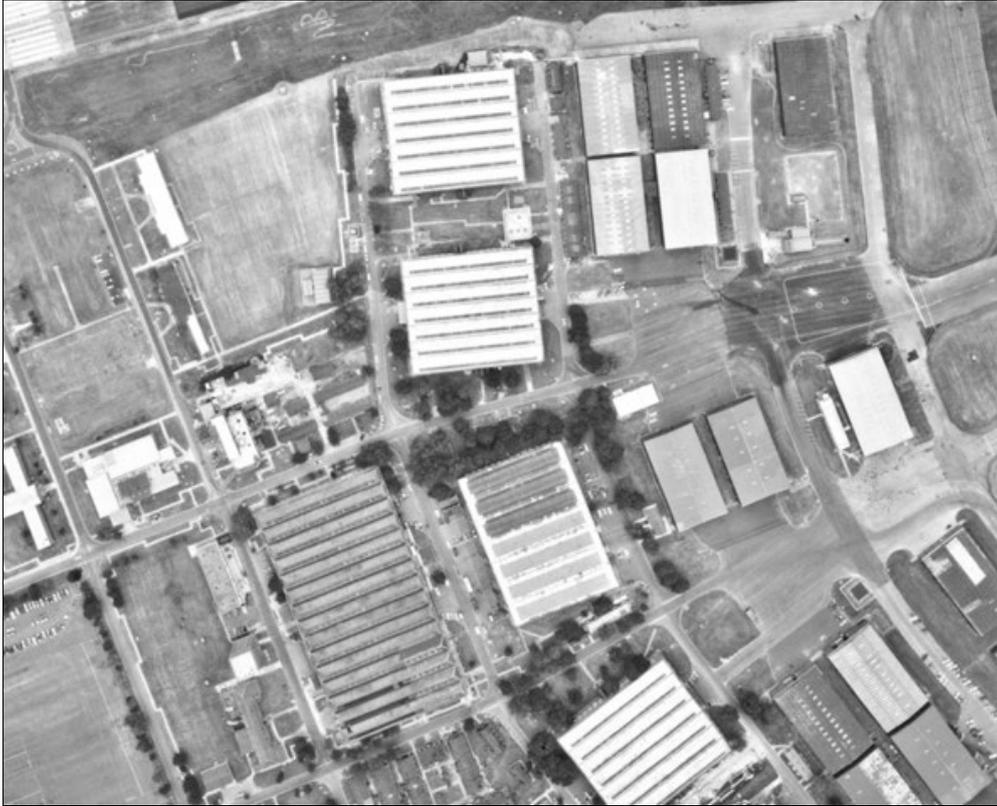
Plate FFF. 1981 general view showing removal of a Bellman hangar and the engine test building in place (top right).

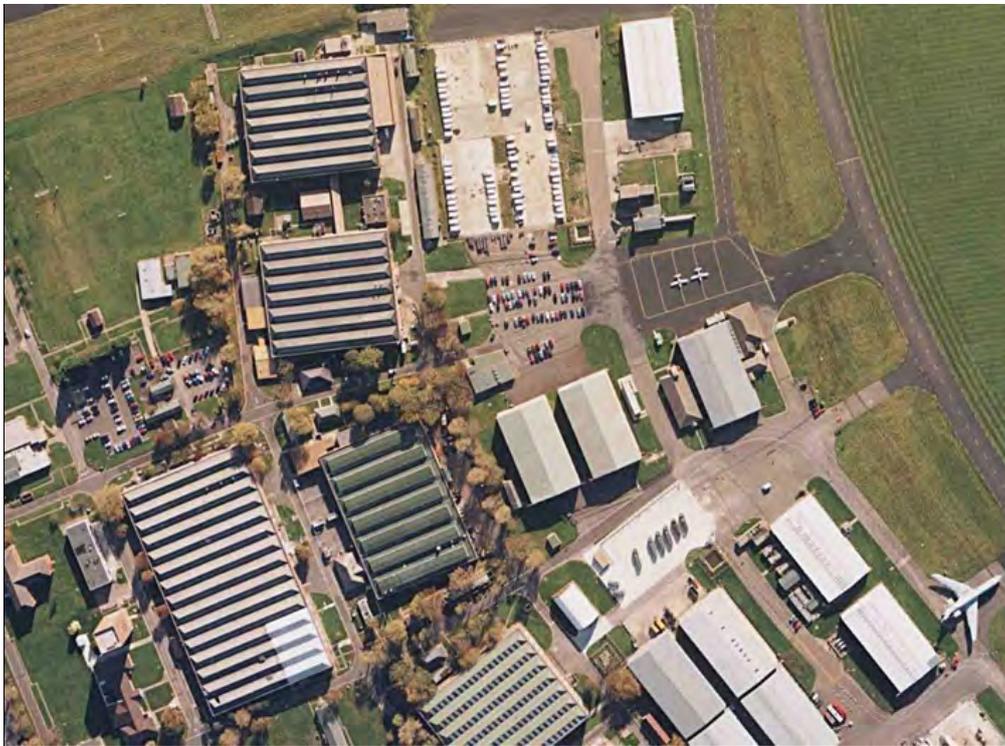
Plate GGG. 2001 photograph showing the Bellman hangar (Bldg. 371, top right) with its new roof, the linking corridor and crew room (Bldg. 375) between the workshops and the ambulance garage (Bldg. 348, upper right) adjacent to the engine test building and the WC block (Bldg. 355) between

The trusses were identical to that issued with the Bellman hangar design. But the roof with two rows of lights had been replaced between 1981 and 1991 evidenced by aerial photographs (Plate HHH).
