Bro Tathan East (former RAF St Athan, East Camp), Vale of Glamorgan

Historic Building Recording. Barrack Block Addendum

Barrack block recording - Barrack 439

Planning Number 2023/00949/Ful
Project Number LD24-049
Client Welsh Government
Date 26/11/2025
Author Tuck M (MCIfA)
HER Search No. 9086 (13/11/2024)
Grid Reference ST 01330 68834 (barrack blocks centre)
ST 01387 68895 (centre barrack 439)

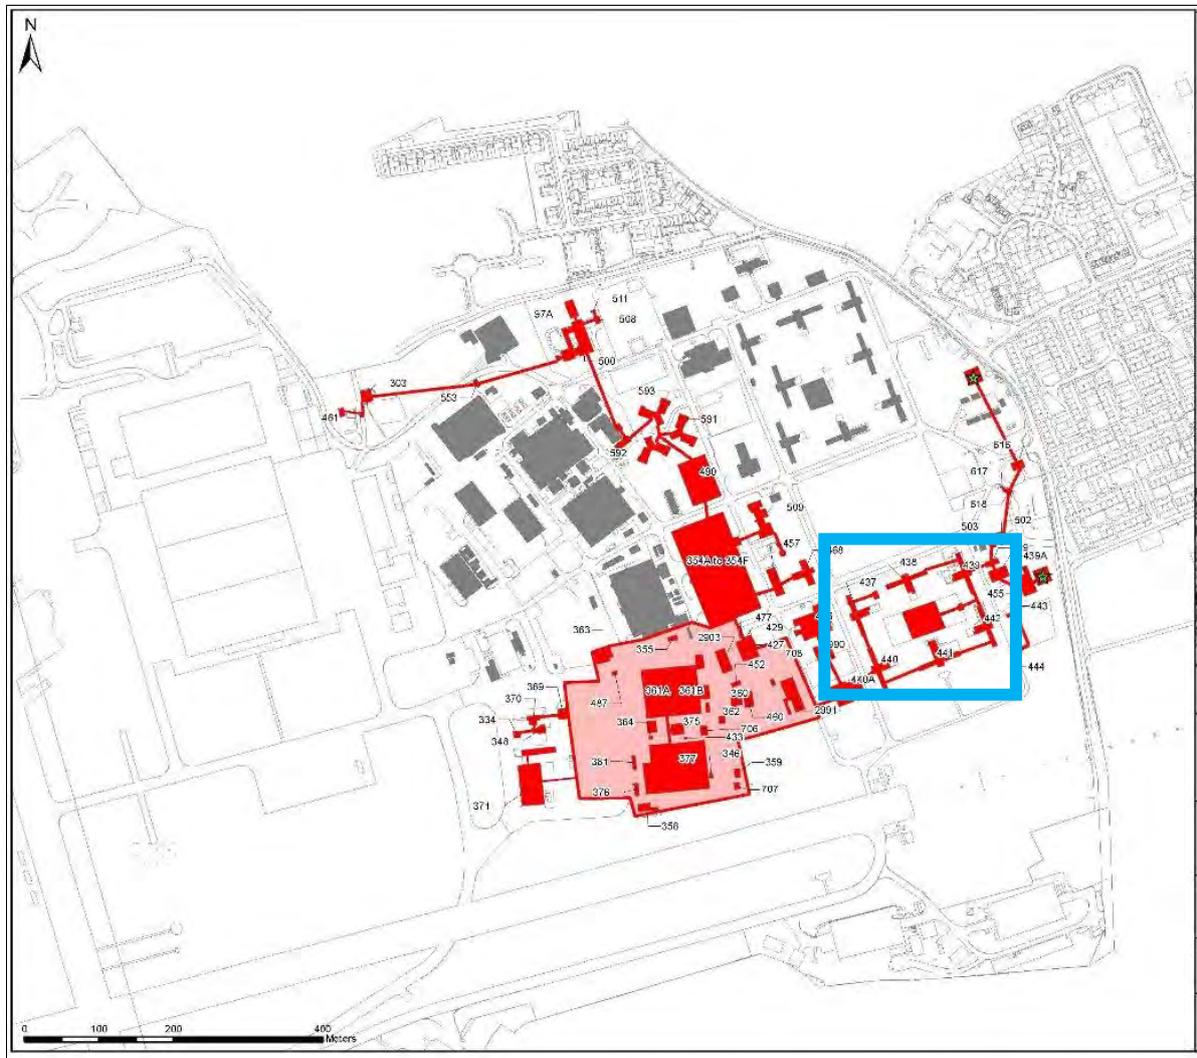
Figure 2. Barracks location (blue rectangle) in relation to the other buildings for demolition (Red).
Grey - previously demolished buildings.

Several phases of demolition works have already taken place at the Bro Tathan site and to clear the site, further buildings, infrastructure, foundations and areas of hardstanding are to be removed (Rio Architects 2023). The proposed demolition area includes additional buildings to those subject to historic survey (Figure 2).

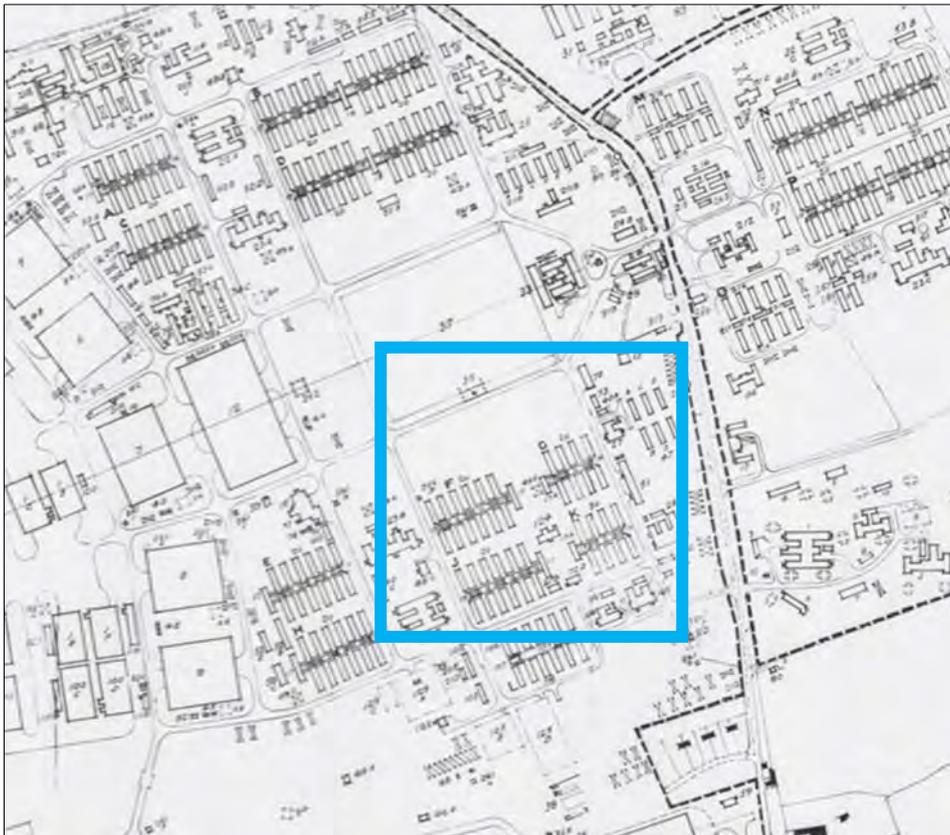
Figure 3. 1944 plan extract showing the earlier extensive wooden hatted barracks with the area of the 2025 surveyed barracks within blue outline

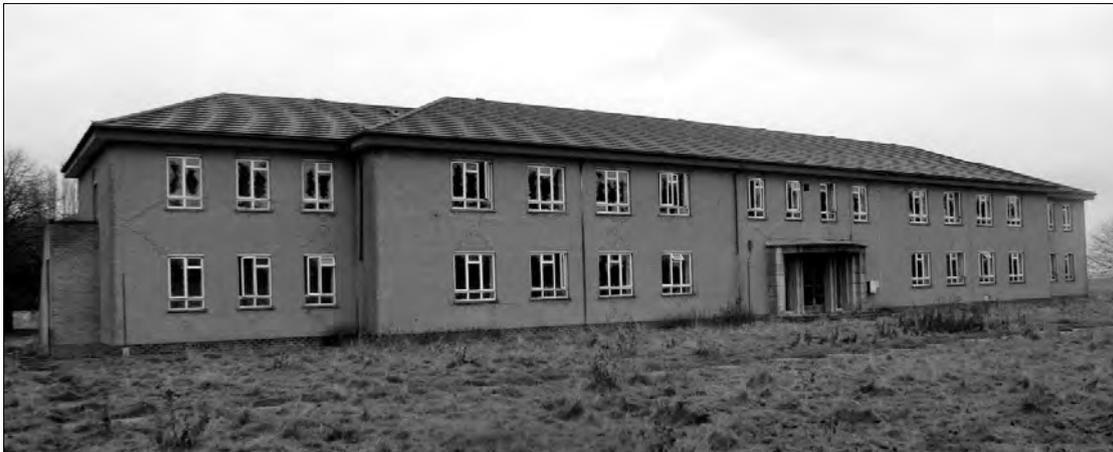
Figure 4. A 1950 style barrack block at Upwood – the original flat roof has been over clad with a hipped one. Photo: 2008

The 1950 version was arranged with a central hall and rear staircase, but ablutions were split between the wings with WCs on one side and lavatories and showers on the other. The wings were further subdivided into four-man dorms served by a corridor. The central dorm at the front on the first floor had five beds making a total of 81 NCOs and central aircraftsmen per barrack block. In 1955, the design was changed slightly from having external inner leaf walls of in-situ concrete to concrete block, the outer leaf remained the same in 4.5-inch facing bricks. The flat concrete slab roofs were retained until 1980s / 1990s when a pitched roof was added to the existing one. They were built to supplement existing accommodation on operational RAF stations as well as technical training schools such as No.1 Radio School at Locking and five were erected at RAF Hereford.

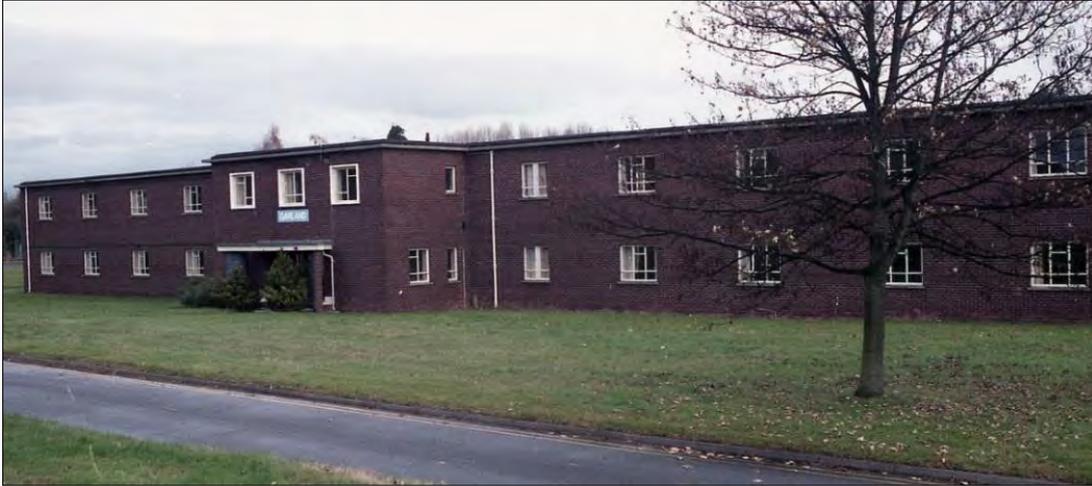
Figure 5. One of the barrack blocks at the former RAF Hereford – all now feature pitched roofs above the original concrete slab. Note the original windows. Photo: 1999

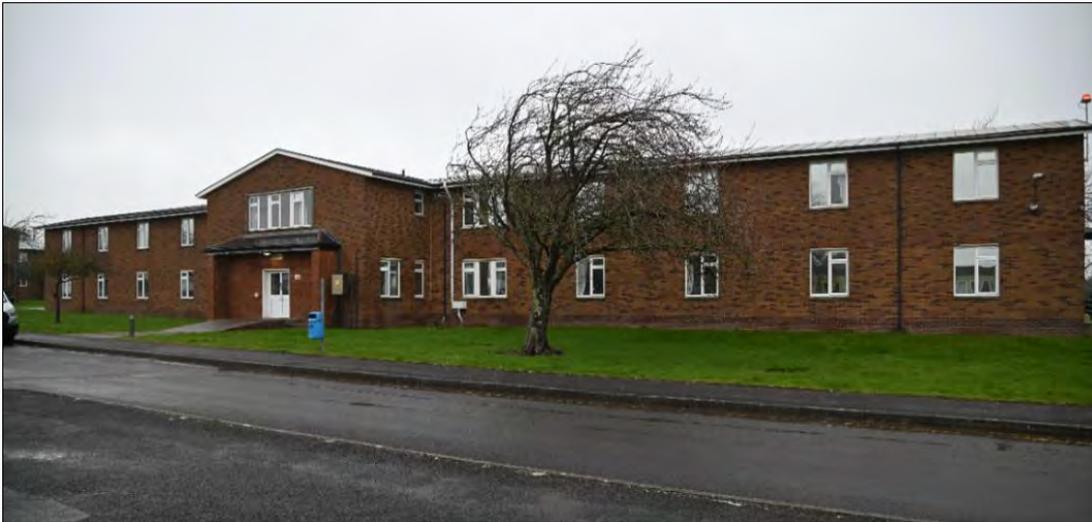
Figure 6. An equivalent building (Bldg.440) on East Camp – note the red hazard light (far right). Photo: 12-02-2024

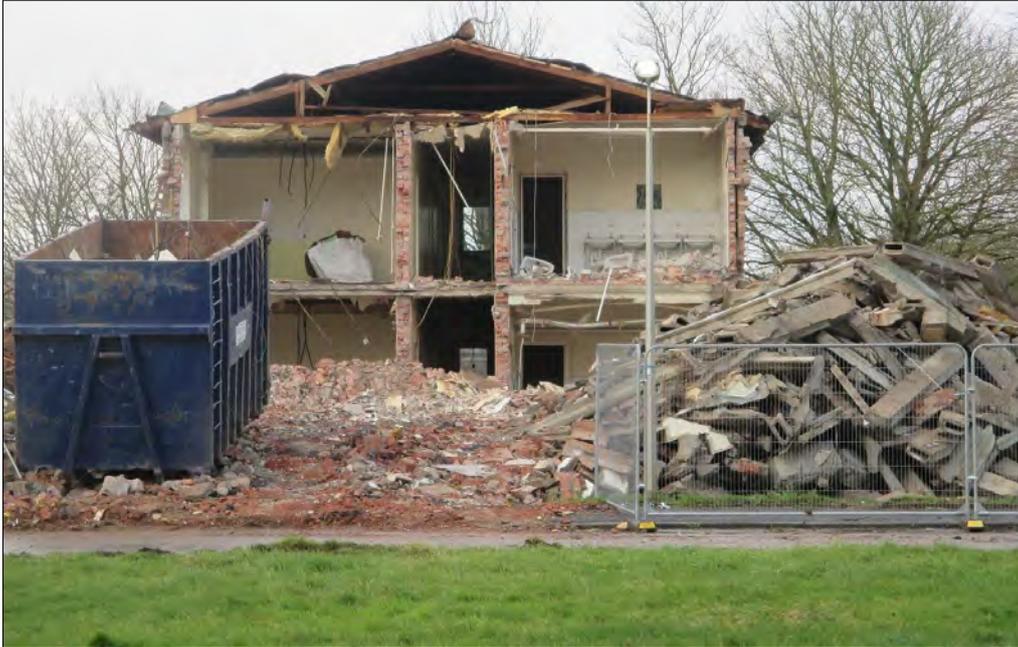
Figure 7. Demolition of the eight St Athan (northern) barrack blocks in January 2020. This shows the ablation annexe with central 9-inch brick corridor, the 11-inch cavity brick exterior walls (stretcher bond) and a simple roof structure of timber purlins. Photo: Hugh Turner on Flickr

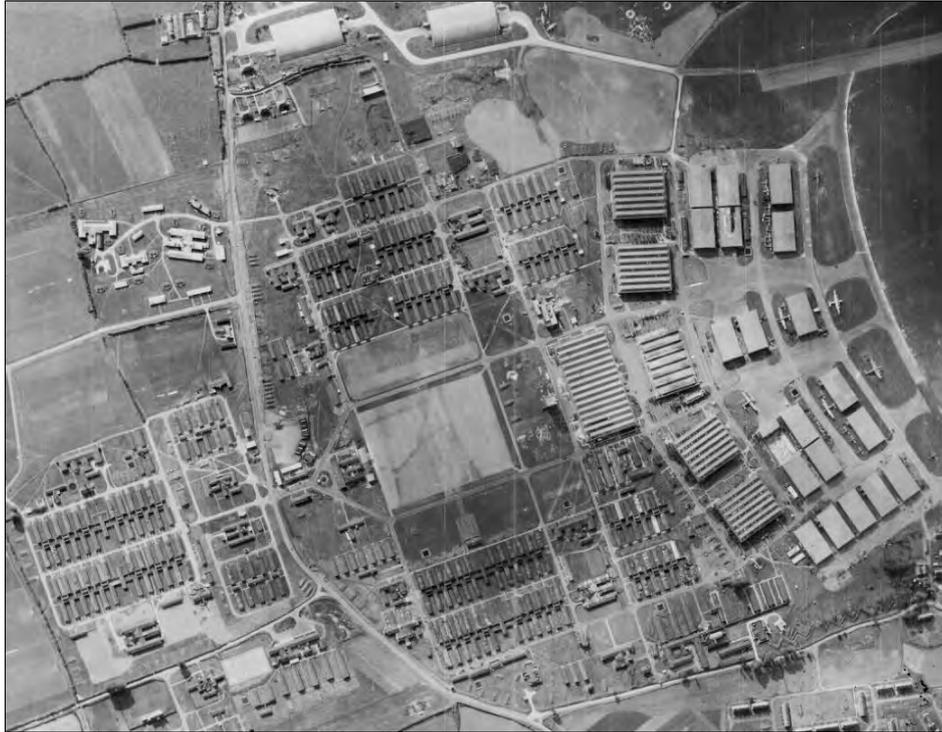
Figure 8. Extract from 1942 (4221 RAF Medmenham 2267 042) showing the extensive wooden hutted accommodation. North to bottom of frame

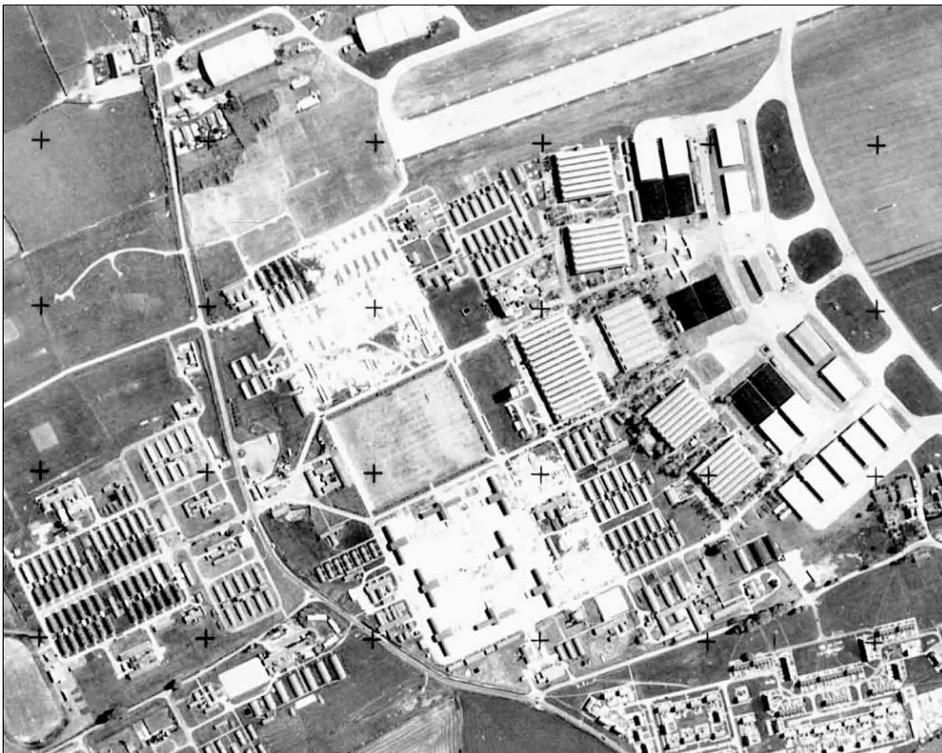
Figure 9. Extract 1963 (OS63 -54 074) showing the new north barracks and work underway on the south barracks. North to bottom of frame

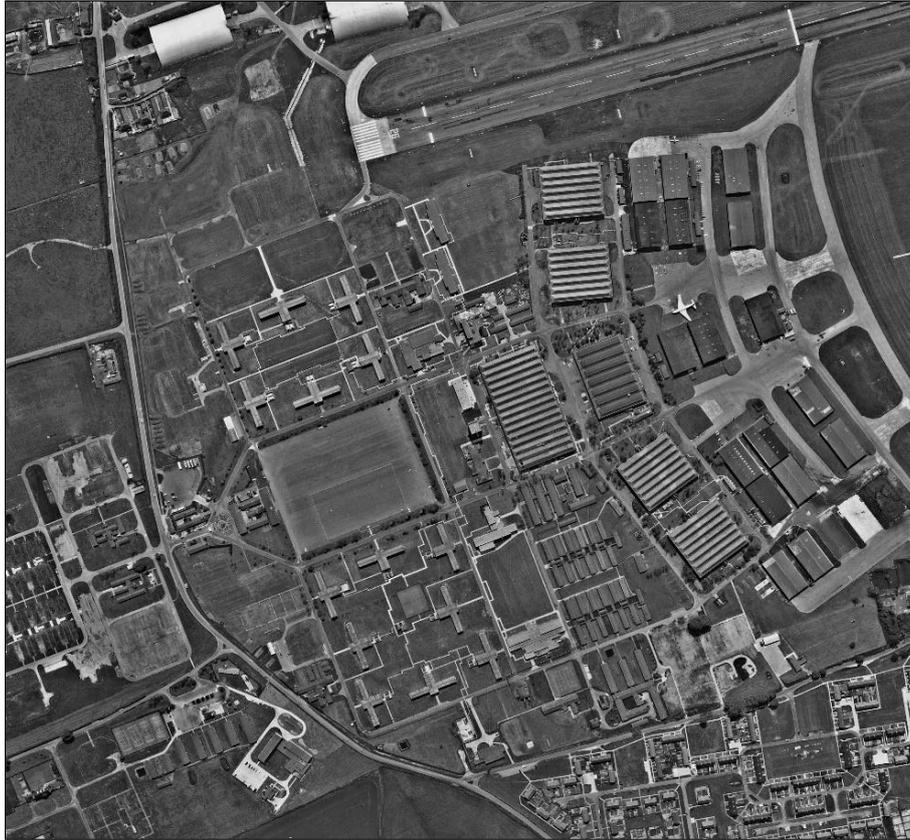
Figure 10. 1969 view of north and south new barrack groups on either side of the parade square (6935 OS69_153 230). Note - 8 barrack blocks in the north but only 6 to the south. To left of frame are surviving wooden huts. North to bottom of frame

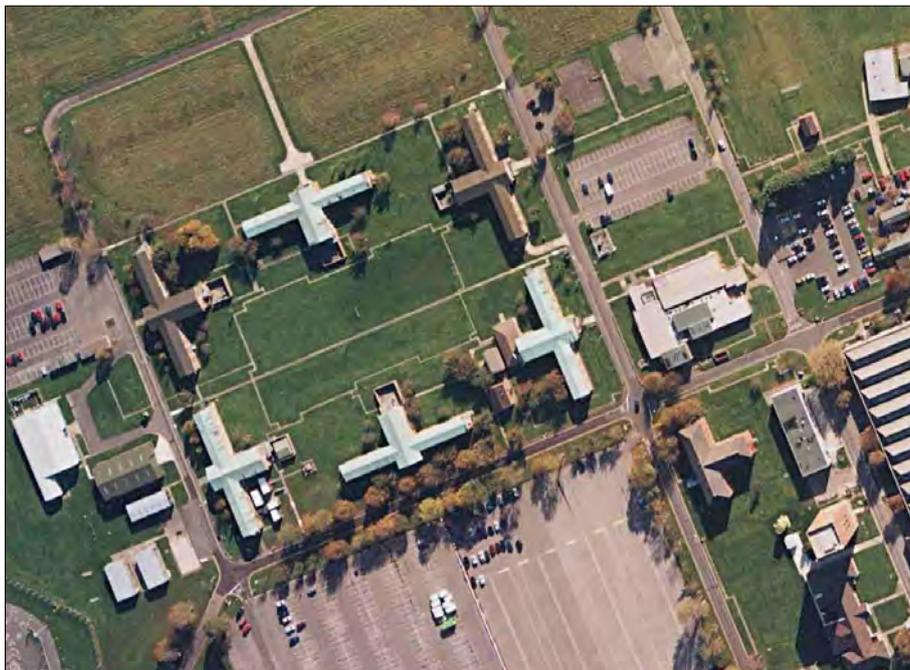
Figure 11. The south barrack grouping in 2001 (2001_11 OS01_1018 1485) showing barracks 442 (left) and 440 (right) with replacement roofing. North to bottom of frame

All barracks were of similar external appearance with the main difference in the use of spiral or straight flights fire-escape staircases (Plates 82, 83, 84), and that roofs on Buildings 440 and 442 although in apparent similar sheets did not have the raised ridge board and were not copper sheeted. It is assumed that these were replacement roofs.

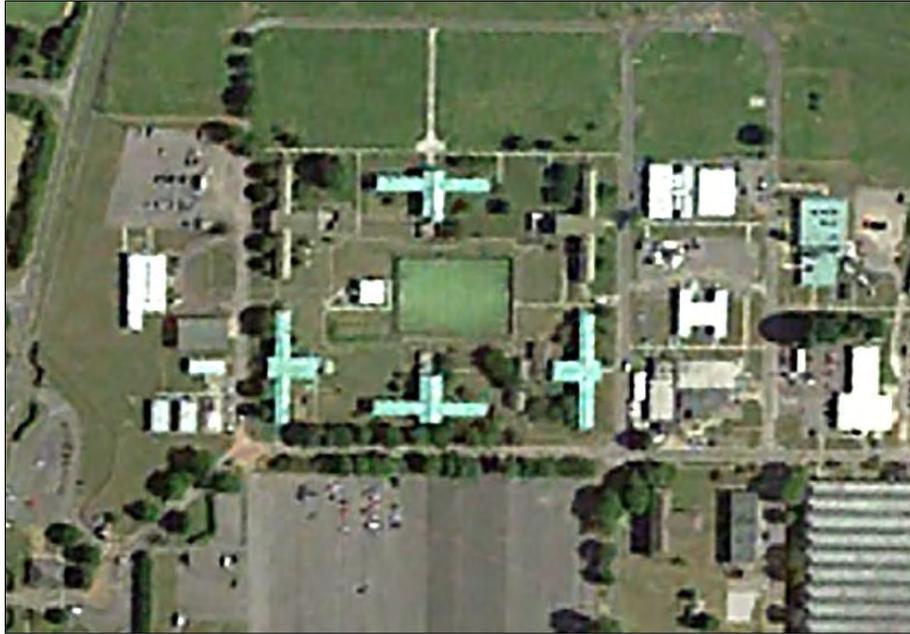
Figure 12. 2018 Google Earth Pro photograph (supplied by CRAPW) showing the sports pitch and demountable building and adjacent earth mound. North to bottom of frame

The earliest aerial photograph, a Luftwaffe photograph from January 1941 shows the extensive original (1938) wooden hatted accommodation to the east of the workshop buildings and taken together they appear to occupy a similar land area to that of the workshops and hangars (Figure 8 shows the huts unchanged in 1942, and Figure 3 a 1944 plan of the huts). Here hatted accommodation remained as the standard until well into the 1950s when a programme of modernisation took place with barrack blocks constructed in brick. The Francis and Crisp report (2024) include an image from 1962 (RAF58 /5098 frame 0381, Date 02-05-1962) showing near completion of the north group of new build barracks, with to the south and east original wooden huts. That work in the north appears to be completed by 1963 where another image (Figure 9) appears to show work taking place on the south group of new build barracks. Thereafter until the present, there appears to be little change visible in the photographs except for by 2001 (Figure 11) reroofing on two of the barrack blocks (440 and 442). Although there was no change to the barrack buildings a 2018 photograph shows provision of a sports pitch, demountable building and an earth mound (similar in shape to an air raid shelter mound) in the area between the six buildings (Figure 12).

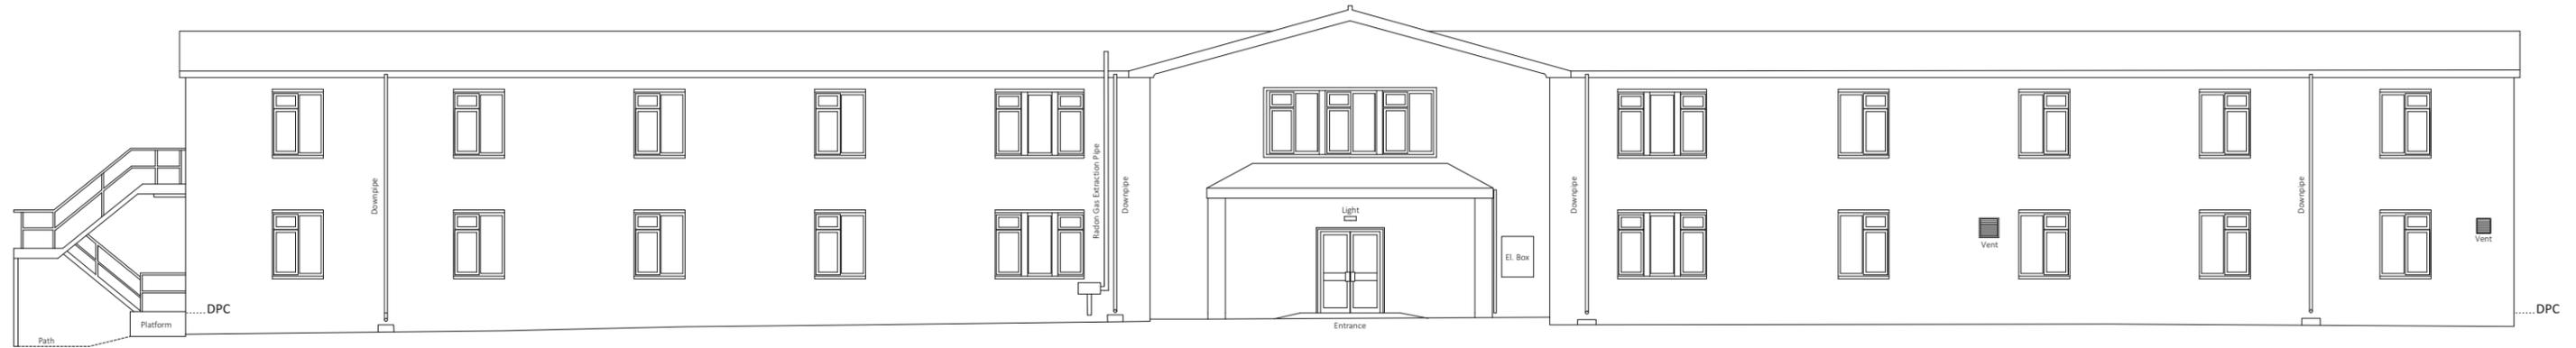
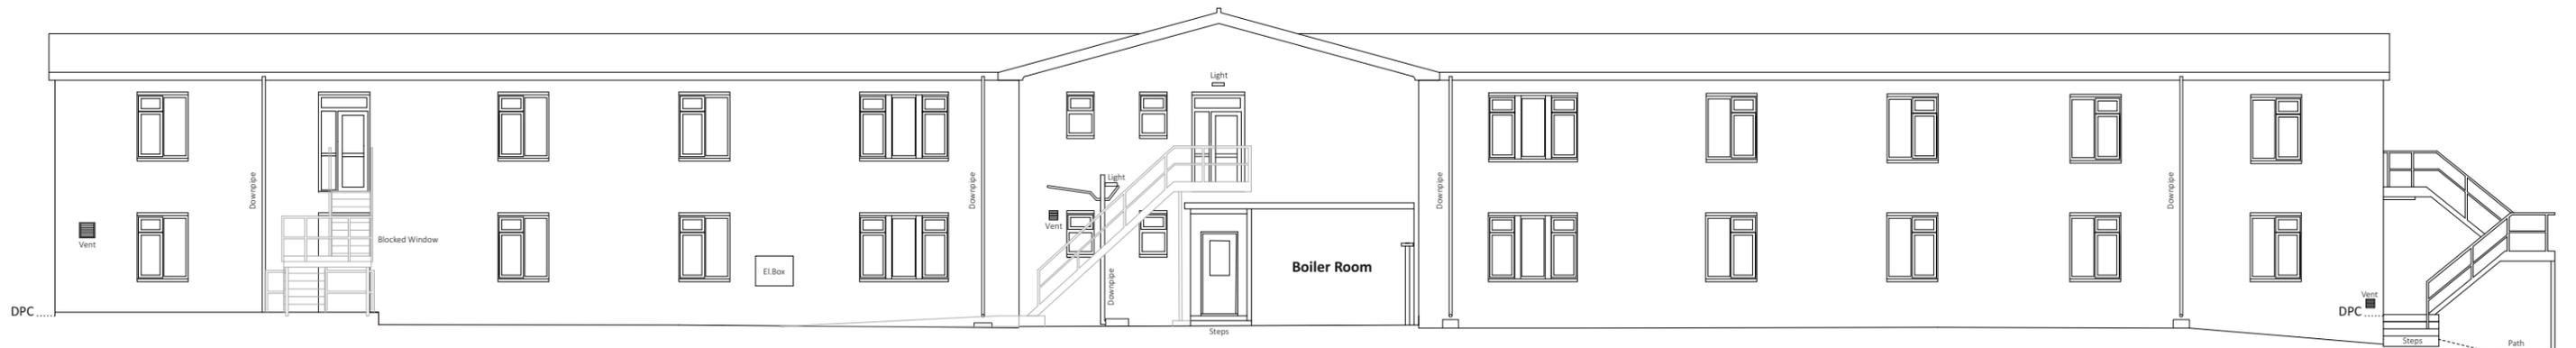
Barrack Block 439 East & West Facing Elevations

Front (East) Facing Elevation

Rear (West) Facing Elevation

The main access for entry and exit was the double doorway in the northeast facing elevation; there were seven doorways in total. The six original doorways in the dormitory wings and at the rear (all in line vertically) were fire exits and not intended for regular usage. Subsequent adaptations to the north wing doorways resulted in replacement of the first-floor doorway with a window and adaptation of a window opening to replace the door it in the west facing elevation. Each first-floor doorway was accessed by fitted external steel staircases.

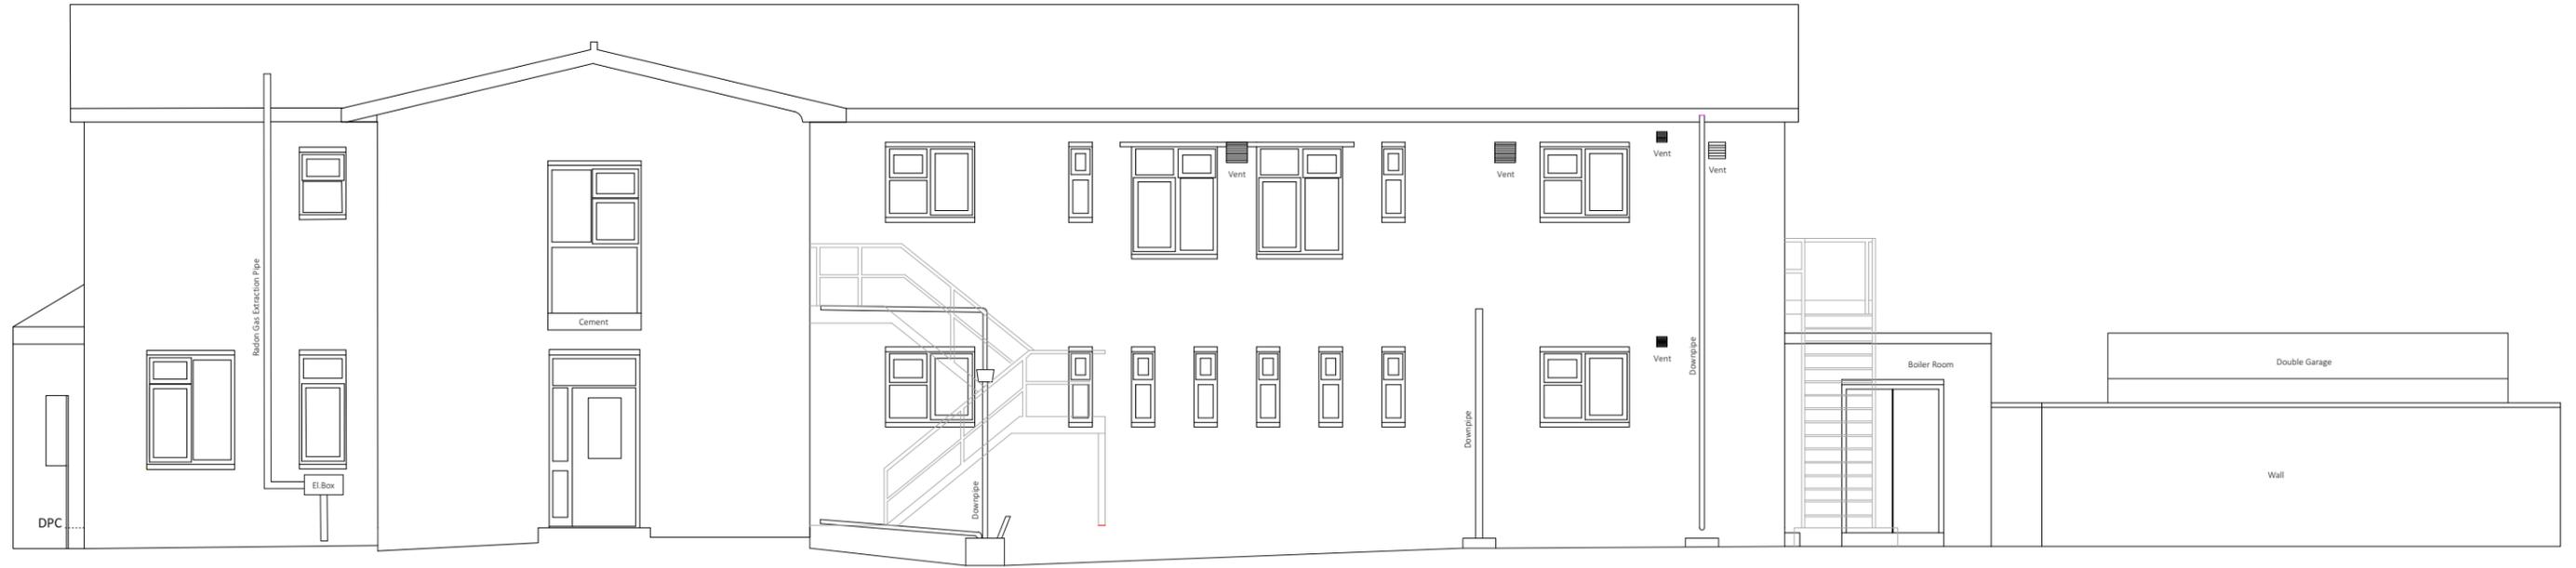
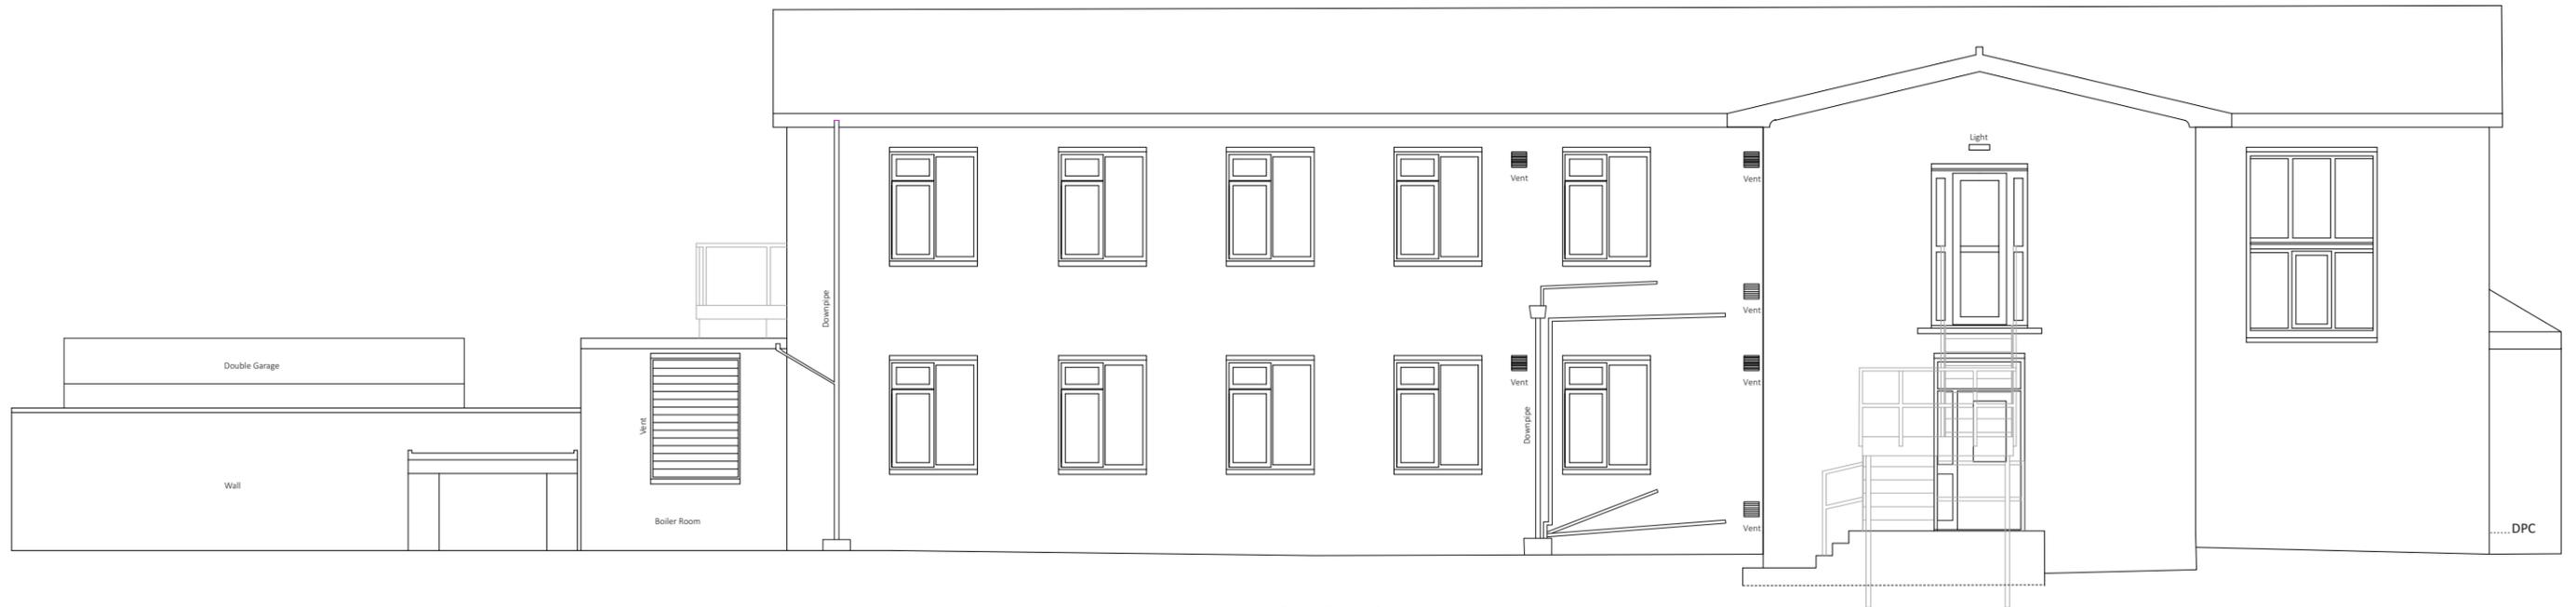
Barrack Block 439 North & South Facing Elevations

North Facing Elevation

South Facing Elevation

The elements of the 6.28m wide north facing gable comprised a ground floor single wooden doorway (1.32m wide overall by 2.52m high) with glazed panels over and to the side, and a window at first floor level, both central to the span. The window (2.14m high) was a replacement for an original doorway (1.36m wide (slightly wider than the lower doorway and common to the other similar elevations) by 2.4m high) with cement infilling below the base of the window frame to fill the difference in height and probably to make good a removed fire escape staircase; This may have been a spiral staircase as observed elsewhere (barrack 442, 438), however a replacement staircase was transferred to the west facing elevation (Plate 14).

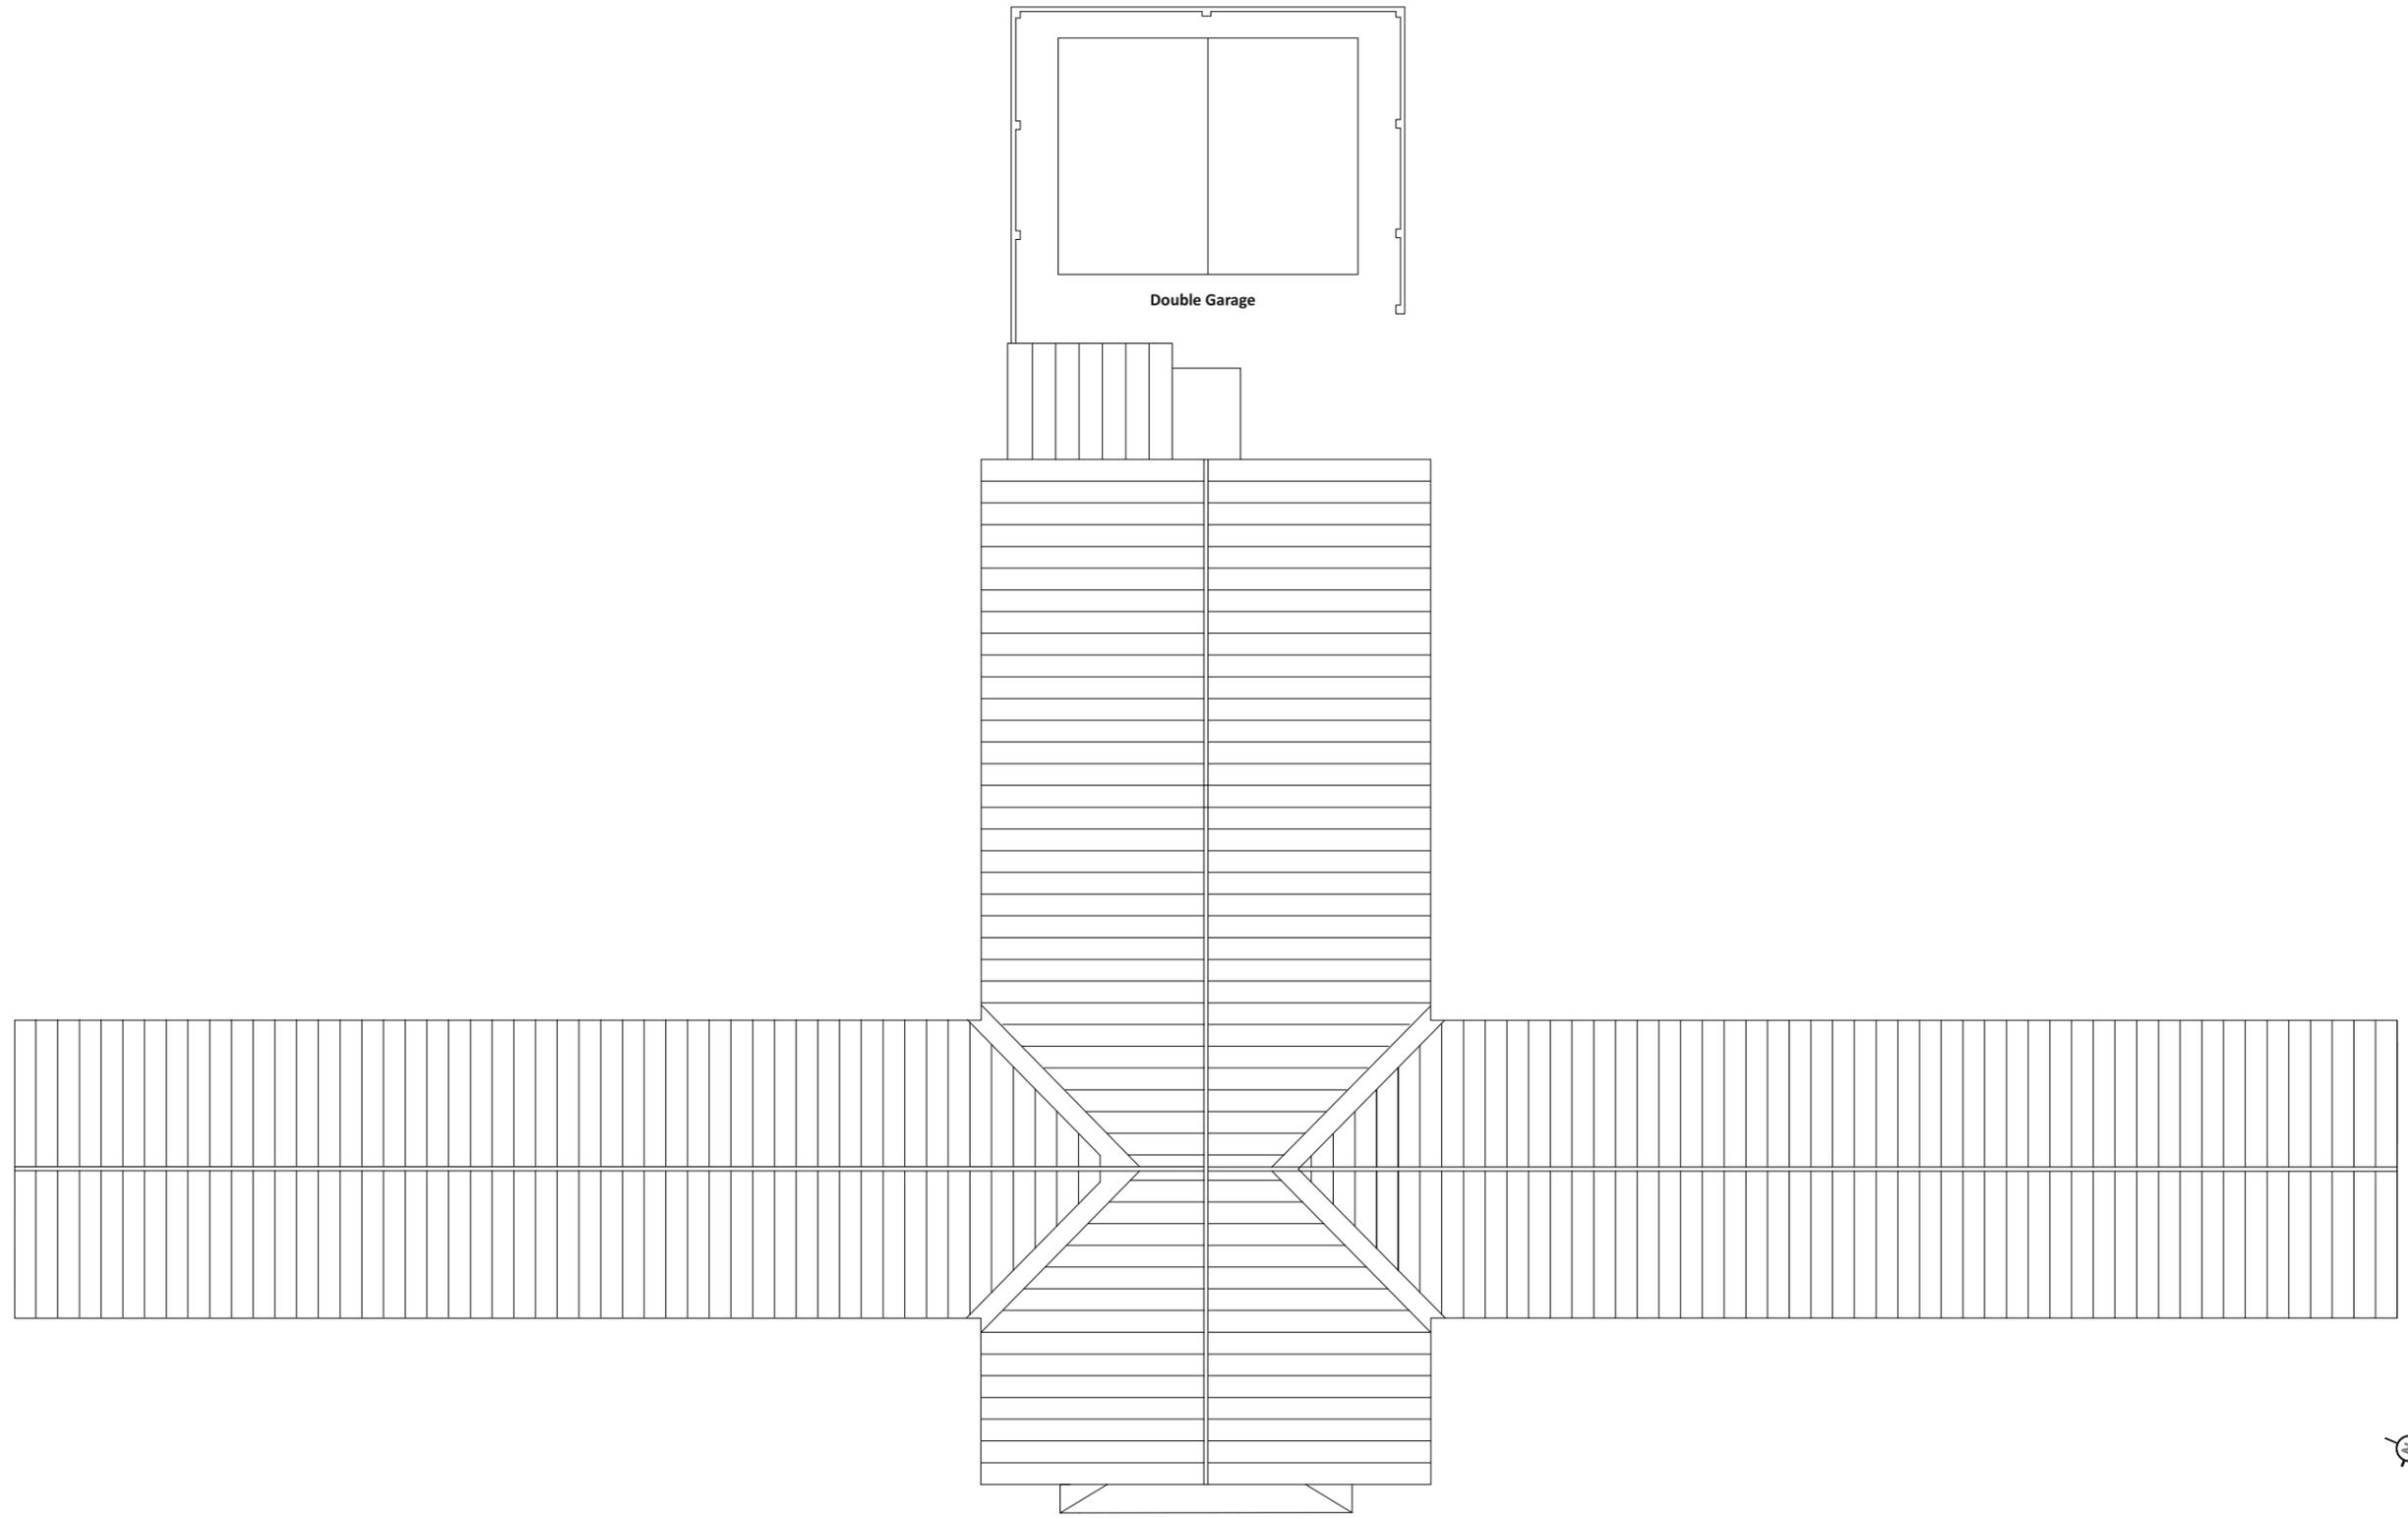
Barrack Block 439 Roof Plan

Project Title Barrack 439, East Camp, St Athan Vale of Glamorgan Historic Building Recording	Project Number LD24_049	Figure Number Figure 15. Barrack 439 Roof Plan Surveyed to 1:200 scale	© Copyright The Trust for Welsh Archaeology (HENEb)
	Report Number 2025/045		
	Survey & CAD MT		
	Digitised SL-J

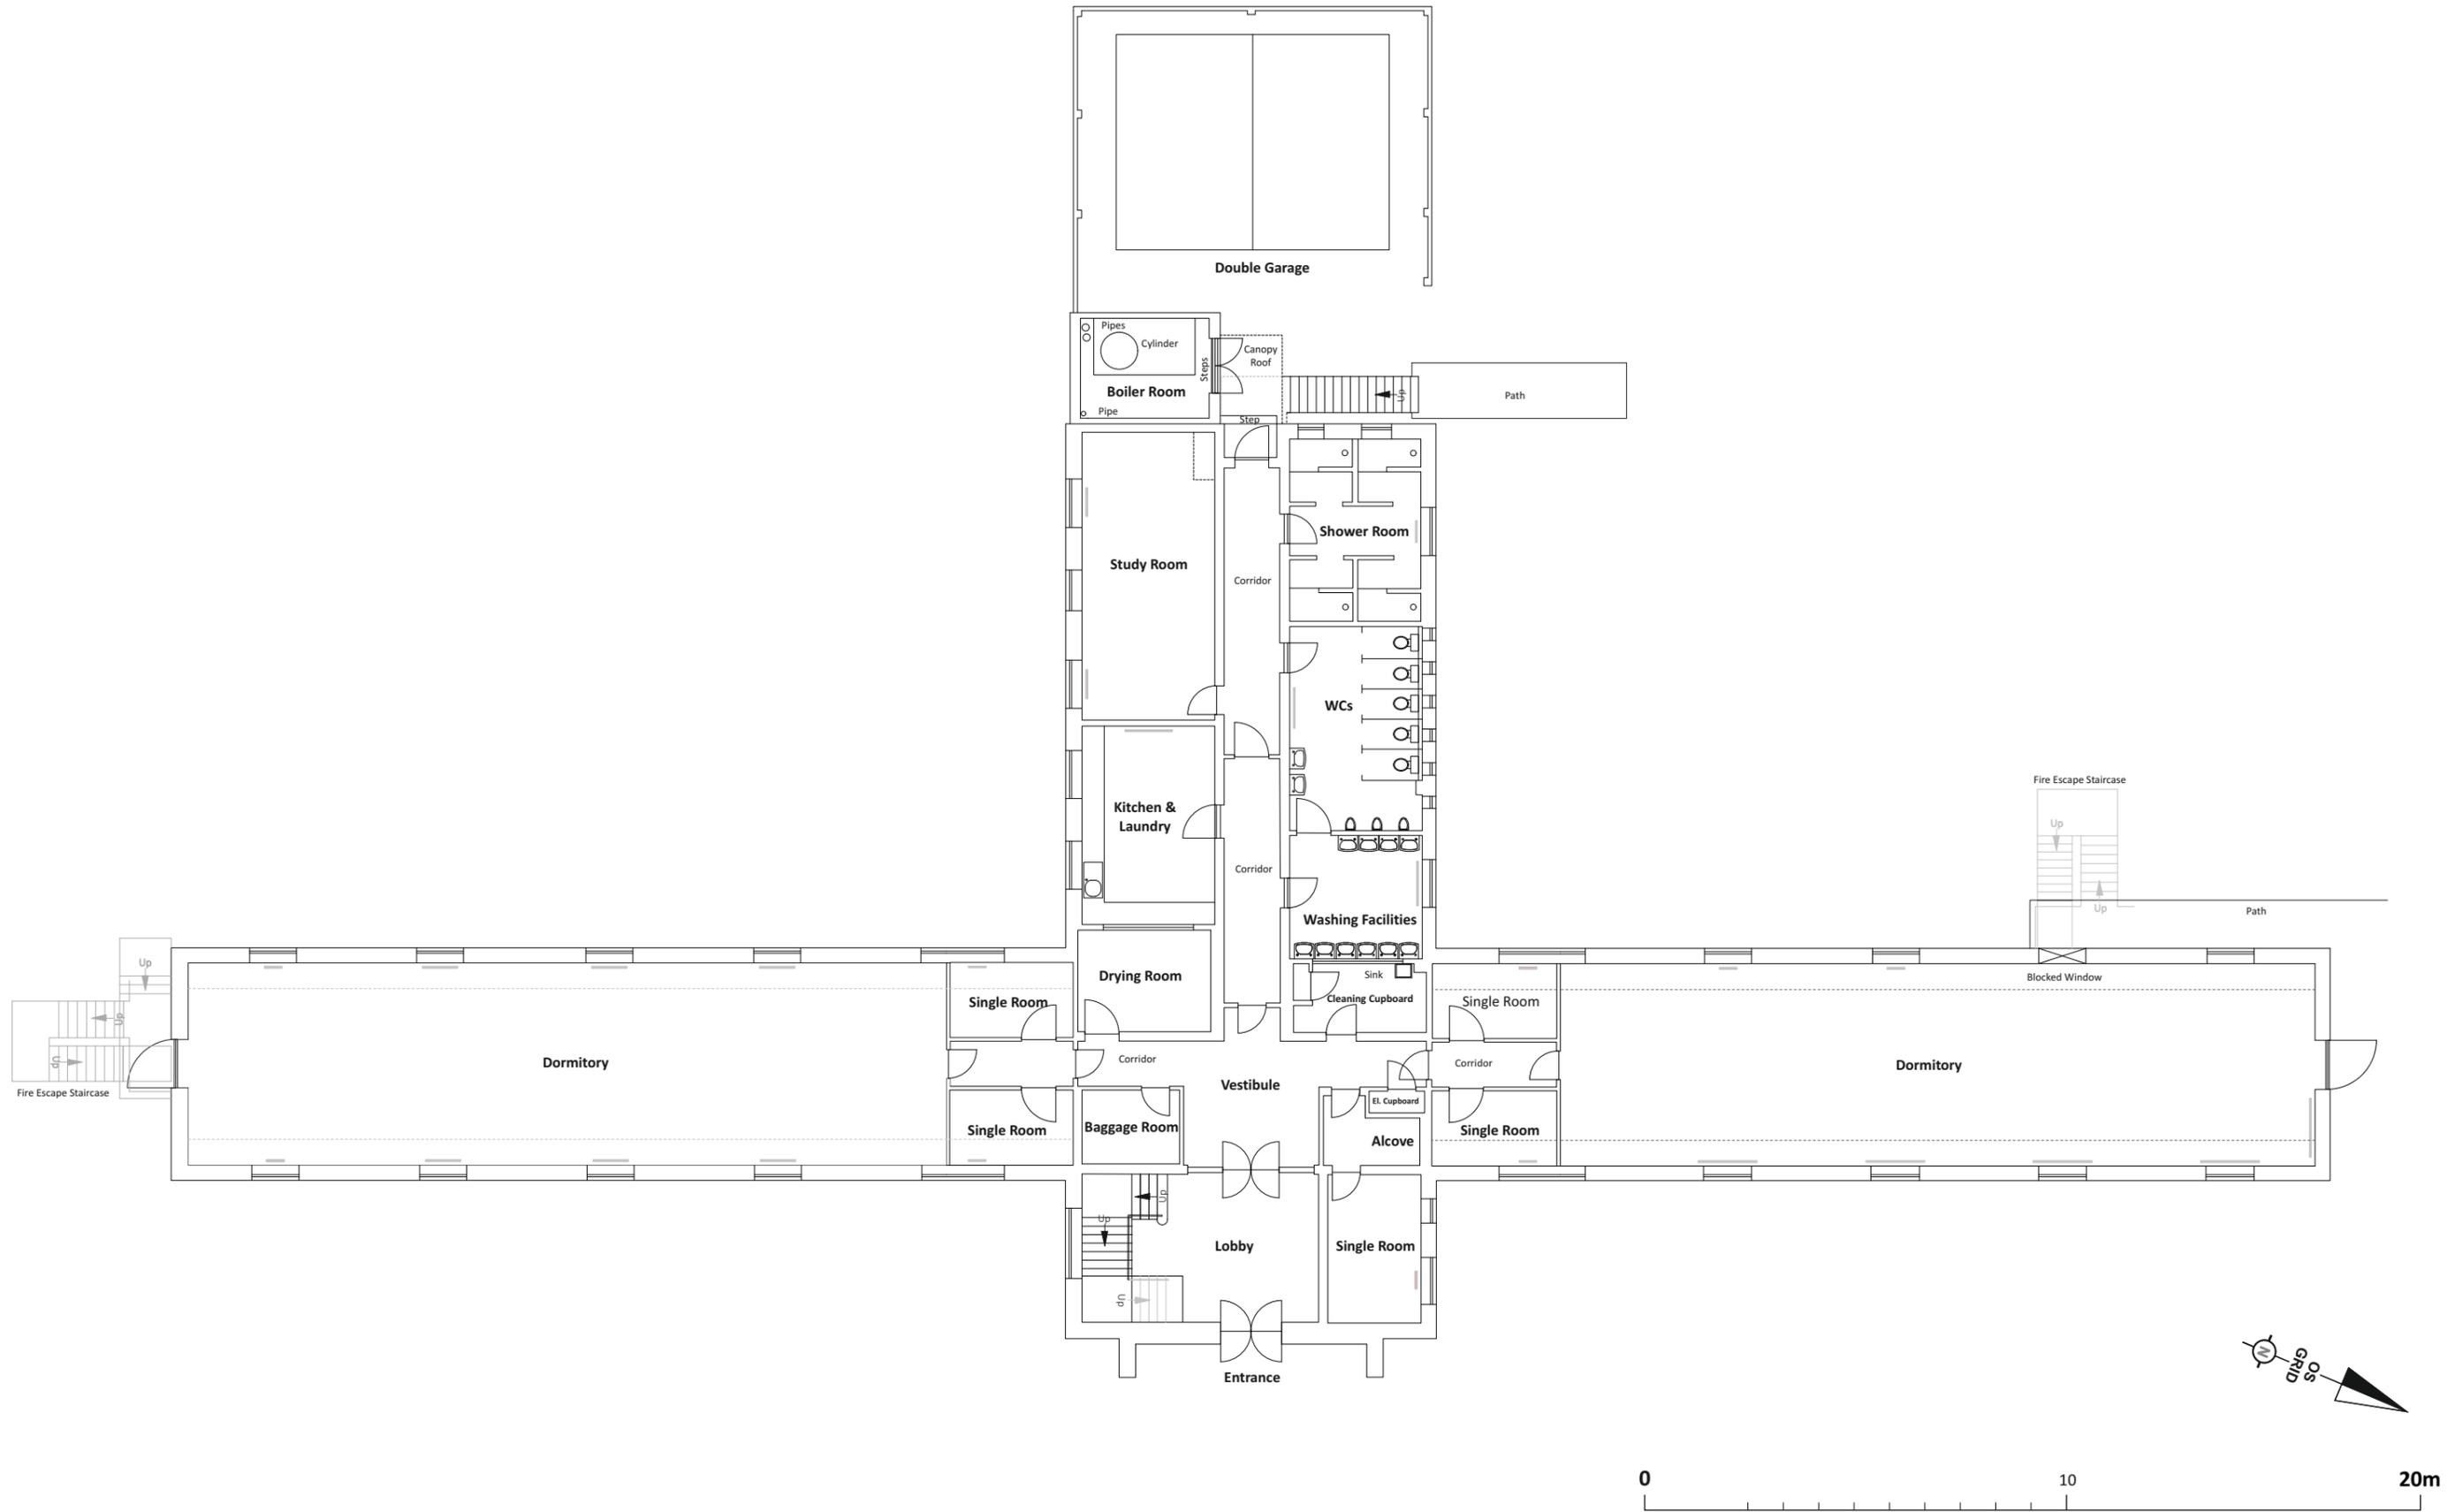
Barrack Block 439 Ground Floor Plan

Figure Number	Figure 16. Barrack 439 Ground Floor Plan
Surveyed to 1:200 scale
