Bro Tathan East (former RAF St Athan, East Camp), Vale of Glamorgan

Historic Building Recording. Barrack Block Addendum

Barrack block recording - Barrack 439

Planning Number 2023/00949/Ful
Project Number LD24-049
Client Welsh Government
Date 26/11/2025
Author Tuck M (MCIfA)
HER Search No. 9086 (13/11/2024)
Grid Reference ST 01330 68834 (barrack blocks centre)
ST 01387 68895 (centre barrack 439)

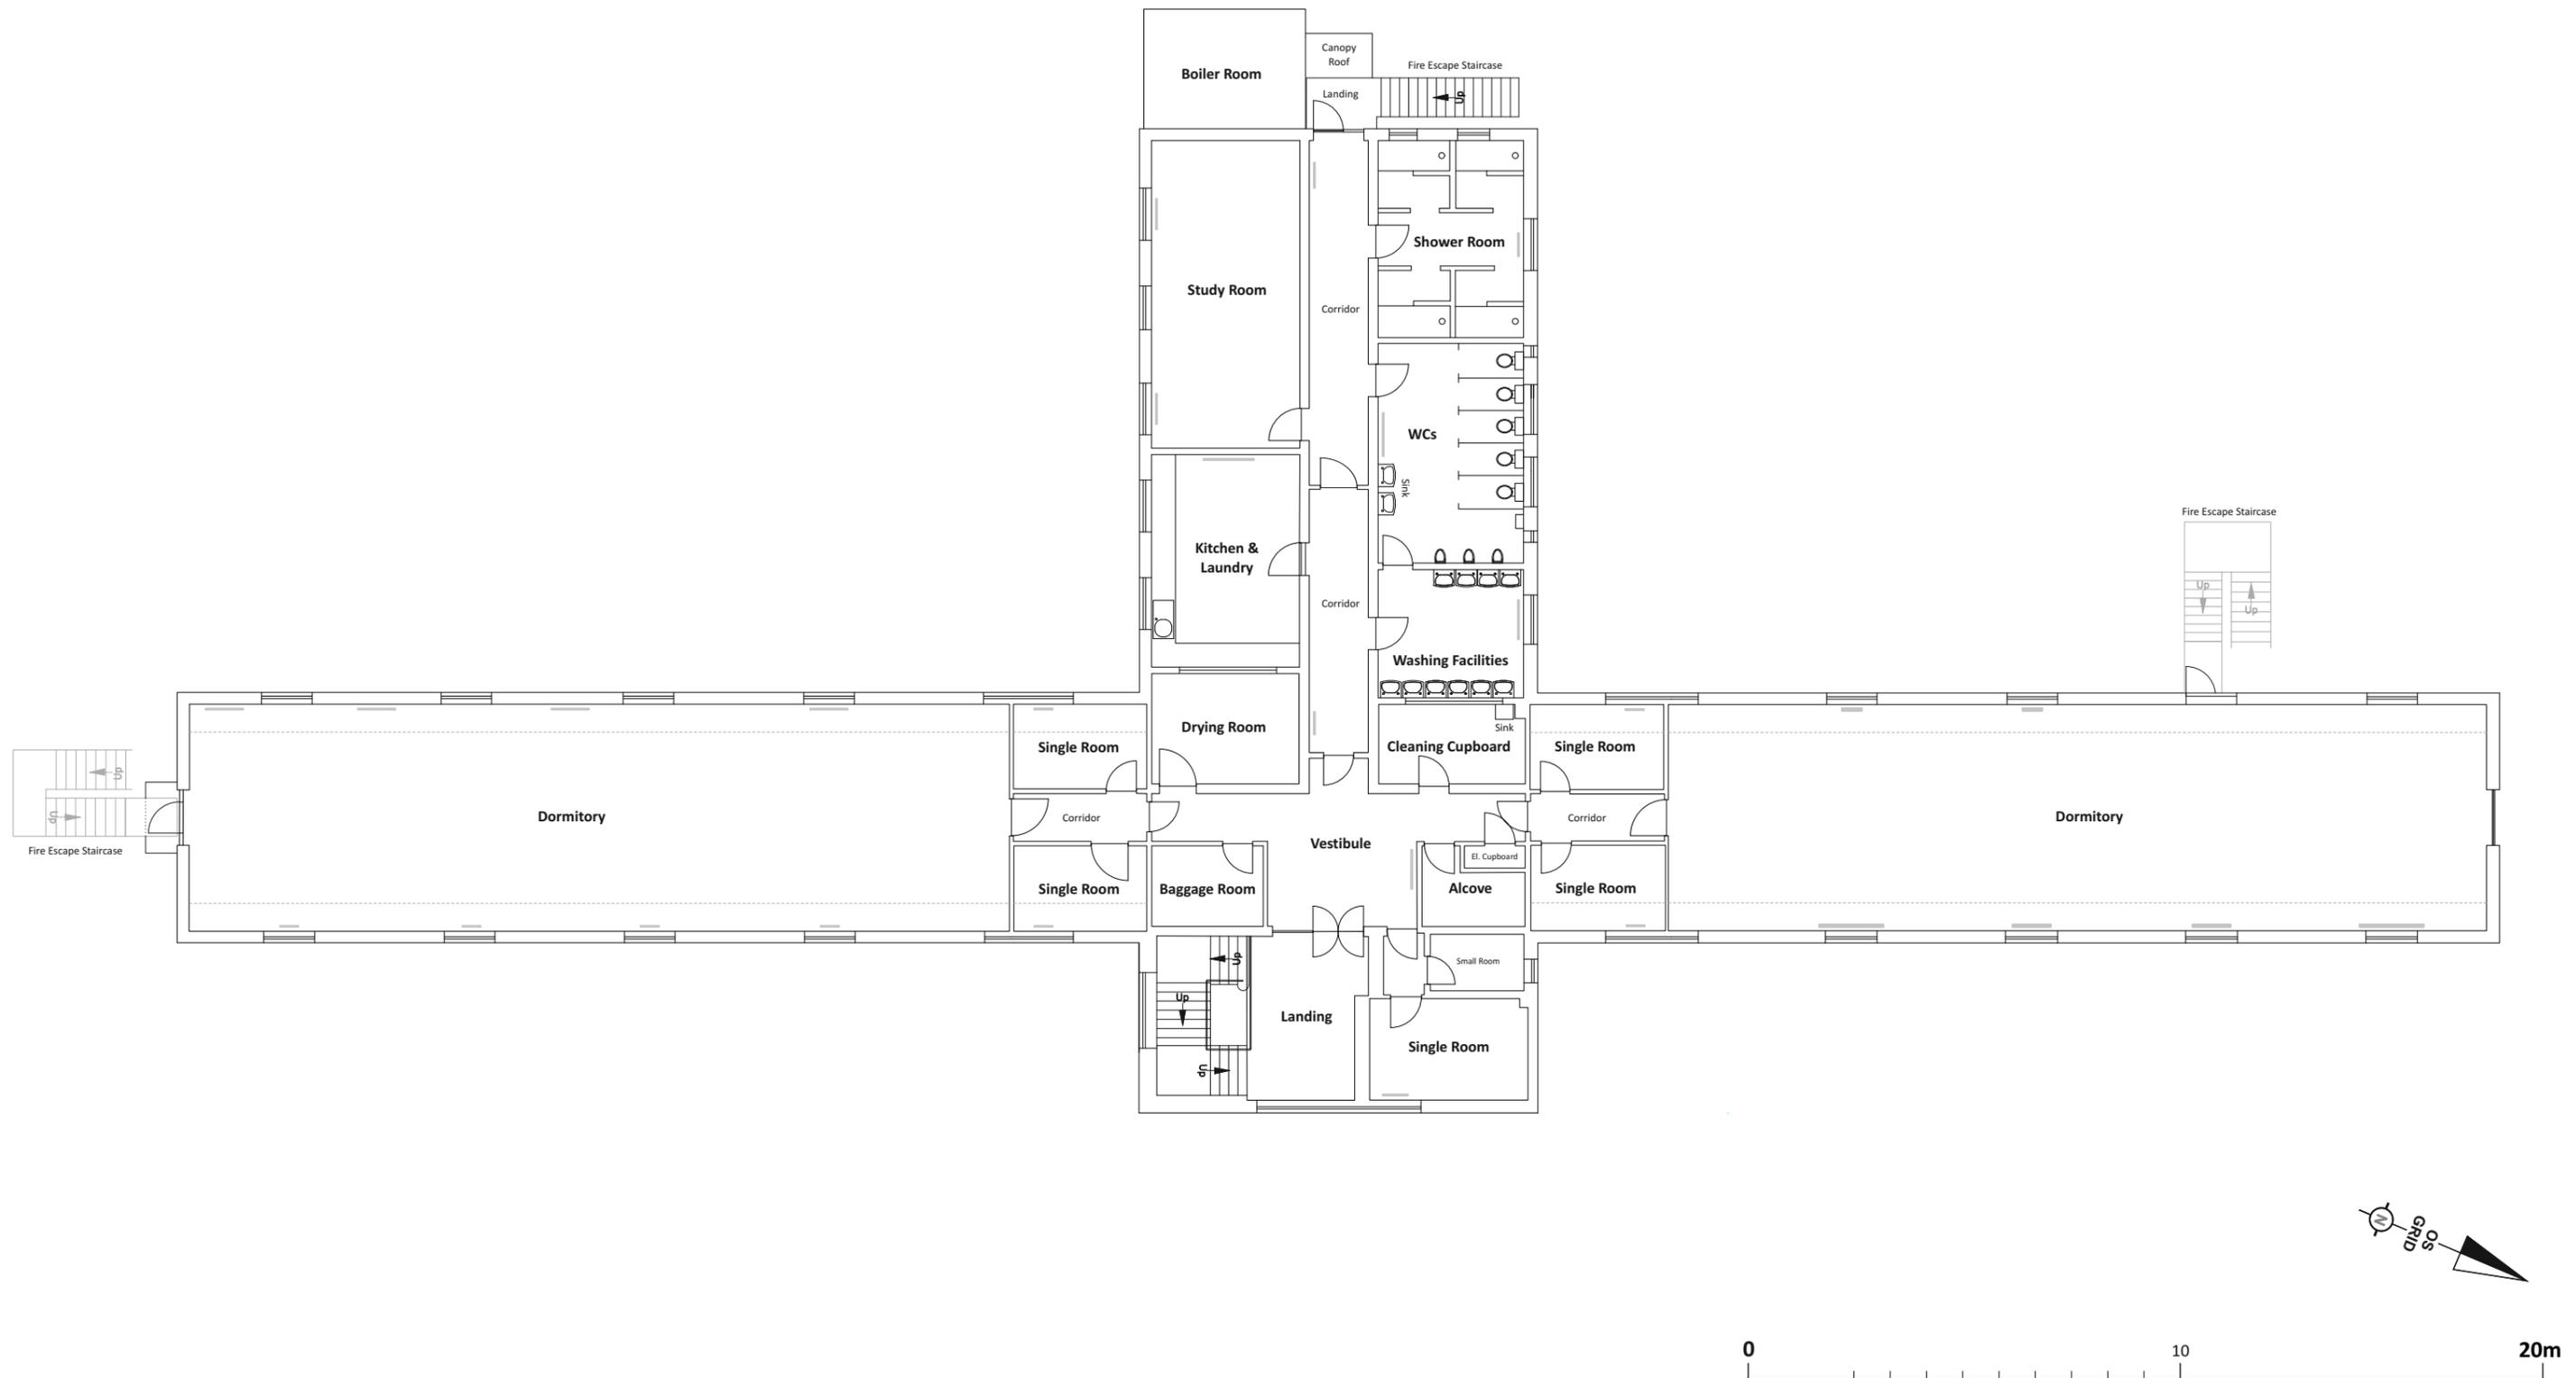
Barrack Block 439 First Floor Plan

Figure Number	Figure 17. Barrack 439 First Floor Plan
	Surveyed to 1:200 scale

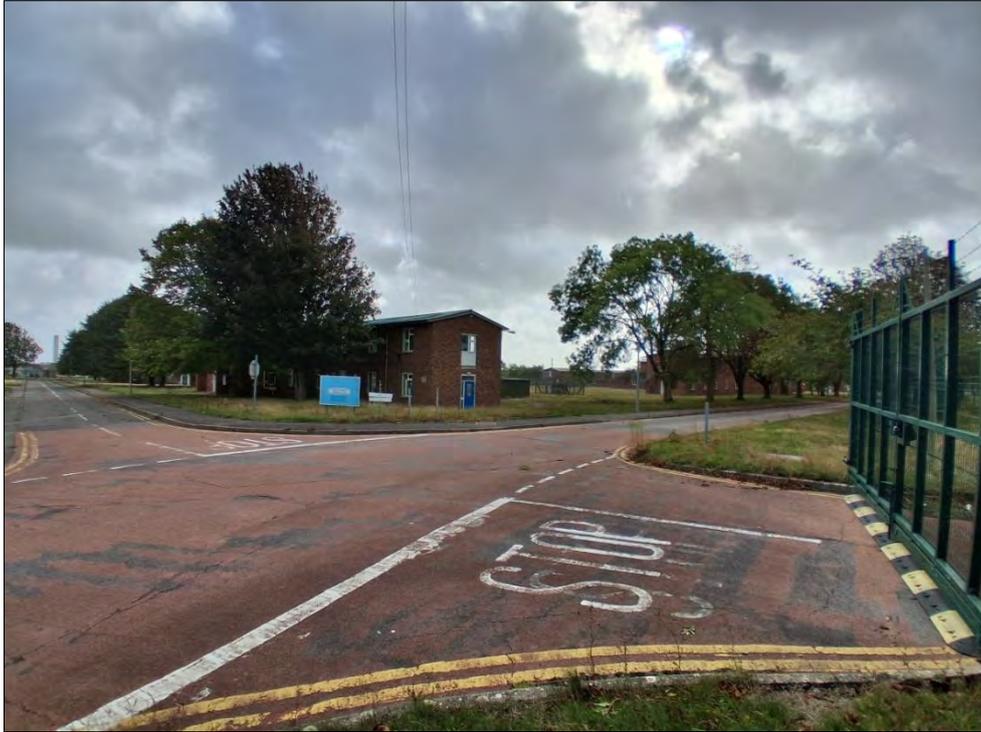
Plate 1. General view to south of Barrack 439 front elevation (left) and camp roads in its wider setting. Barrack 438 to right

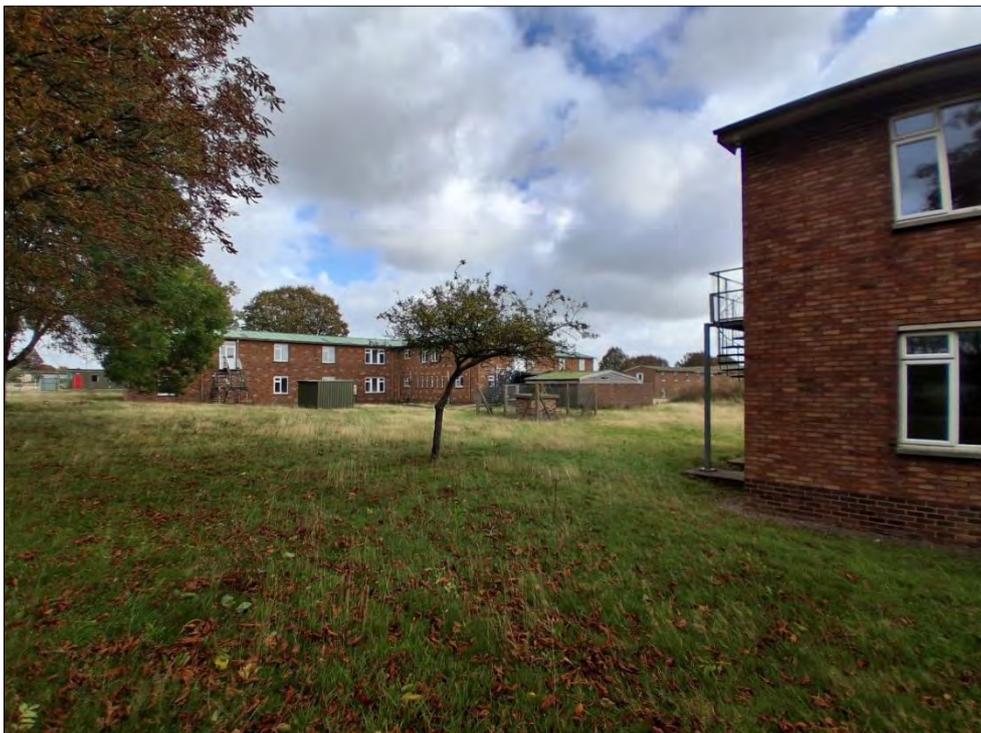
Plate 2. General view to southeast of Barrack 439 rear (left) in its wider setting. Barrack 438 to right

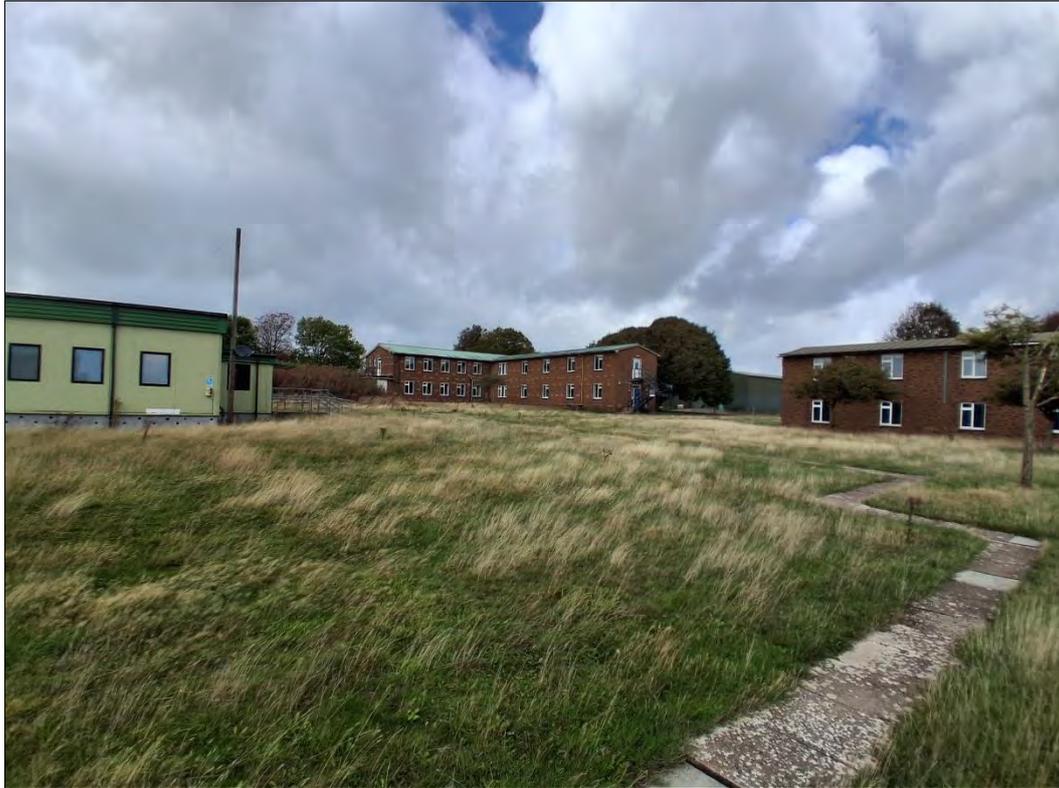
Plate 3. General view to north of Barrack 439 rear elevations (centre) in its wider setting. Barrack 442 to right

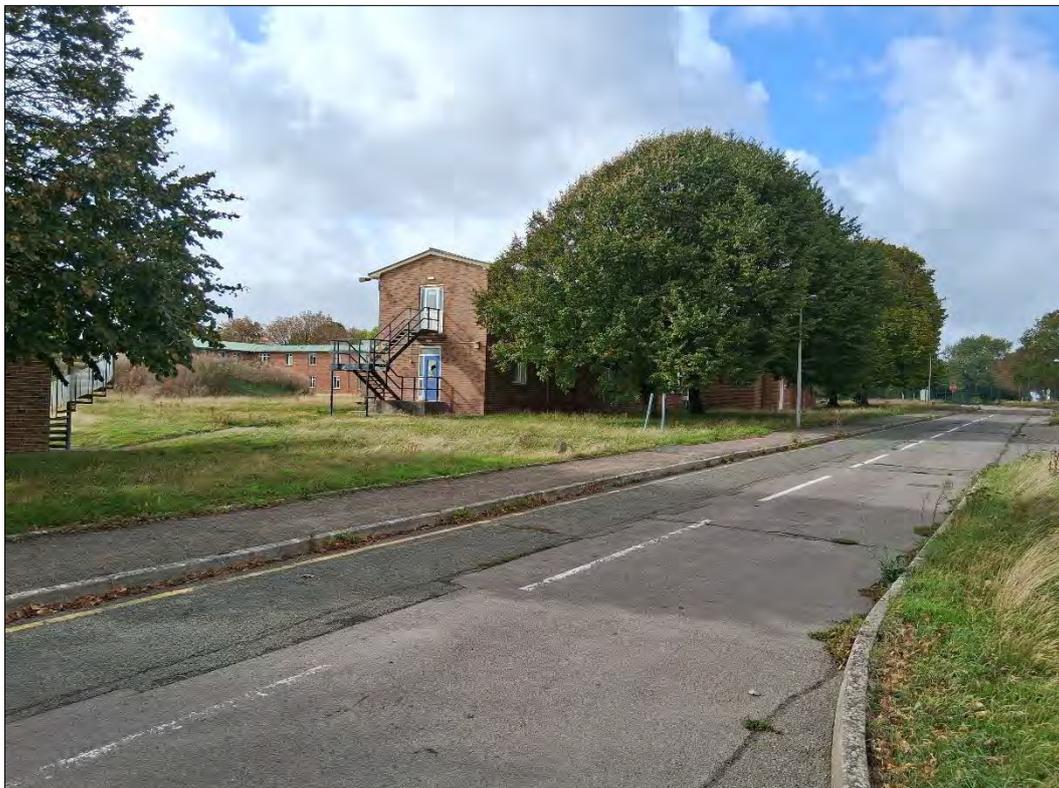
Plate 4. General view to northwest of Barrack 439 south wing in its wider setting. Barrack 438 behind to left

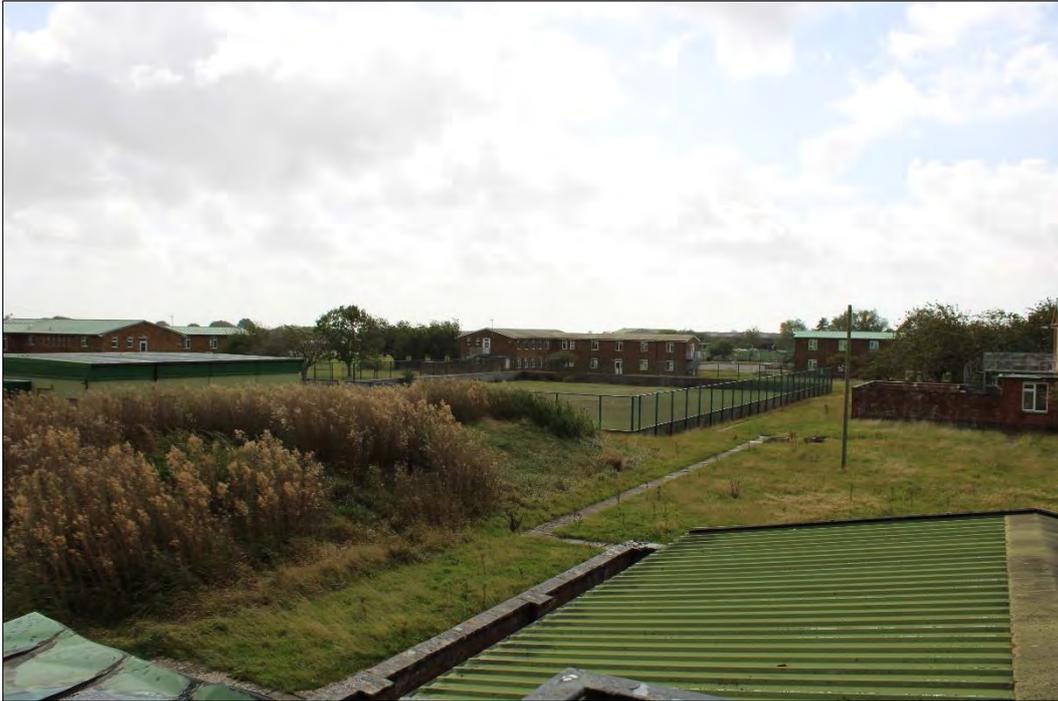
Plate 5. View to southwest from upper floor of showing comparable barracks 441 left, 440 centre and 437 right with a sports pitch and air raid shelter in the centre foreground

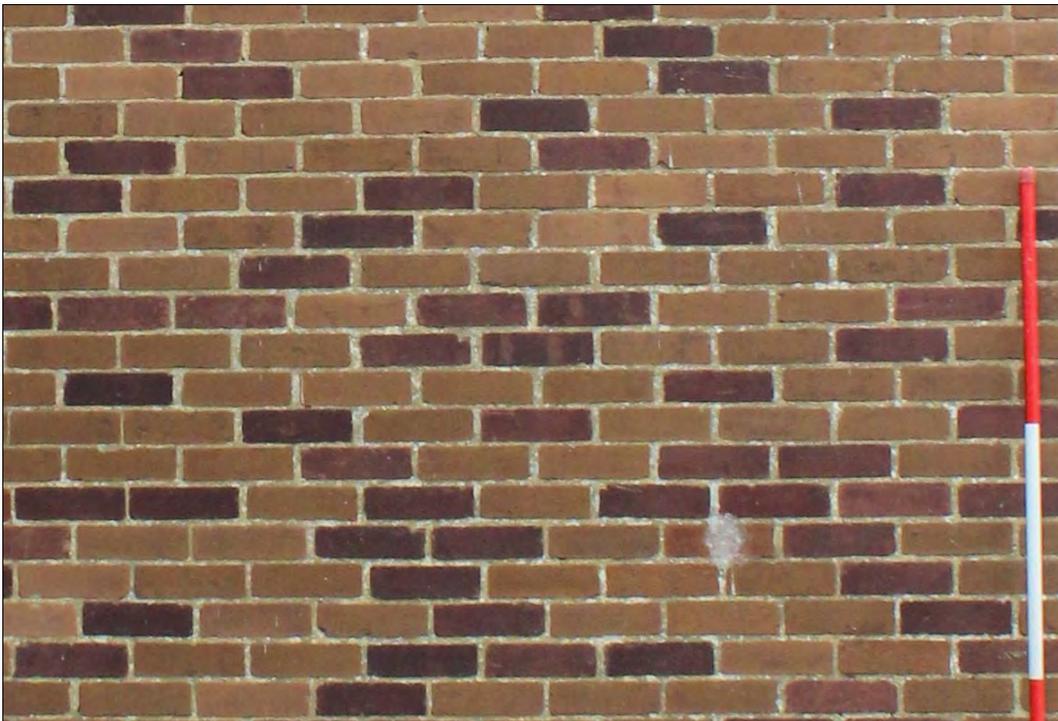
Plate 6. Typical brickwork pattern used in barracks. Scale 0.5m divisions

The accommodation block of cruciform shape was in stretcher bond polychrome standard size brick (mainly light brown but with random dark brown brick), with light brown/yellow mortar (Plate 6); beige coloured brick in the rear elevations is considered later repair work because of its apparent in many cases horizontal distribution and clear different mortar (see conclusion). The coursing below DPC had a greater number of the darker coloured brick sufficient to suggest different batches and/or different building phases, (the base course followed later by the main walls) under a pitched roof was with overall dimensions of 58.4m long between the dormitory wings and 24.73m along the short axis from the entrance to rear. The open gable roof was in two heights with the height above the entrance (short axis) the higher at 7.7m including the ridge board, and at a transverse pitch 7.07m over the dormitories, again to ridge board height. The choice of roofing was copper sheeting in 0.53m (21 inch) wide panels with a thin 20mm high rib dividing each sheet (Plate 7, Figure 15). Soffits were generally 0.5m wide except for over the gables where they were 0.2m.

There was no real comparison with the buildings surveyed previously which were mainly wartime buildings and buildings from the 1980s and later, and those buildings served different functions. However, the choice of brick pattern used in the barracks was not dissimilar to that of the wartime buildings in the use of light and dark bricks in a random pattern. Not noted in the neighbouring barracks but the brick pattern in the rear elevations was markedly different with the use of light beige brick with lighter coloured mortar contrasting with the original. The pattern was not entirely random but in places more horizontally aligned and as such would suggest replacement brickwork possibly because of a structural defect, and similarly the west facing south wing has patches of orange coloured brick mainly around the lower windows but also two large patches in the centre, again suggesting repairs and particularly in the case of possibly making good the walls following window replacement (see Plates 17, 19 and 20).

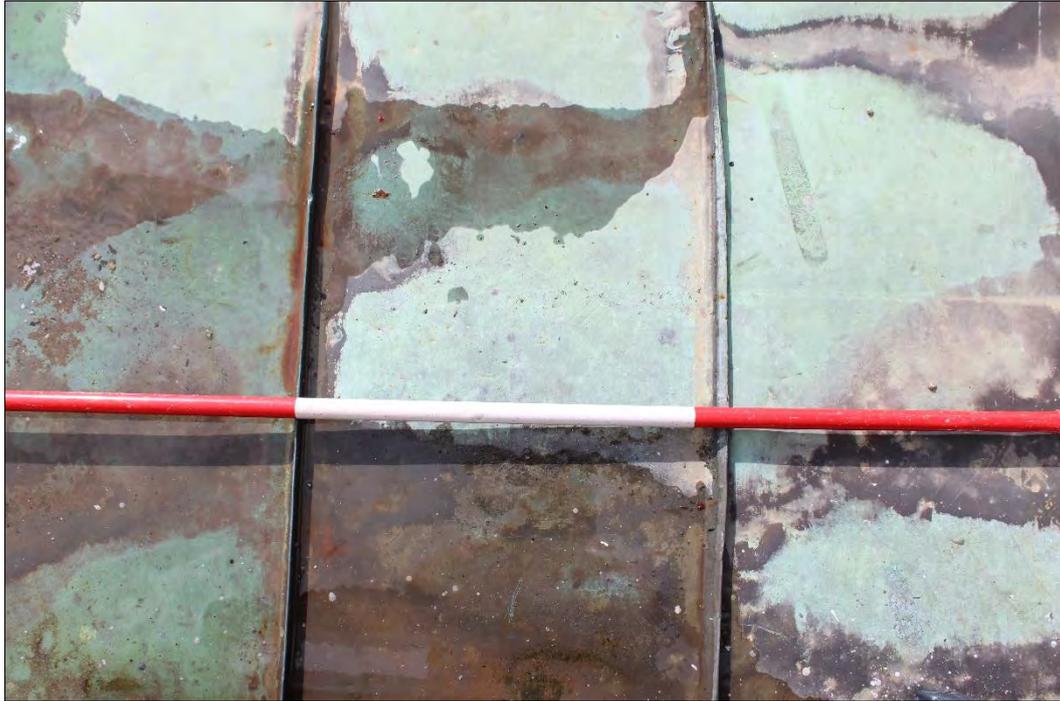
Plate 7. Copper sheeting used for the roof covering. Scale in 0.5m divisions

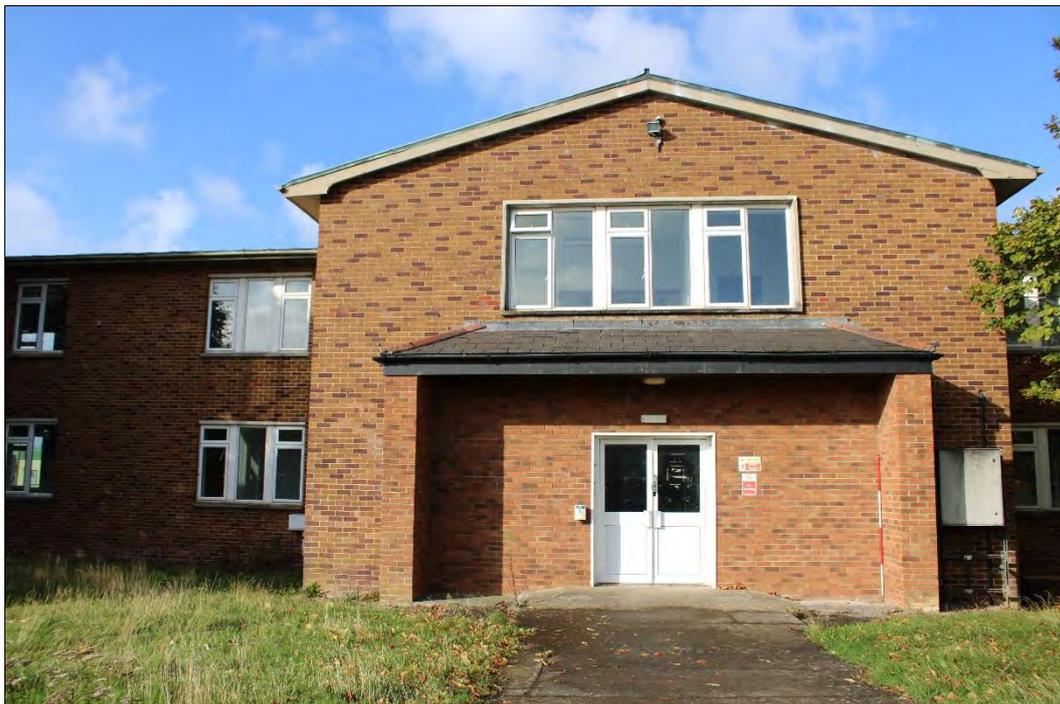
Plate 8. Barrack 439 front elevation. View to southwest. Scale in 0.5m divisions

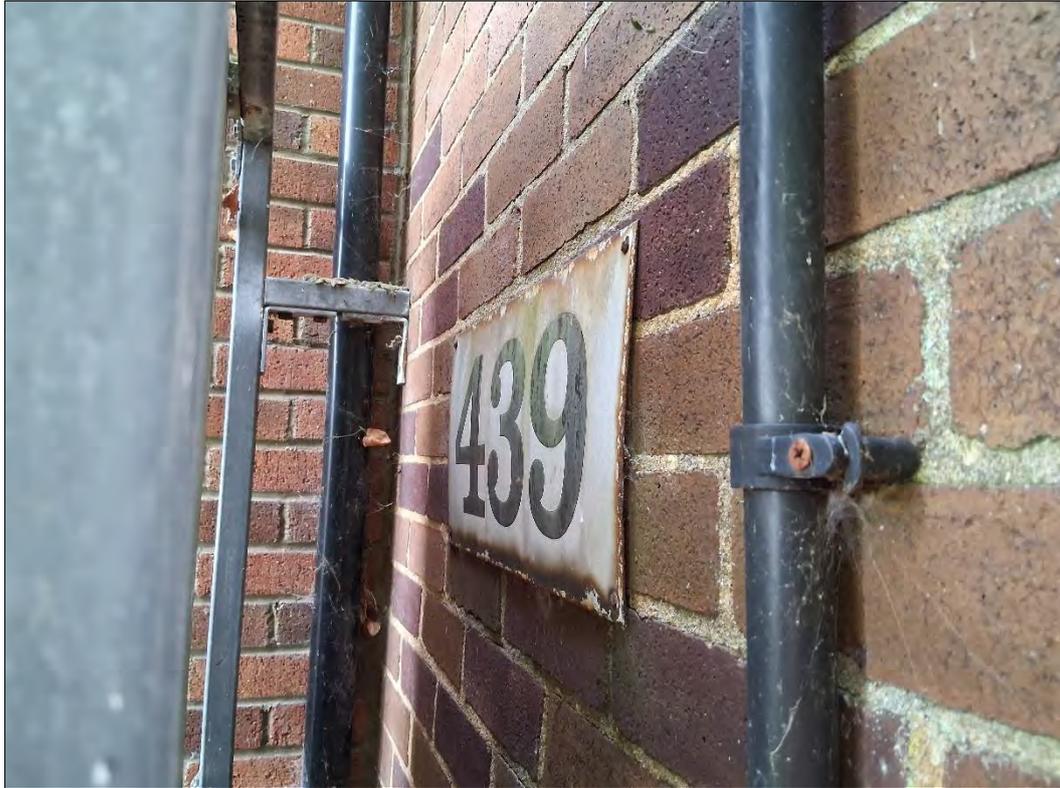
Plate 9. Barrack 439 original enamel building number on front elevation

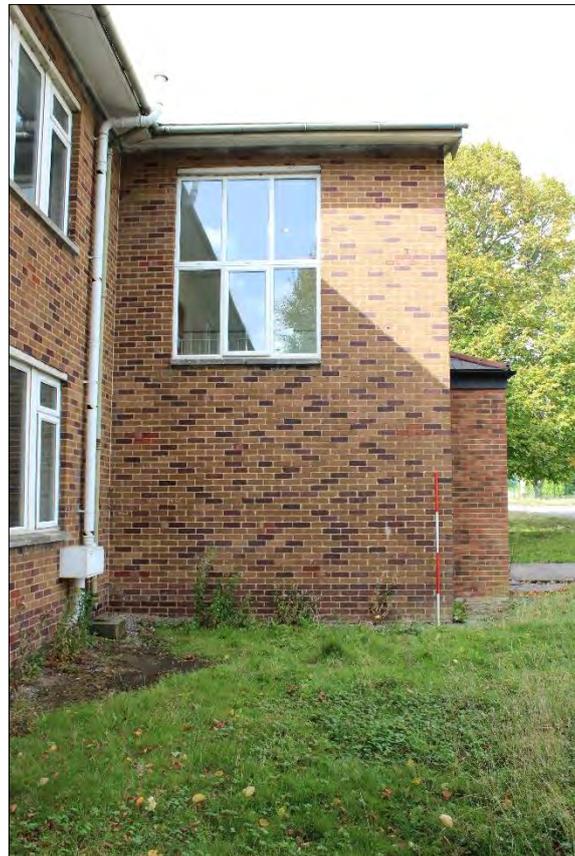
Plate 10. Barrack 439 south side of front elevation. View to northwest. Scale in 0.5m divisions

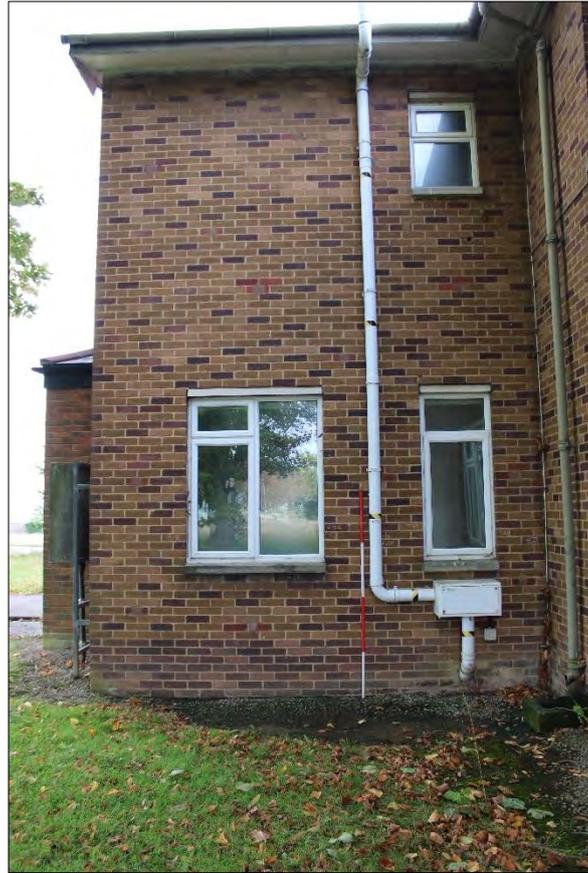
Plate 11. Barrack 439 north side of front elevation. View to southeast. Scale in 0.5m divisions

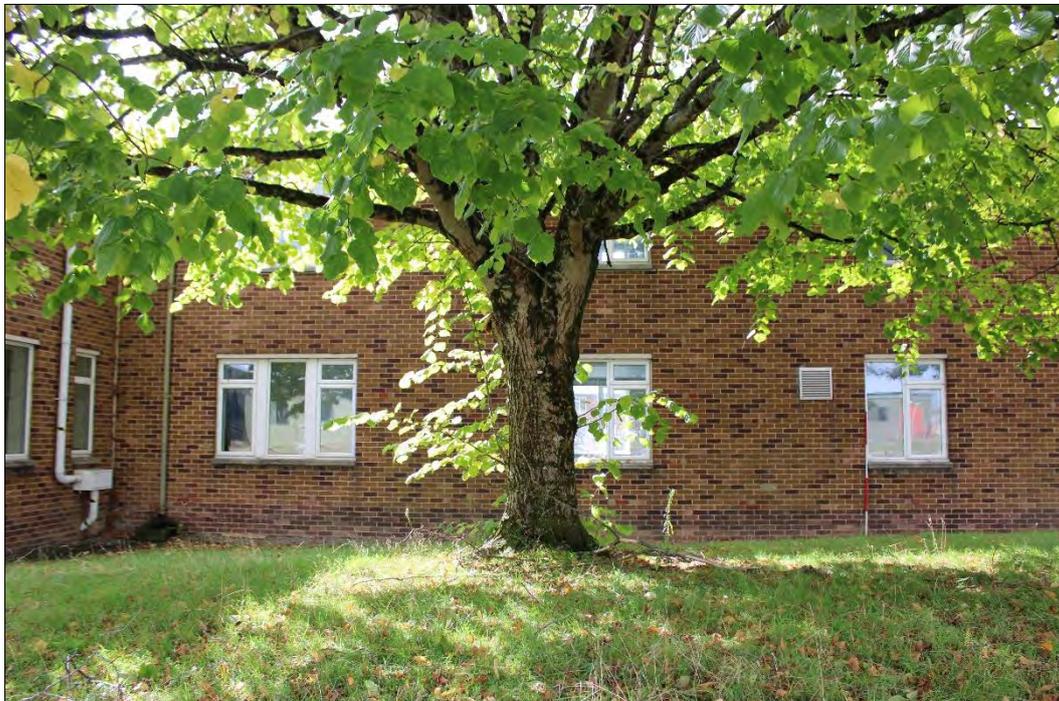
Plate 12. Barrack 439 front elevation north wing south half . View to southwest. Scale in 0.5m divisions

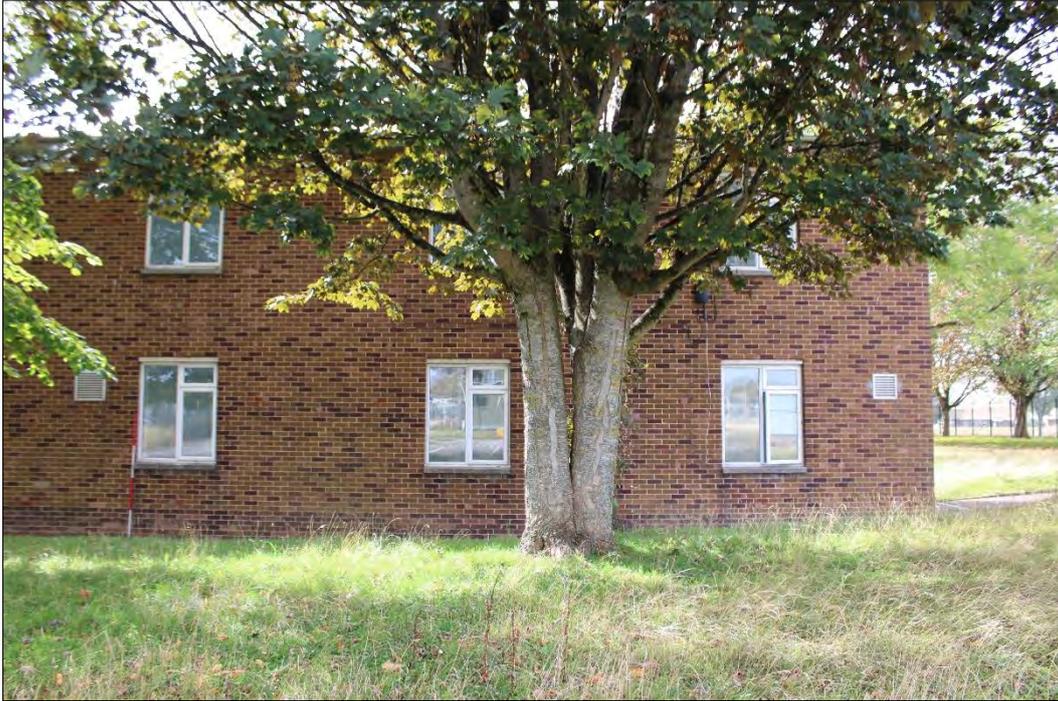
Plate 13. Barrack 439 front elevation north wing north half. View to southwest. Scale in 0.5m divisions

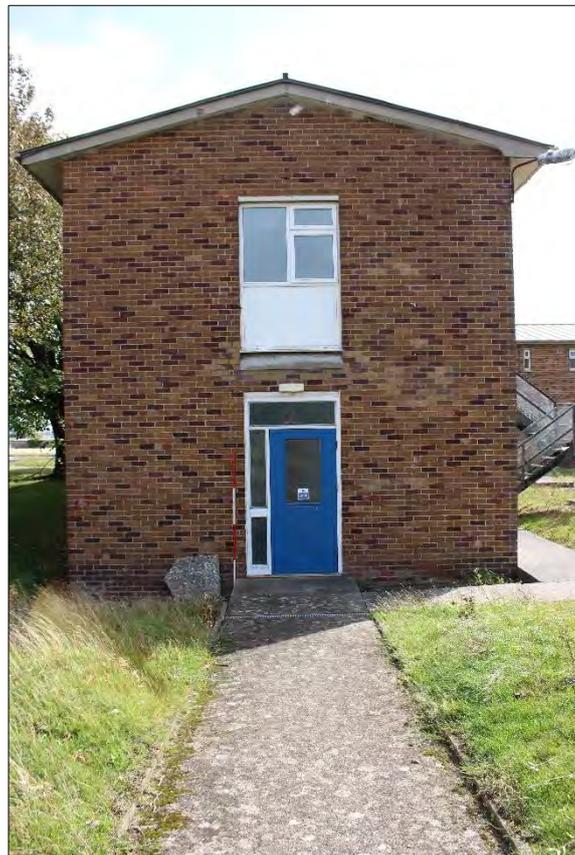
Plate 14. Barrack 439 north wing gable. View to southeast. Scale in 0.5m divisions

The elements of the 6.28m wide north facing gable comprised a ground floor single wooden doorway (1.32m wide overall by 2.52m high) with glazed panels over and to the side, and a window at first floor level, both central to the span. The window (2.14m high) was a replacement for an original doorway (1.36m wide (slightly wider than the lower doorway and common to the other similar elevations) by 2.4m high) with cement infilling below the base of the window frame to fill the difference in height and probably to make good a removed fire escape staircase; This may have been a spiral staircase as observed elsewhere (barrack 442, 438), however a replacement staircase was transferred to the west facing elevation (Plate 14).

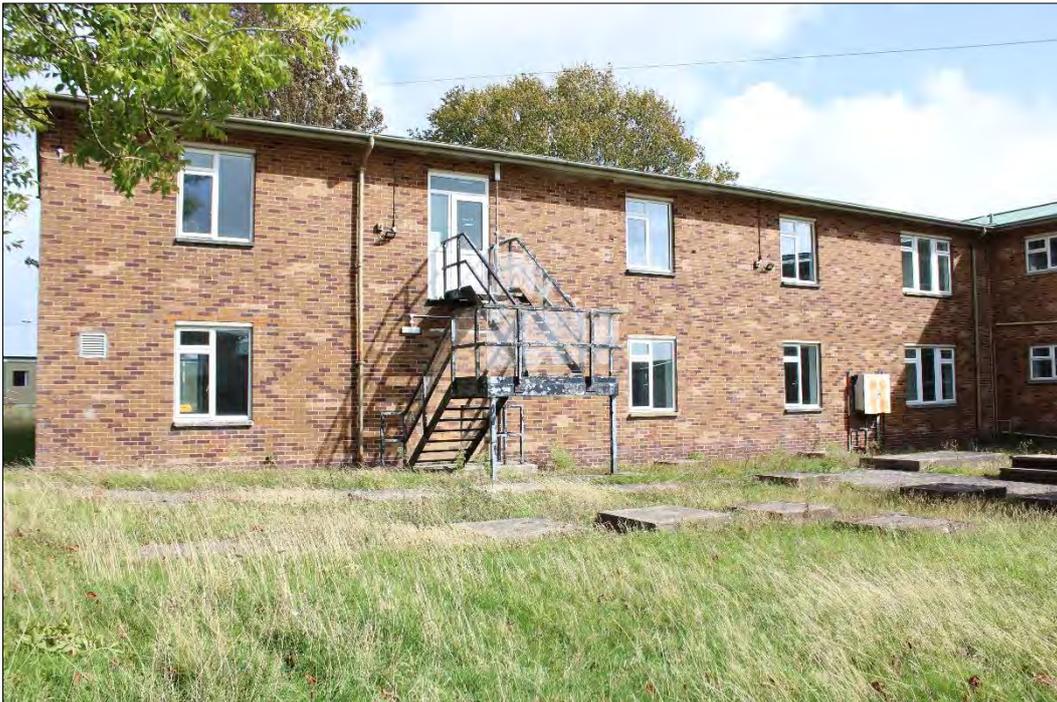
Plate 15. Barrack 439 north wing rear elevation. View to southeast. Scale in 0.5m divisions

The west facing dormitory elevation originally matched that of the east with a similar number of windows directly opposite each other. The major change occurred in the second window positions (6.6m south of the northwest corner) where the ground floor window was blocked in with brick below the lintel and the first-floor window replaced by a single UPVC door with side and over glazing and panelling. The doorway opened to a rectangular fire escape staircase comprised of two parallel flights of steps and a halfway height landing demarking the change in steps direction. Other features included a vent, two security lights, downpipes and an external electrical box toward the south corner between the windows (Plate 15).

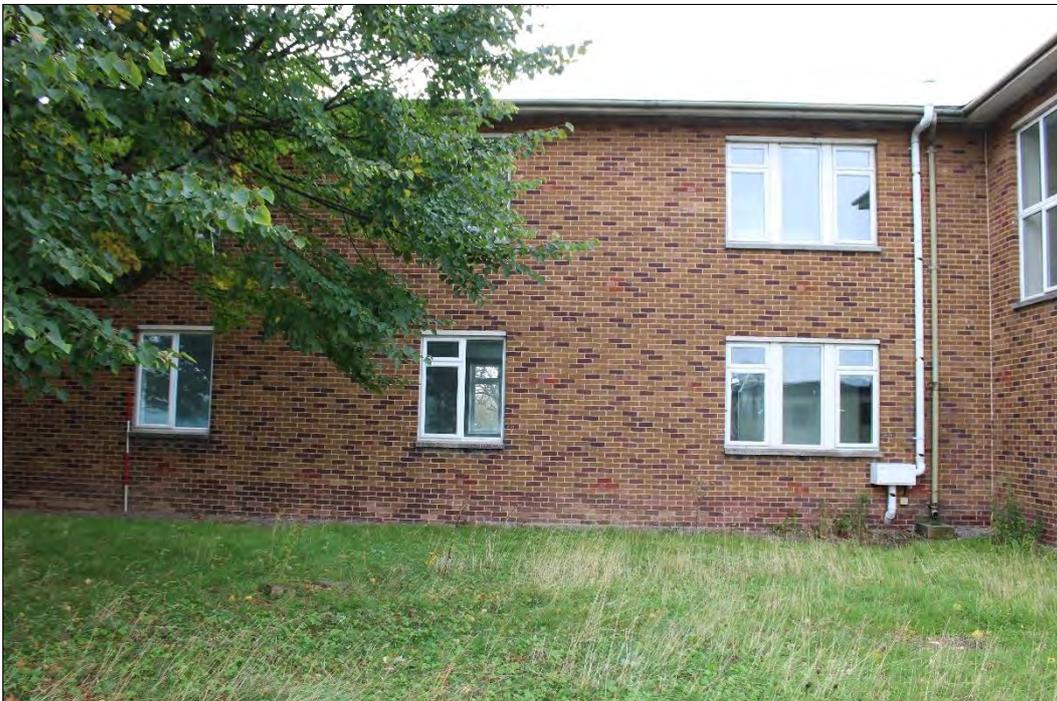
Plate 16. Barrack 439 front elevation south wing north half. View to southwest. Scale in 0.5m divisions

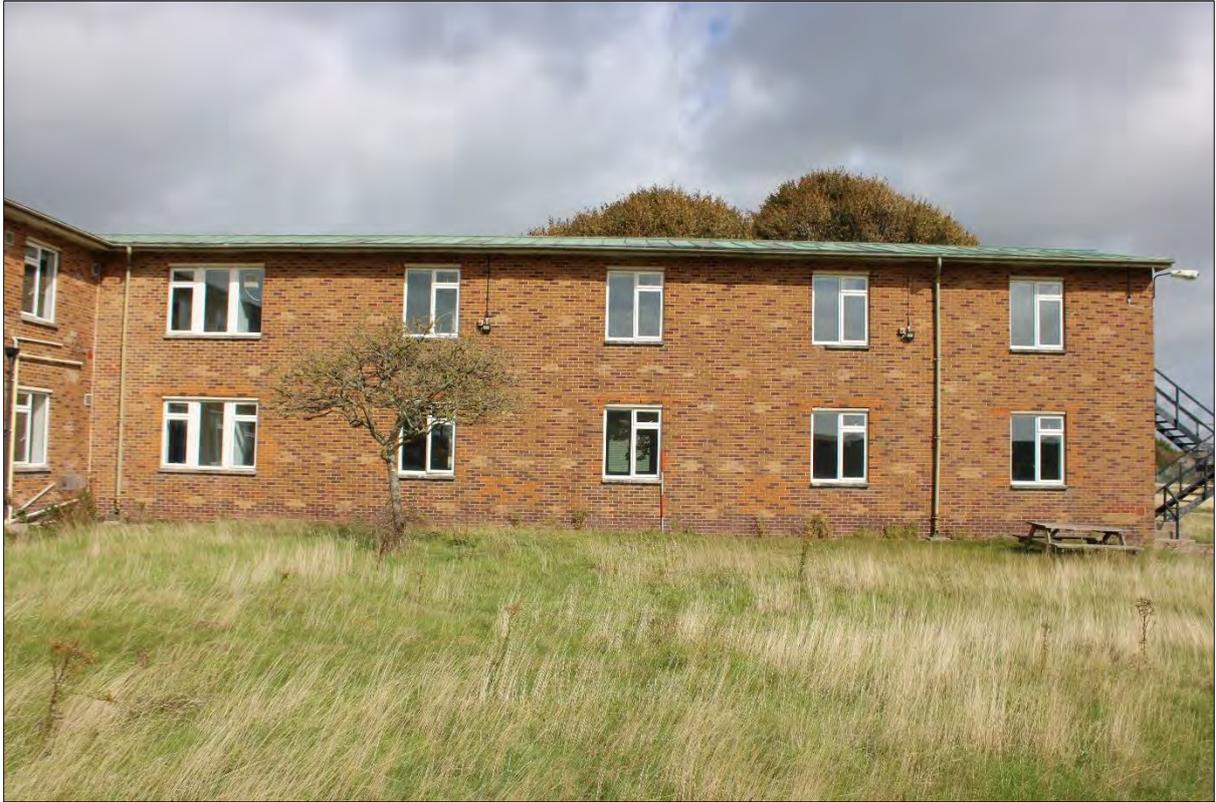
Plate 17. Barrack 439 rear elevation south wing. View to southeast. Scale in 0.5m divisions

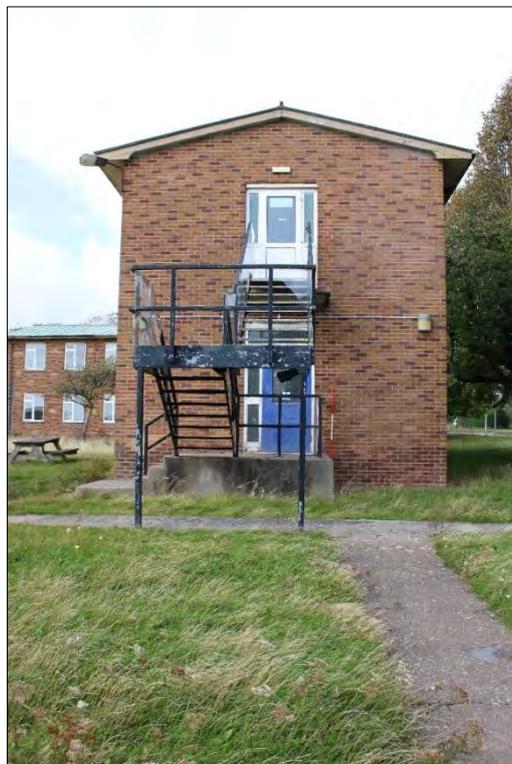
Plate 18. Barrack 439 south wing gable. View to northwest. Scale in 0.5m divisions
