Bro Tathan East, Vale of Glamorgan

Archaeological Evaluation Report

Date: February 2023
By: Barry Cosham
Client: Welsh Government
RRA Project Code: RR0576
GGAT Ref : VOG1563

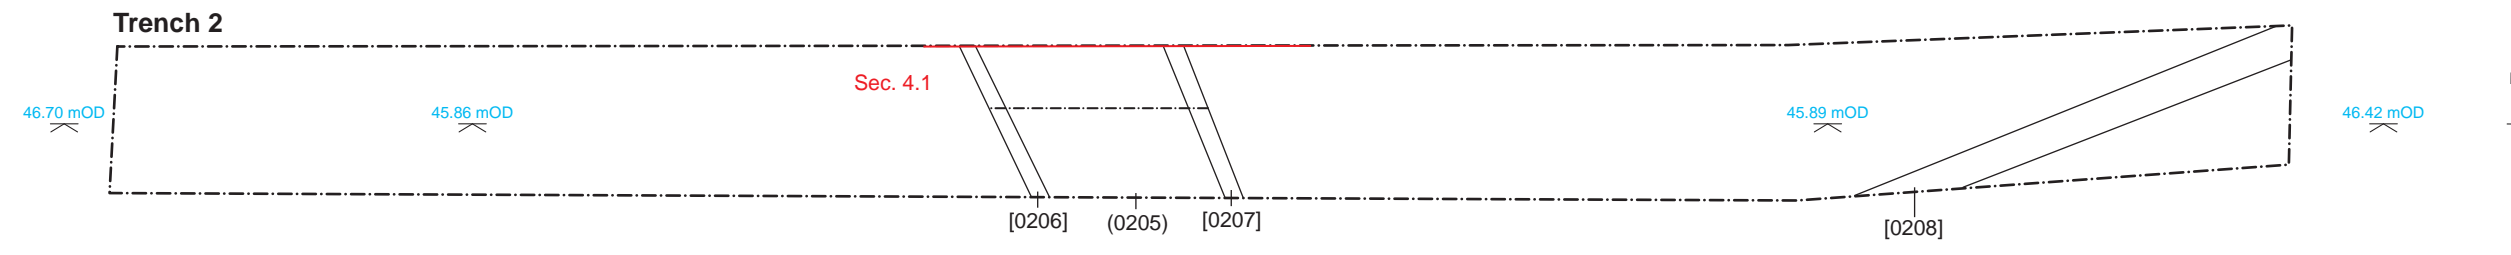
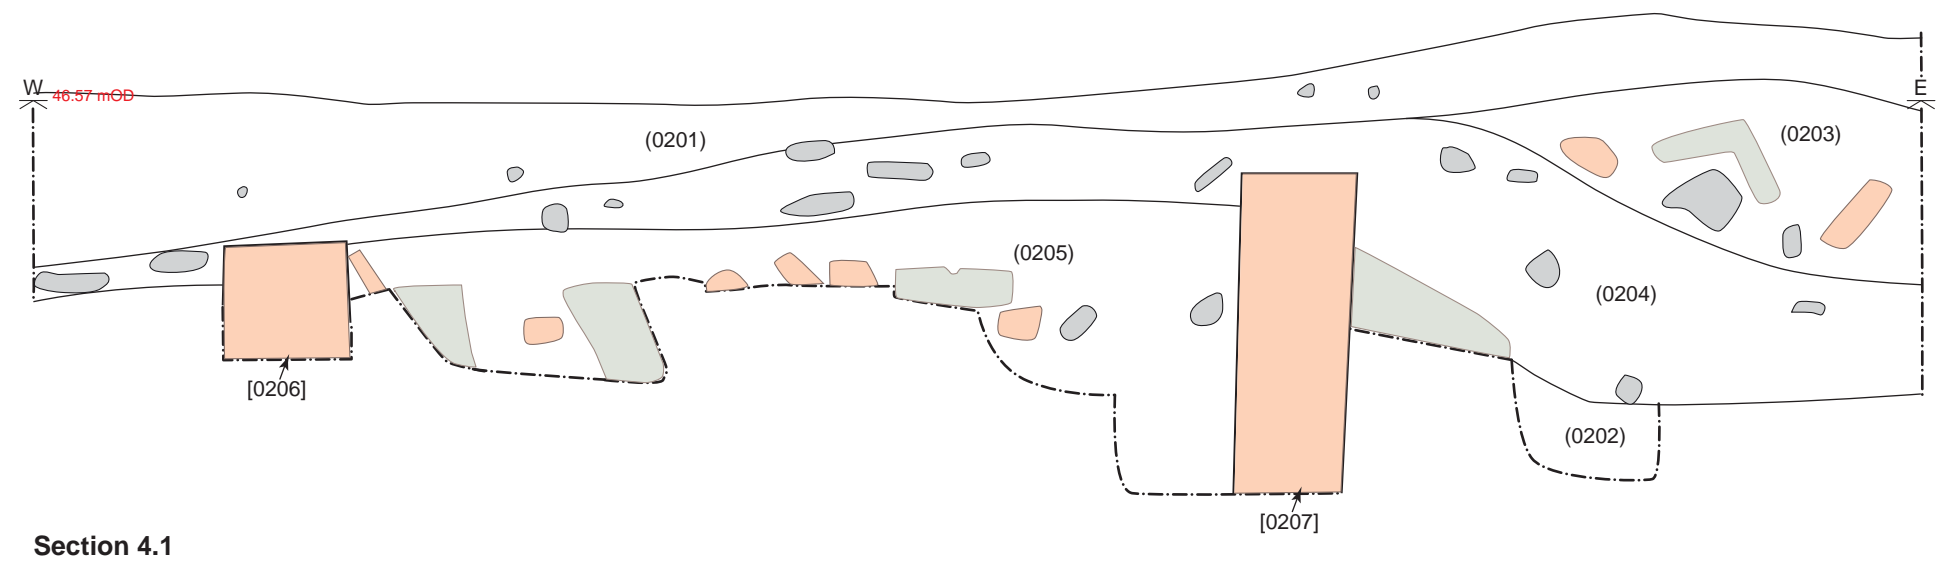
Figure 4 - Plan of Trench 2 and section for deposit (0205) & WW2 features [0206], [0207].

- 4.2.1 The remains of two structures were present in trench 2. Located close to the centre of the trench, the first structure (Plate 1) comprised two parallel brick-built walls approximately 2.2m apart orientated northwest-southeast. The walls, [0206] and [0207], were one brick length thick, cement mortared and well pointed on both faces. Over ten courses survived although the floor of the structure was not encountered as it was over 1m below the ground surface. The space between the walls was filled with a mixture of brick and concrete rubble with re-bar (0205) in

a matrix of redeposited natural. Overlying the structure and the infill was a layer of redeposited natural (0204). Above this was another demolition deposit (0203) which comprised block and brick fragments in a matrix of tarmac which was immediately below the topsoil/sod layer (0201).

4.2.2 The second structure comprised the remains of a single hollow block-built wall [0208] (Plate 2) which was orientated northeast-southwest. This wall was one block wide and was partly covered/filled with coarse sand. The southeast side of the wall appeared to be the interior of this structure as it was heavily disturbed.

5.3.2 The brick-built structure located in trench 2 was most likely the remains of a WW2 air-raid shelter or other sub-surface building. An 'L' shaped earthwork or possible structure of some kind can be made out on an aerial photograph from 1945 (Figure 2.2). The structure identified within trench 2 was located immediately to the south in an area that may have been an entrance or ancillary structure. Across the rest of the Site the aerial photograph shows a dense concentration of buildings, these appear to have been of primarily light/temporary construction, probably timber as no evidence remained in any of the excavated trenches.

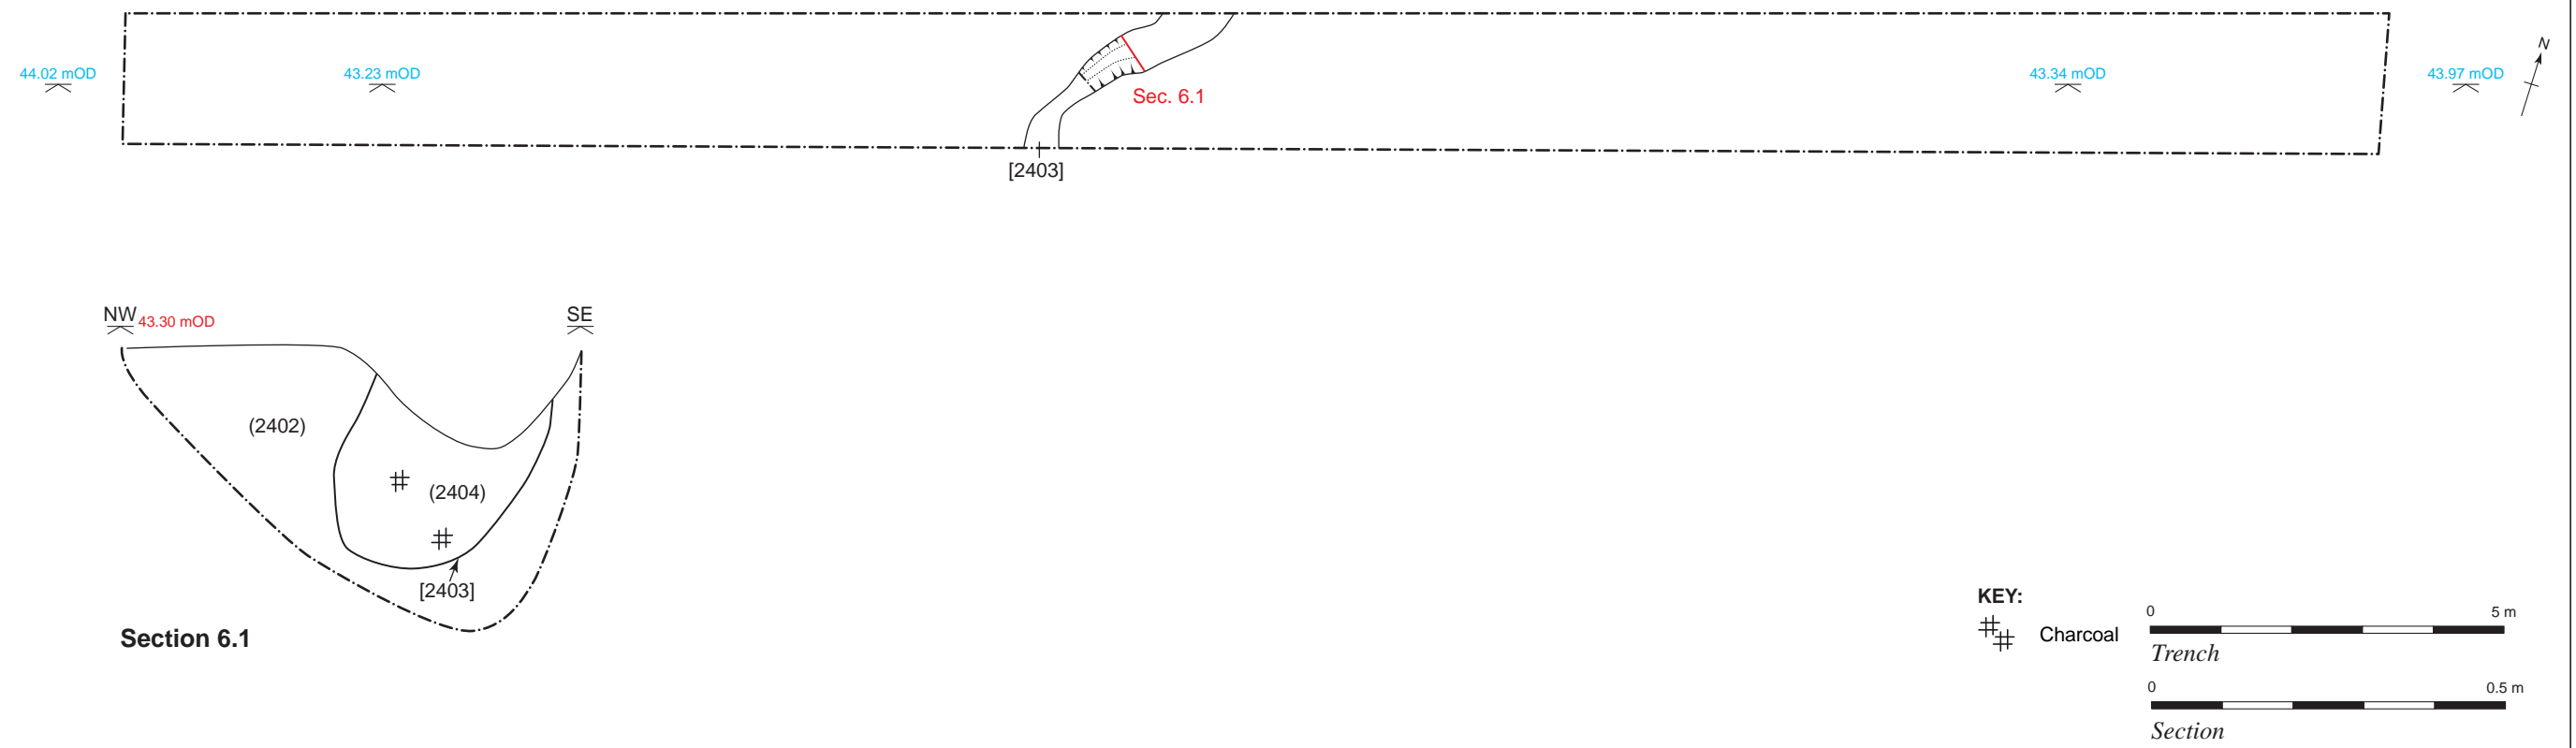
Figure 6 - Plan of Trench 24 and section of feature [2403].

4.4.1 A single feature [2403] (Plate 4) was located within trench 24, orientated broadly northeast-southwest it was irregularly linear/crescent shaped in plan and was on average 0.3m wide and 0.27m deep with irregular undercutting sides and an irregular rounded base. The single fill (2404) was mid brownish grey silty clay with occasional charcoal flecks, no finds were recovered.

- 5.3.5 The crescent shaped feature identified in trench 24 was initially suspected to be a linear feature of some kind and did have some charcoal flecks within the fill. However, upon excavation it became clear that this feature was undercutting itself and had diffuse irregular edges – clear indicators that it derived from natural processes such as tree roots or animal burrowing.

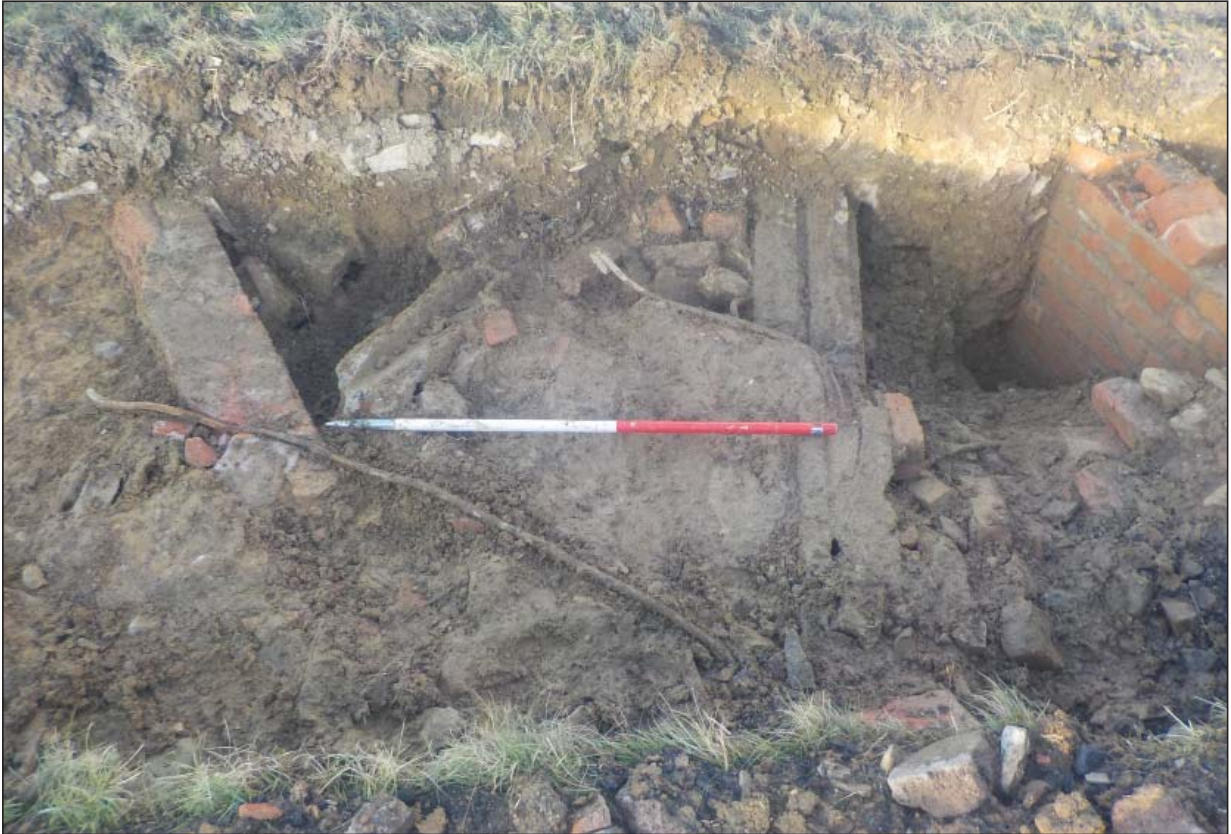
Plate 1 - Overview of WW2 structure in trench 2 facing north.

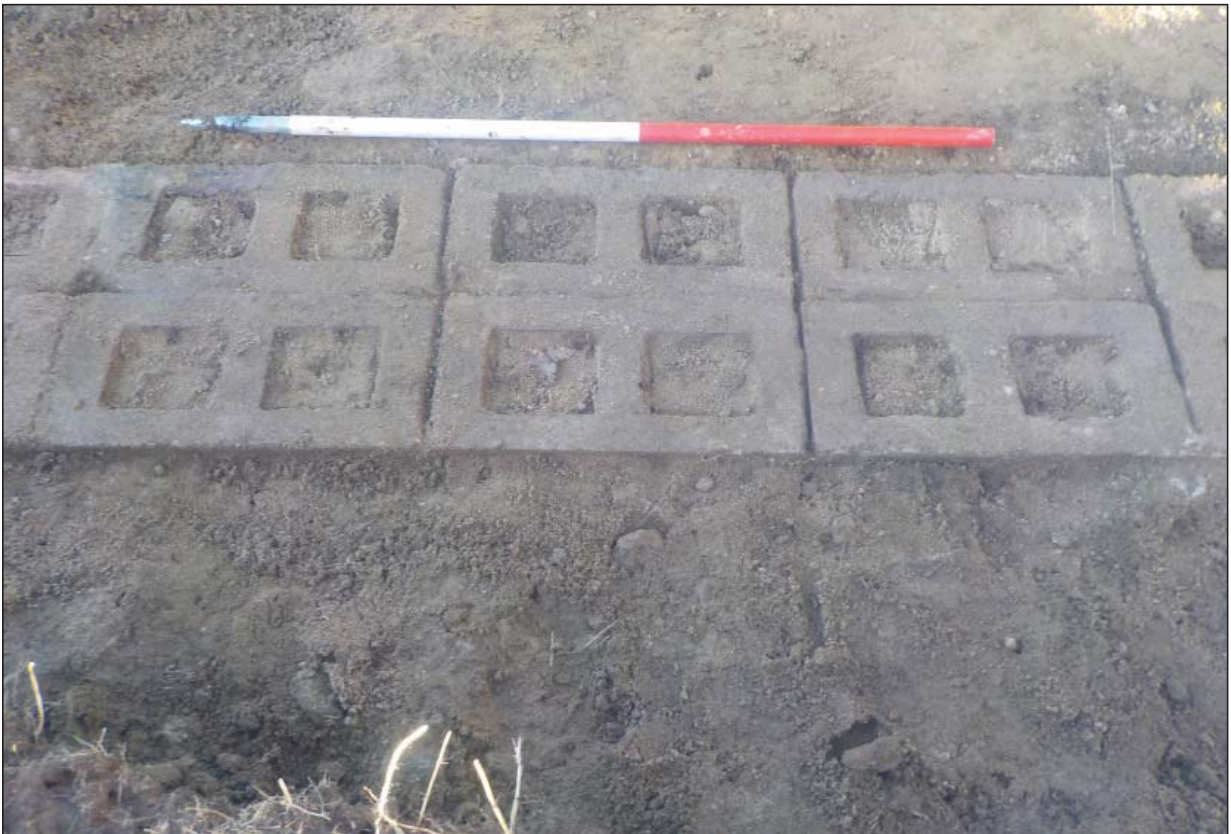
Plate 2 - Representative section of (0208) facing northwest.

5.3.3 The post-WW2 phase was by far the most represented within the evaluation data, with at least small amounts of modern demolition material being present in every trench. Structural remains from this phase were present in trenches 2 and 25 and the buildings outlines can be seen on the 1969 OS map. Interestingly not every structure shown on that map was identified in the relevant evaluation trenches suggesting some buildings were of slighter construction than others.

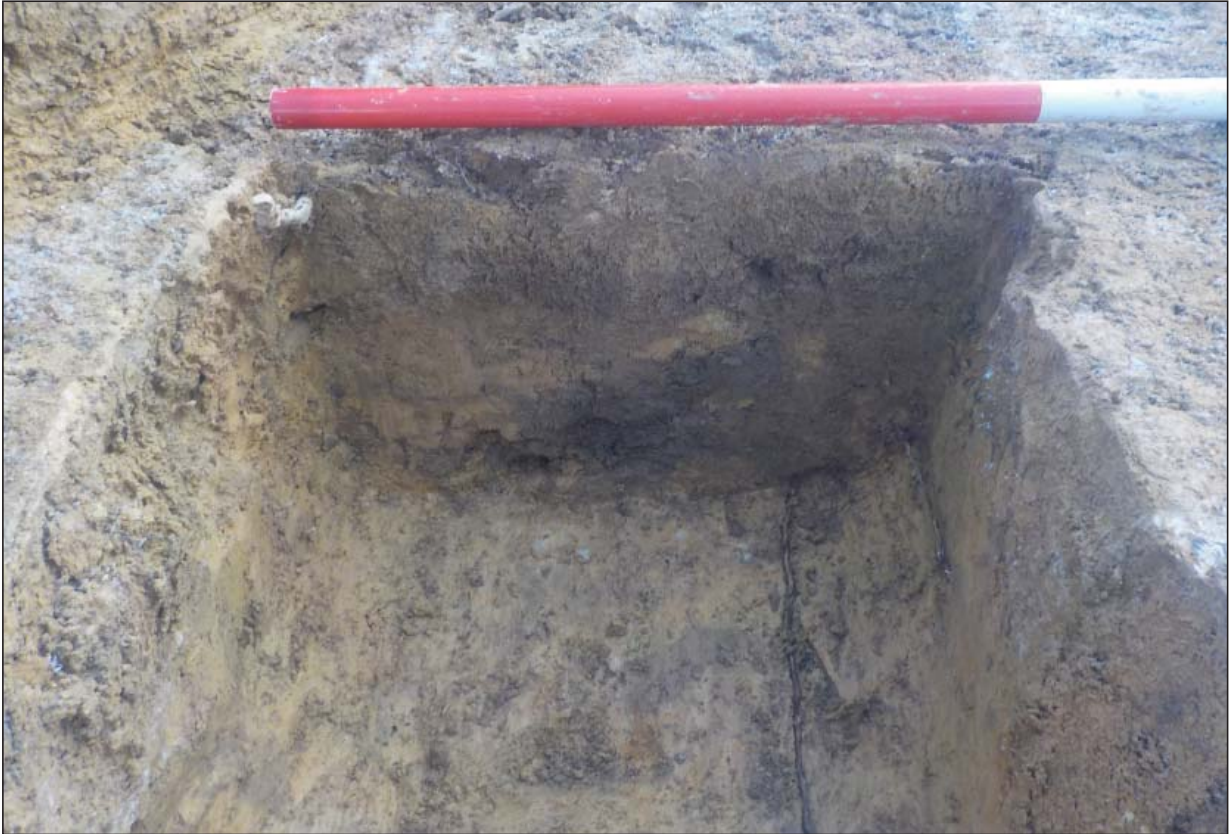
4.3.1 A narrow linear feature [1603] (Plate 3) was located within trench 16; orientated broadly northeast-southwest it was 0.5m wide and 0.6m deep. The feature had vertical sides and a slightly irregular flat base. The fill (1604) was a mixture of dark brown silty clay and greyish yellow clay redeposited natural. Modern window glass was recovered but not retained.

Plate 3 - Southwest facing section of [1603] facing northeast.

5.3.4 The narrow trench-like feature identified in trench 16 contained modern window glass and was seen to cut through the topsoil to some extent. It had the appearance of a machine dug service trench but contained no cable or pipe, perhaps therefore it was instead some kind of robber trench.

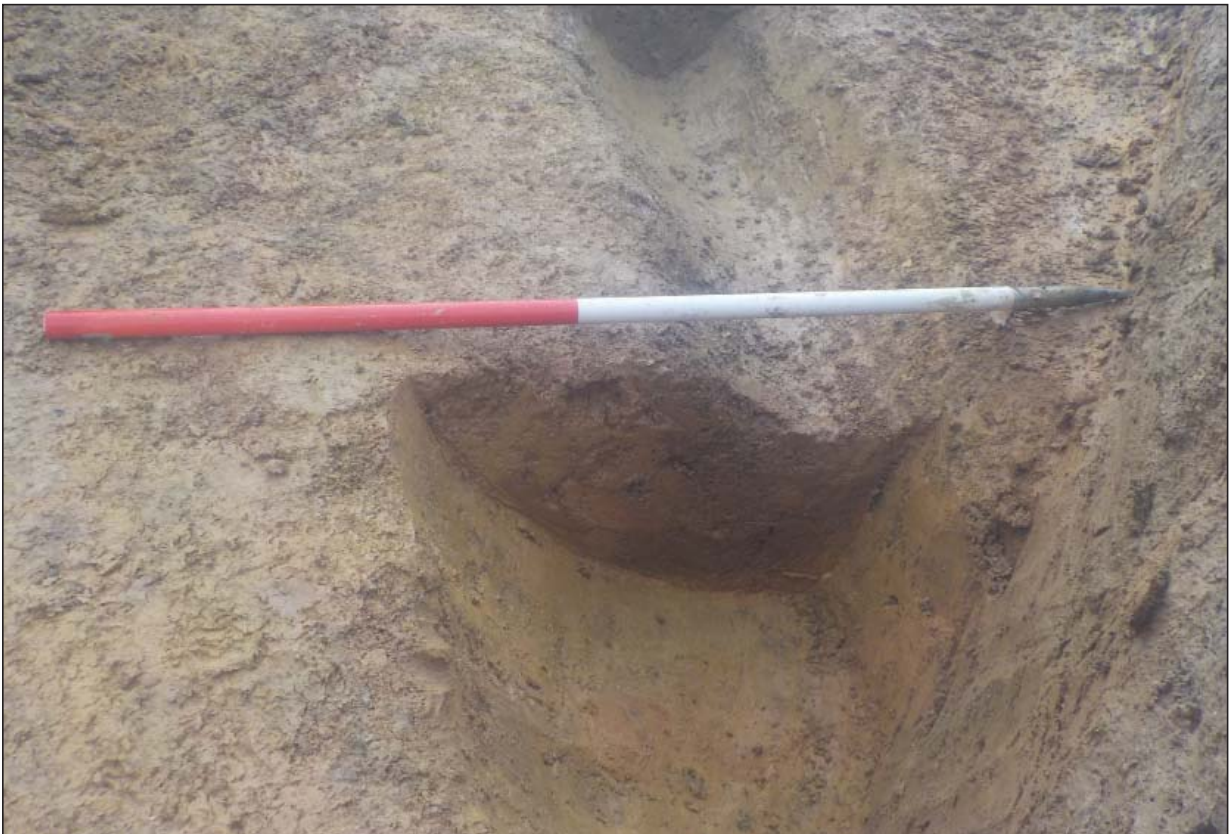
Plate 4 - Northeast facing section of [2403] facing southwest.
