**Land off A473 & A4222, Talbot Green
Proposed Residential & Retail/Commercial Development
Supplementary Controlled Waters Risk Assessment (CWRA)**

Report Reference: ESP.9211.02a.4501

Land off A473 & A4222, Talbot Green Proposed Residential & Retail/Commercial Development Supplementary Controlled Waters Risk Assessment (CWRA)

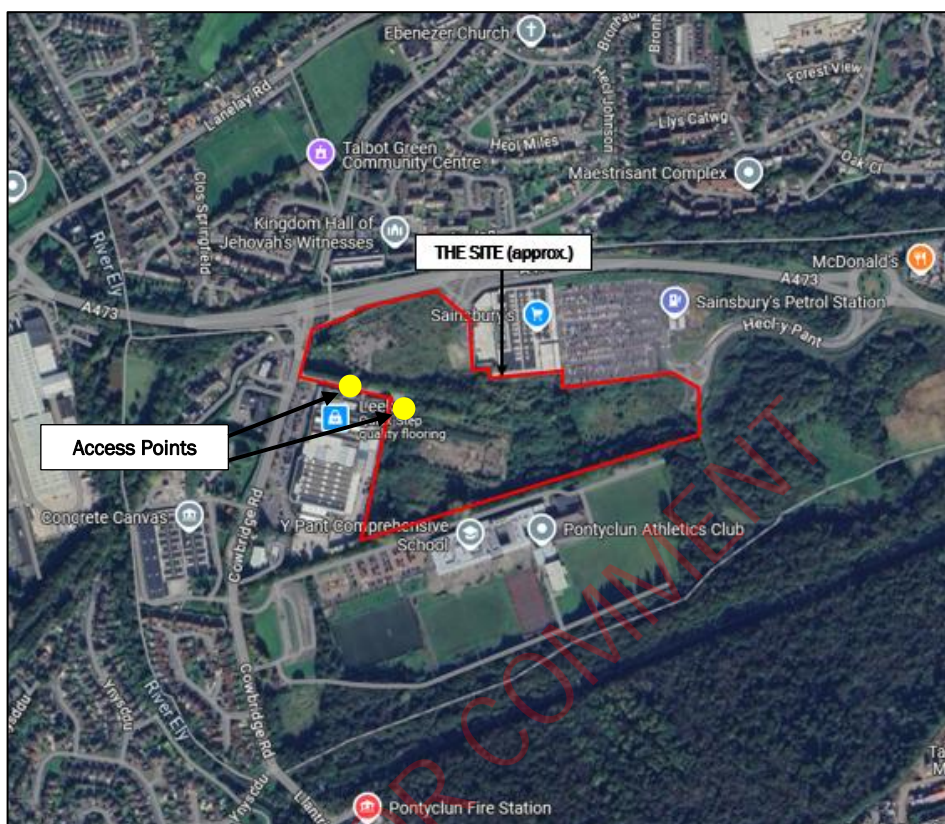
Insert 2 - Site Plan from Google Maps (Image taken May 2023)

To show the current status of the site, an aerial image of the current site status is shown as Insert 2 below, followed by an OS site plan from the previous assessment (ESP, 2025) presented as Insert 3.

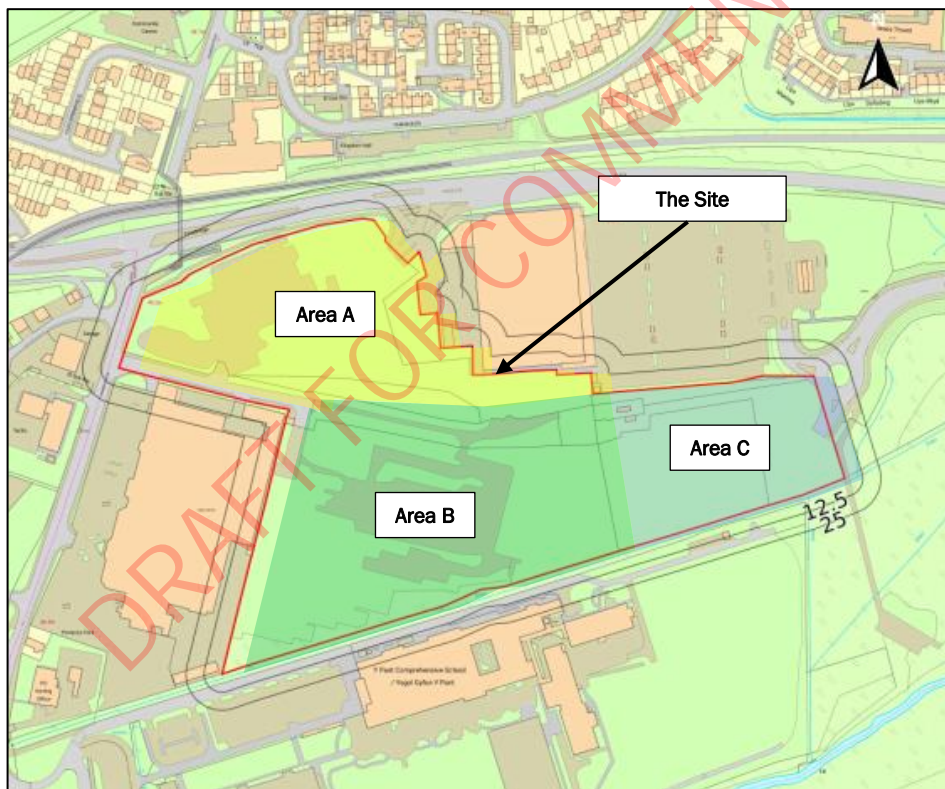
Insert 4 – OS Mapping Site Plan from data report (Appendix C) – See Below Site Descriptions

To aid in the description of the site in this section, the site has been separated into three areas (Area A, B and C) as shown on Insert 4 below.

This comprises a large area of former hardstanding, located in the central and west, with the remainder being open grass/scrub where scrub and limited small trees have been previously cleared by the Client. In the northwest, a former possible pumping station associated with former water mains remains.

This comprises the former entrance to the site and a localised area of tarmacadam. The central area is occupied by a large concrete slab, with further areas of concrete and tarmacadam in the south and southwest. Steel runs were identified within the concrete in the central area, possibly associated with former crane/lifting runs or reinforcement to the slabs. Several drain covers were also identified but could not be lifted.

This comprises an open field with the Area B/Area C fence line in the west, partial fencing in the north, a fence line along the south boundary and open access in the east/northeast. Areas of trees are present in the south and west, with recently cleared ground across the central area.
