## Appendix C – Infiltration Test Results

**Re: Mounton Road, Chepstow - Infiltration Assessment**

On behalf of Barwood Development Securities Ltd (the 'client'), T&P Regeneration Ltd (T&P) is pleased to provide the results of a ground investigation undertaken at Mounton Road, Chepstow (the Site).

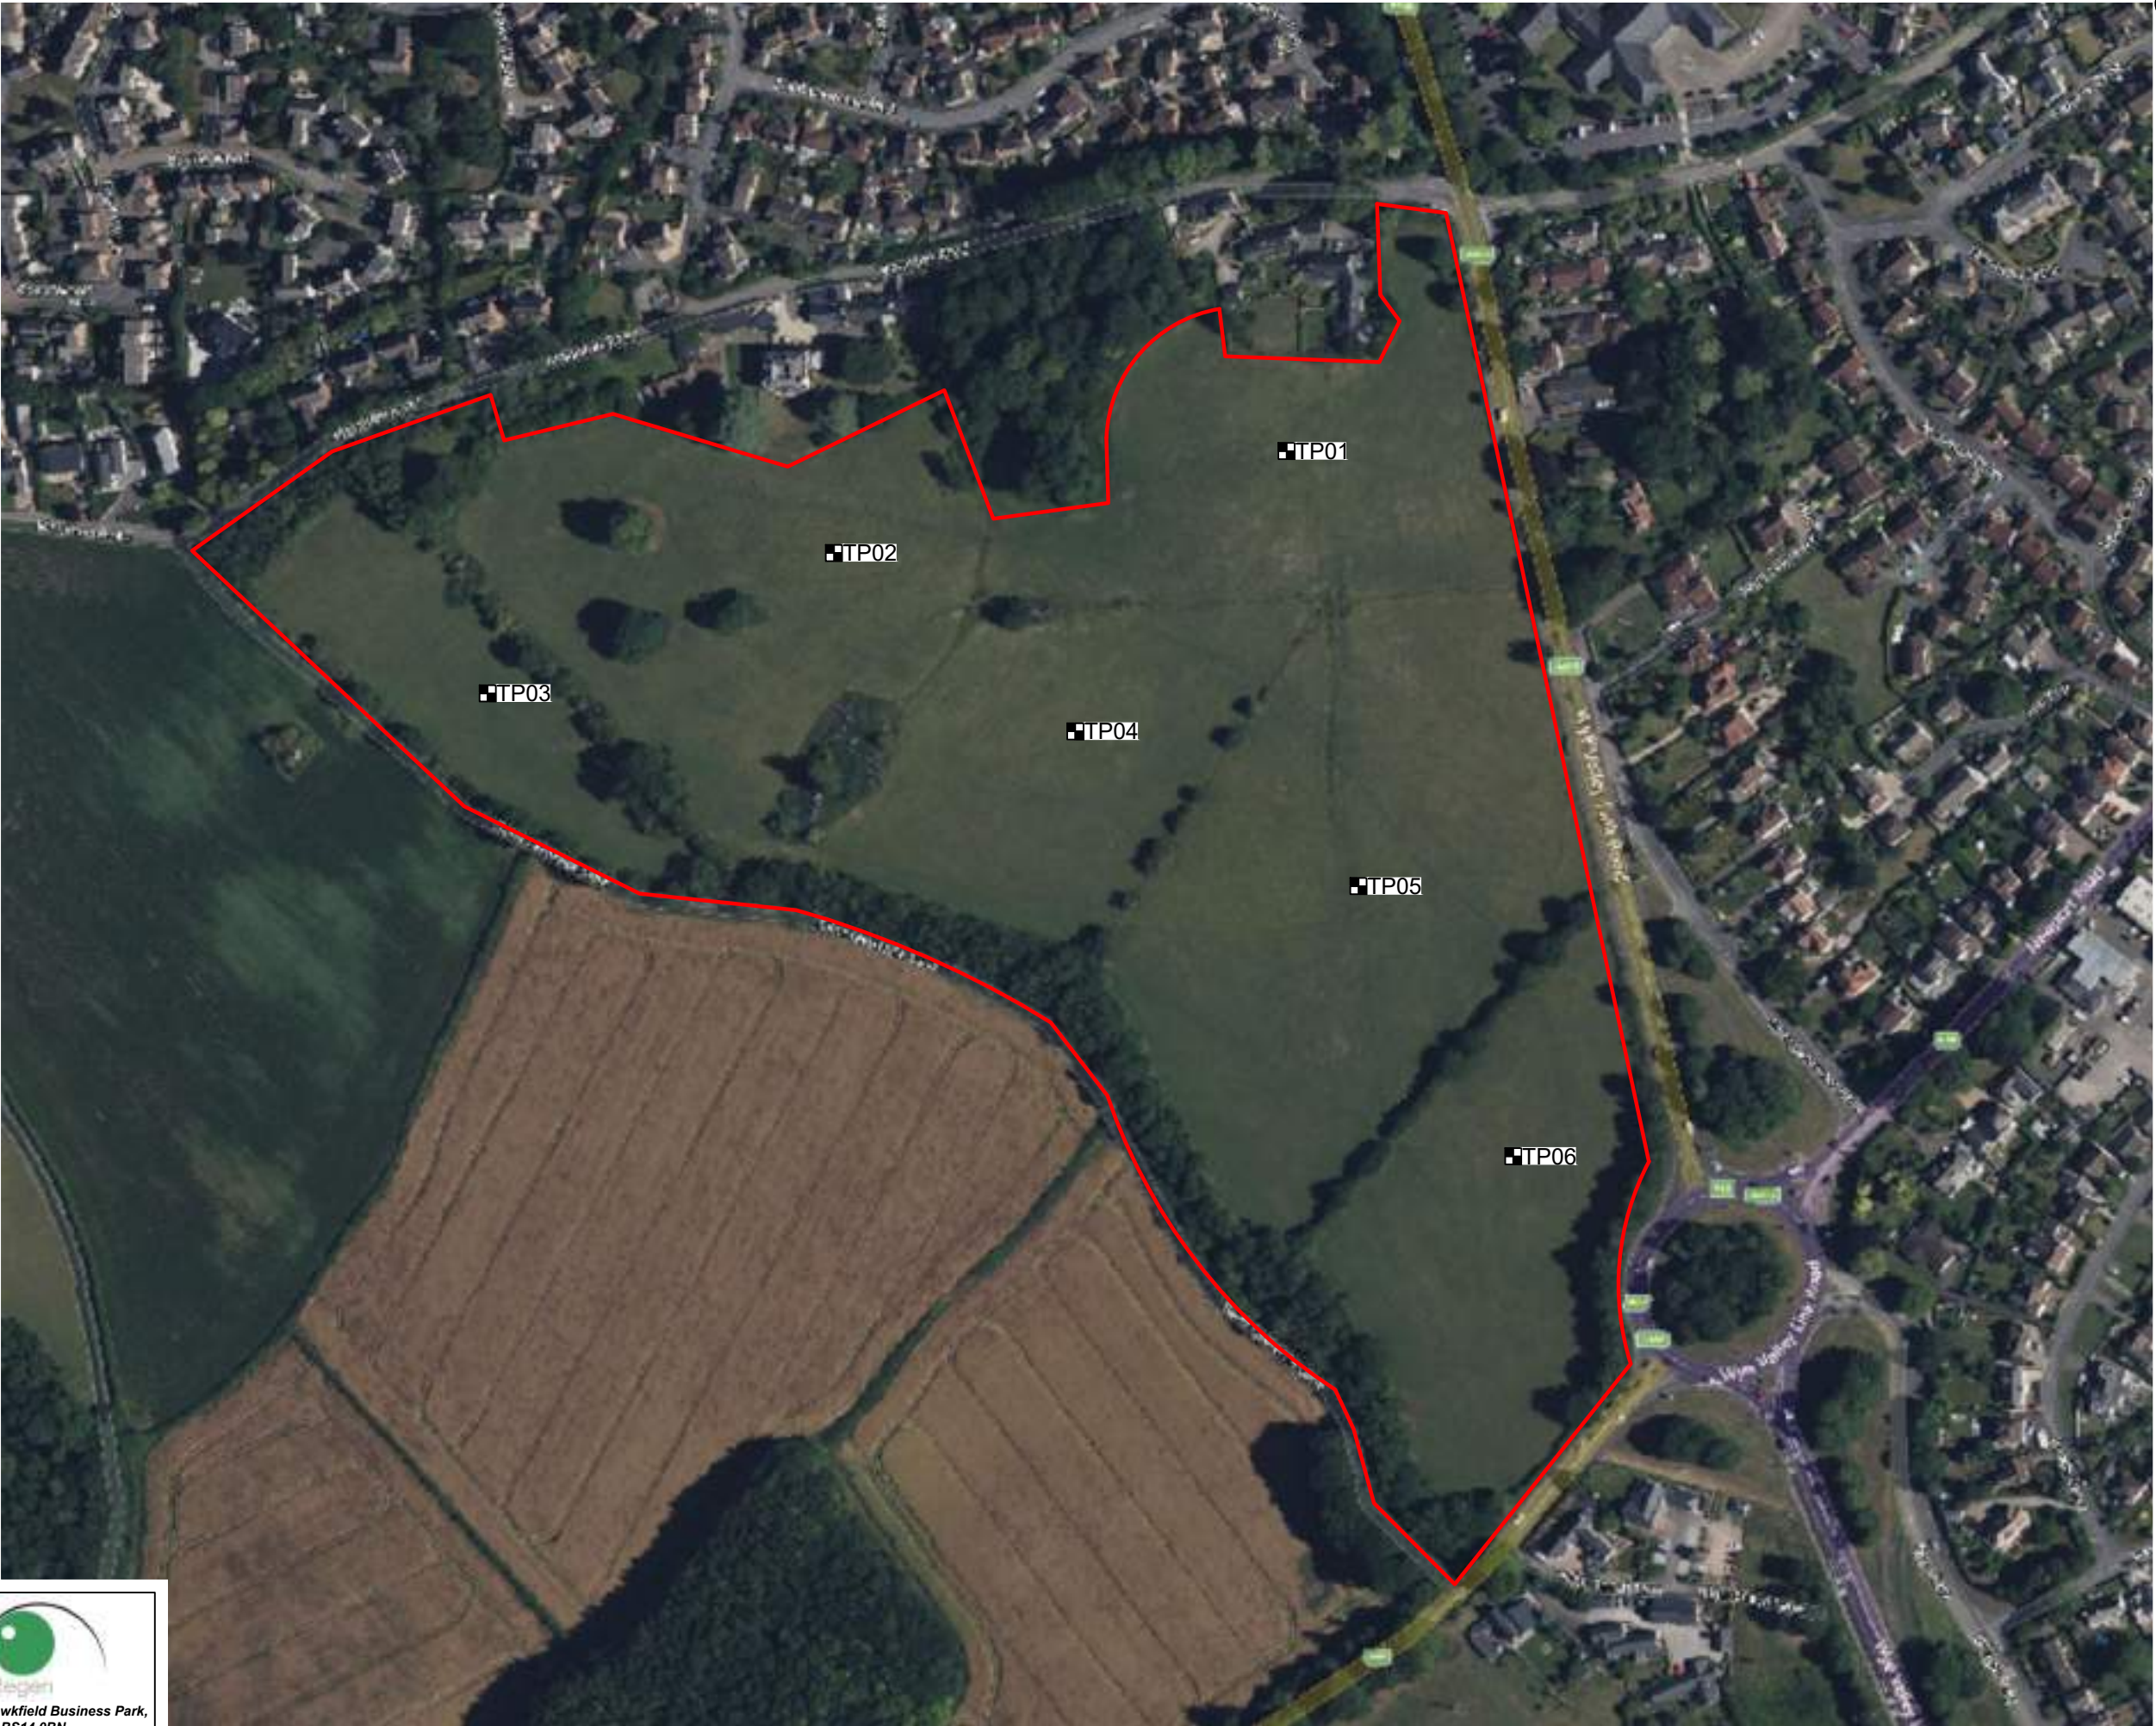
| Exploratory Hole Location Plan | | | | |

An exploratory hole location plan is included within Appendix A, a selection of photographs from the ground investigation are included within Appendix B with exploratory hole logs in Appendix C.

■ Trial Pit Locations  
(TP01 - TP06)

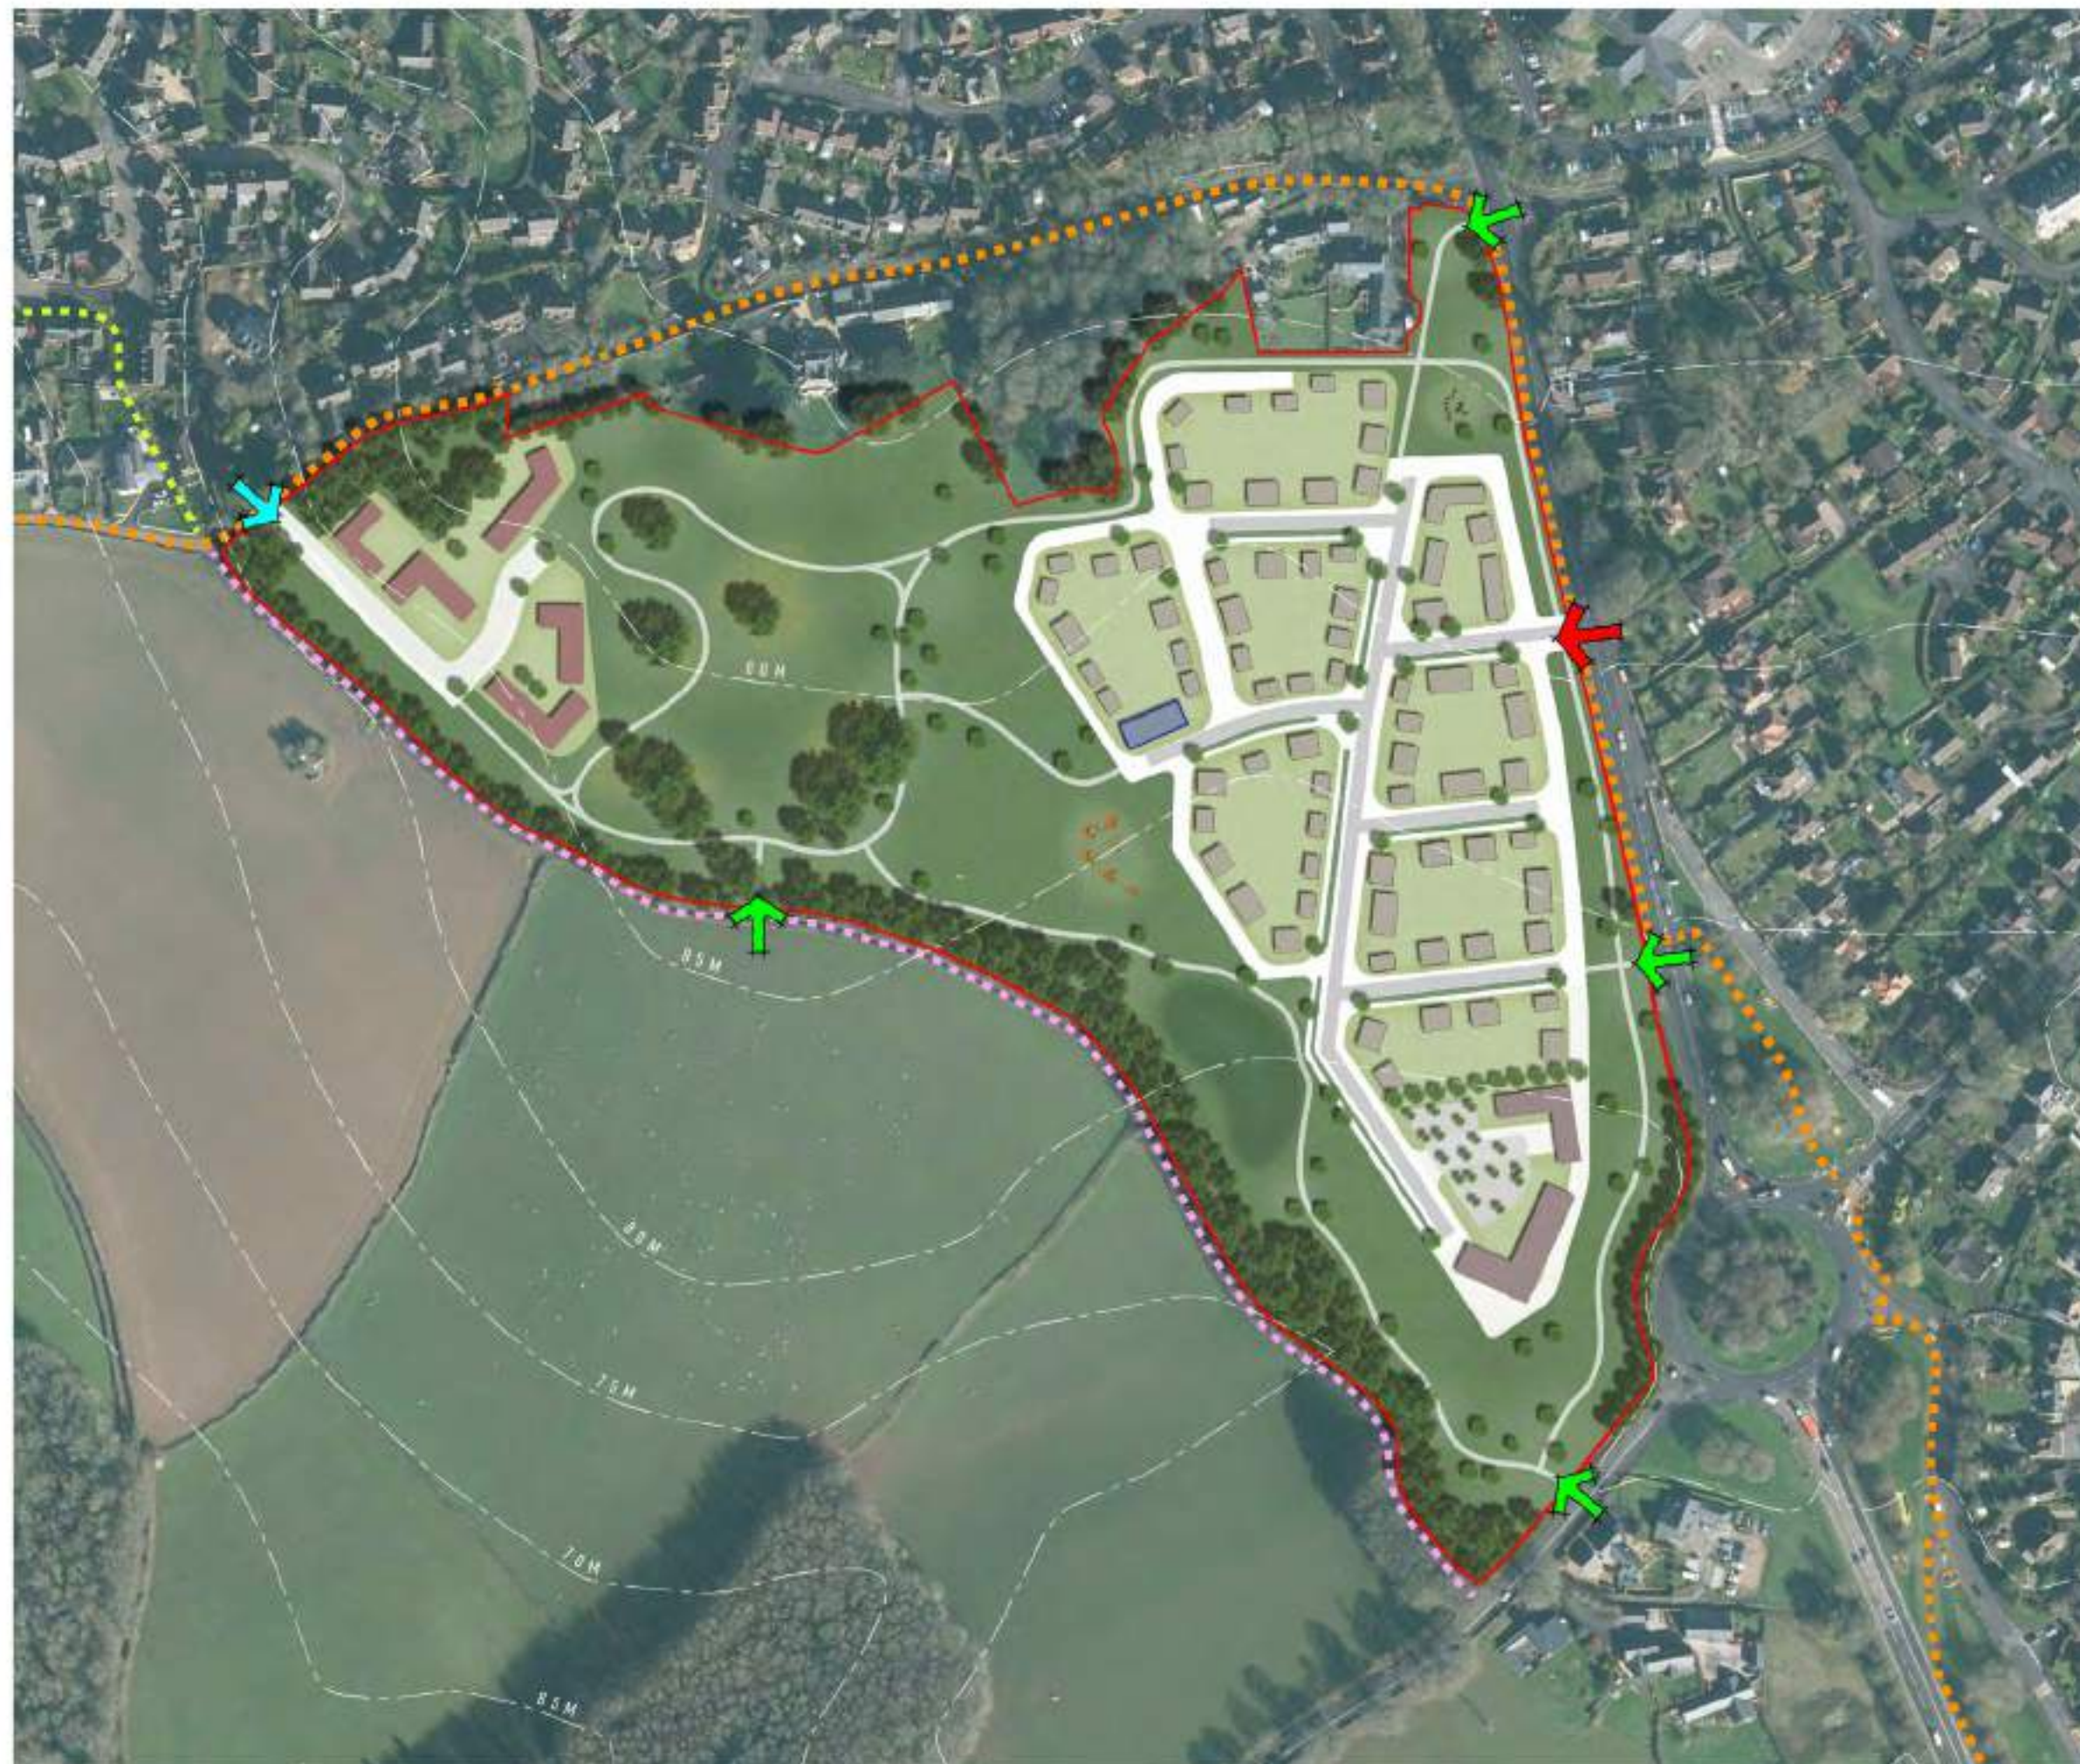
| 1:2500@A3 | 15/01/24 | HL | CS | - | P1058-01-003 |

- Site Boundary
- Residential Development
- Community Hub
- Hotel/Commercial Office Space
- Retirement/Care Home
- Main Access
- Pedestrian/Cycle Access
- Secondary Access
- Public Right of Way
- St Lawrence Lane
- National Cycle Route (4)
- Local Equipped Areas of Play
- Natural Play
- Indicative Roadside Swale
- Indicative Roadside Underdrained Swale
- Indicative Infiltration Basin

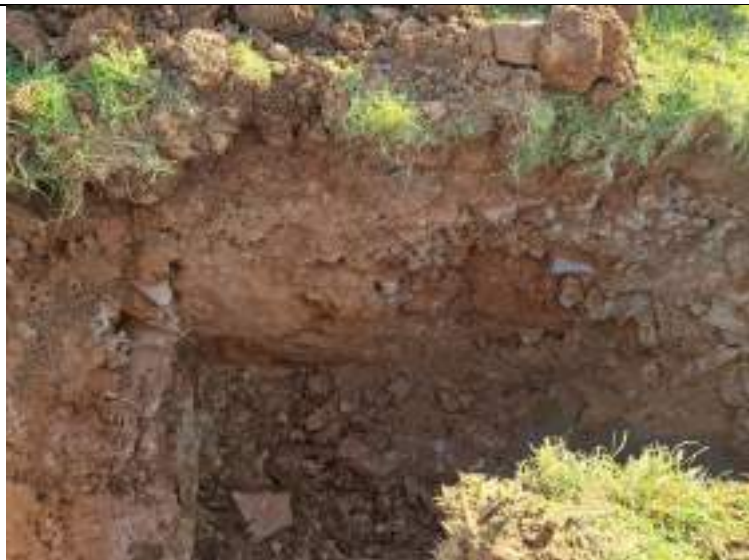
**PLATE 01 – Trial Pit Excavation – TP01.**

| | | | | (0.80) | | Extremely weak light grey LIMESTONE. Recovered as slightly clayey angular fine to coarse limestone GRAVEL with a high cobble content. Cobbles are angular of limestone. (BLACK ROCK LIMESTONE SUBGROUP) | 1 | |

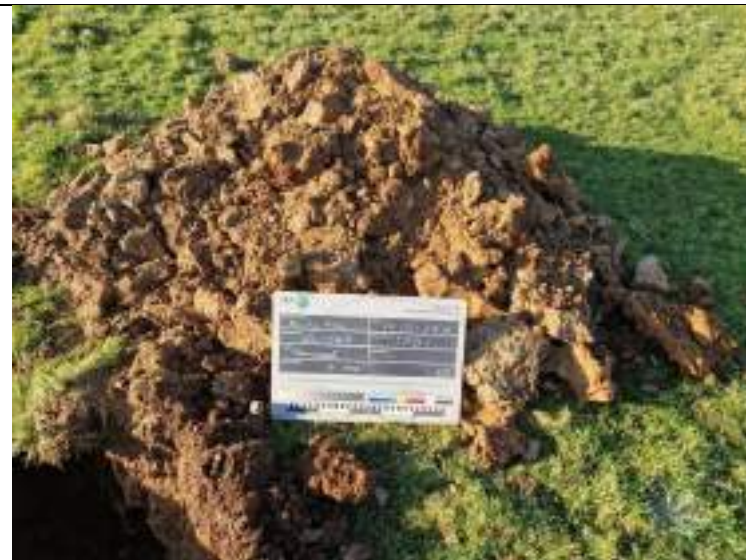
**PLATE 02 – Trial Pit Spoil – TP01.**

| | | | 92.82 | 0.40 | | Firm brown mottled grey slightly sandy slightly gravelly CLAY with a low cobble content. Gravel is subangular fine to coarse of limestone. Cobbles are subangular of limestone. (BLACK ROCK LIMESTONE SUBGROUP) | | |

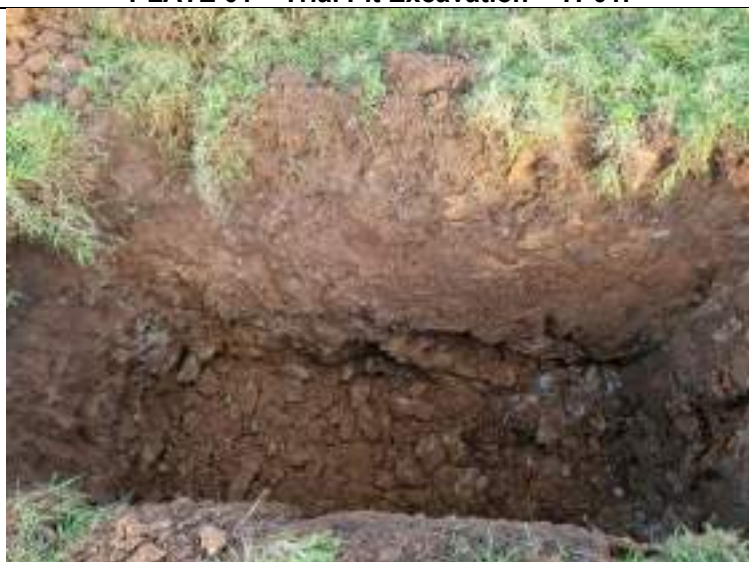
**PLATE 03 – Trial Pit Excavation – TP02.**

| | | | | (0.80) | | Extremely weak light grey LIMESTONE. Recovered as slightly clayey slightly sandy angular fine to coarse limestone GRAVEL and COBBLES. Cobbles are angular of limestone. (BLACK ROCK LIMESTONE SUBGROUP) | | |

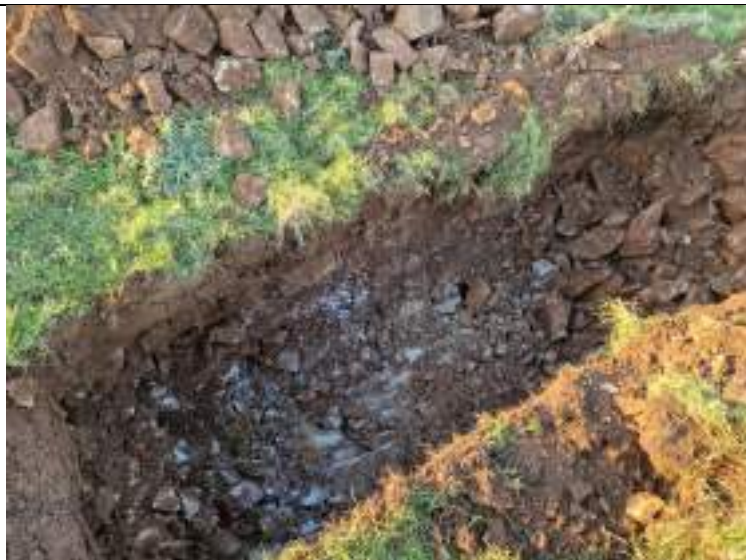
**PLATE 05 – Trial Pit Excavation – TP03.**

| | | | | (0.70) | | Soft reddish brown silty friable CLAY. (BLACK ROCK LIMESTONE SUBGROUP) | | |
| | | | 83.76 | 0.90 | | Extremely weak light grey LIMESTONE. Recovered as slightly clayey slightly sandy angular fine to coarse limestone GRAVEL and COBBLES. Cobbles are angular of limestone. (BLACK ROCK LIMESTONE SUBGROUP) | 1 | |

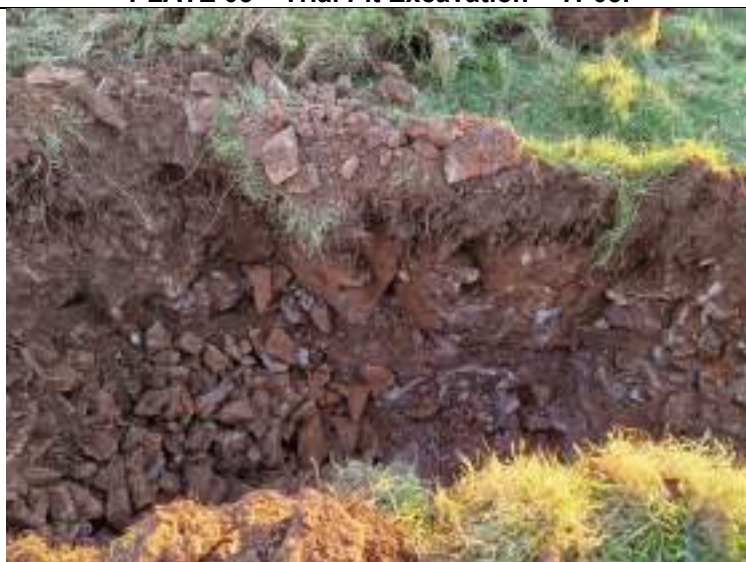
**PLATE 07 – Trial Pit Excavation – TP04.**

| | | | | (0.70) | | Extremely weak light grey LIMESTONE. Recovered as slightly clayey slightly sandy angular fine to coarse limestone GRAVEL and COBBLES. Cobbles are angular of limestone. (BLACK ROCK LIMESTONE SUBGROUP) | | | |

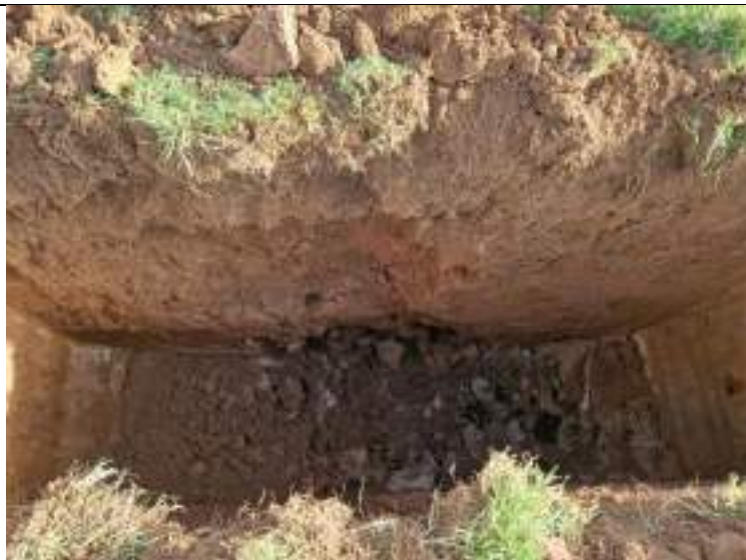
**PLATE 09 – Trial Pit Excavation – TP05.**

| | | | | | | Soft reddish brown silty friable CLAY. (BLACK ROCK LIMESTONE SUBGROUP) | | | |
| | | | 82.20 | 1.50 | | Extremely weak light grey LIMESTONE. Recovered as slightly clayey slightly sandy angular fine to coarse limestone GRAVEL with a medium cobble content. Cobbles are angular of limestone. (BLACK ROCK LIMESTONE SUBGROUP) | | | |
