Remada Ltd was commissioned by Lidl Great Britain Ltd ('the client') to undertake a Phase 1 Geoenvironmental Site Investigation for a proposed store development at Narberth Road, Tenby, SA70 8BD. The objectives of this assessment were to present a preliminary conceptual site model to identify plausible pollutant linkages as a preliminary risk assessment and to provide recommendations for subsequent investigation work.

Phase 1 Site Investigation & Preliminary Risk Assessment Narberth Road, Tenby 1323.01.02 December 2024

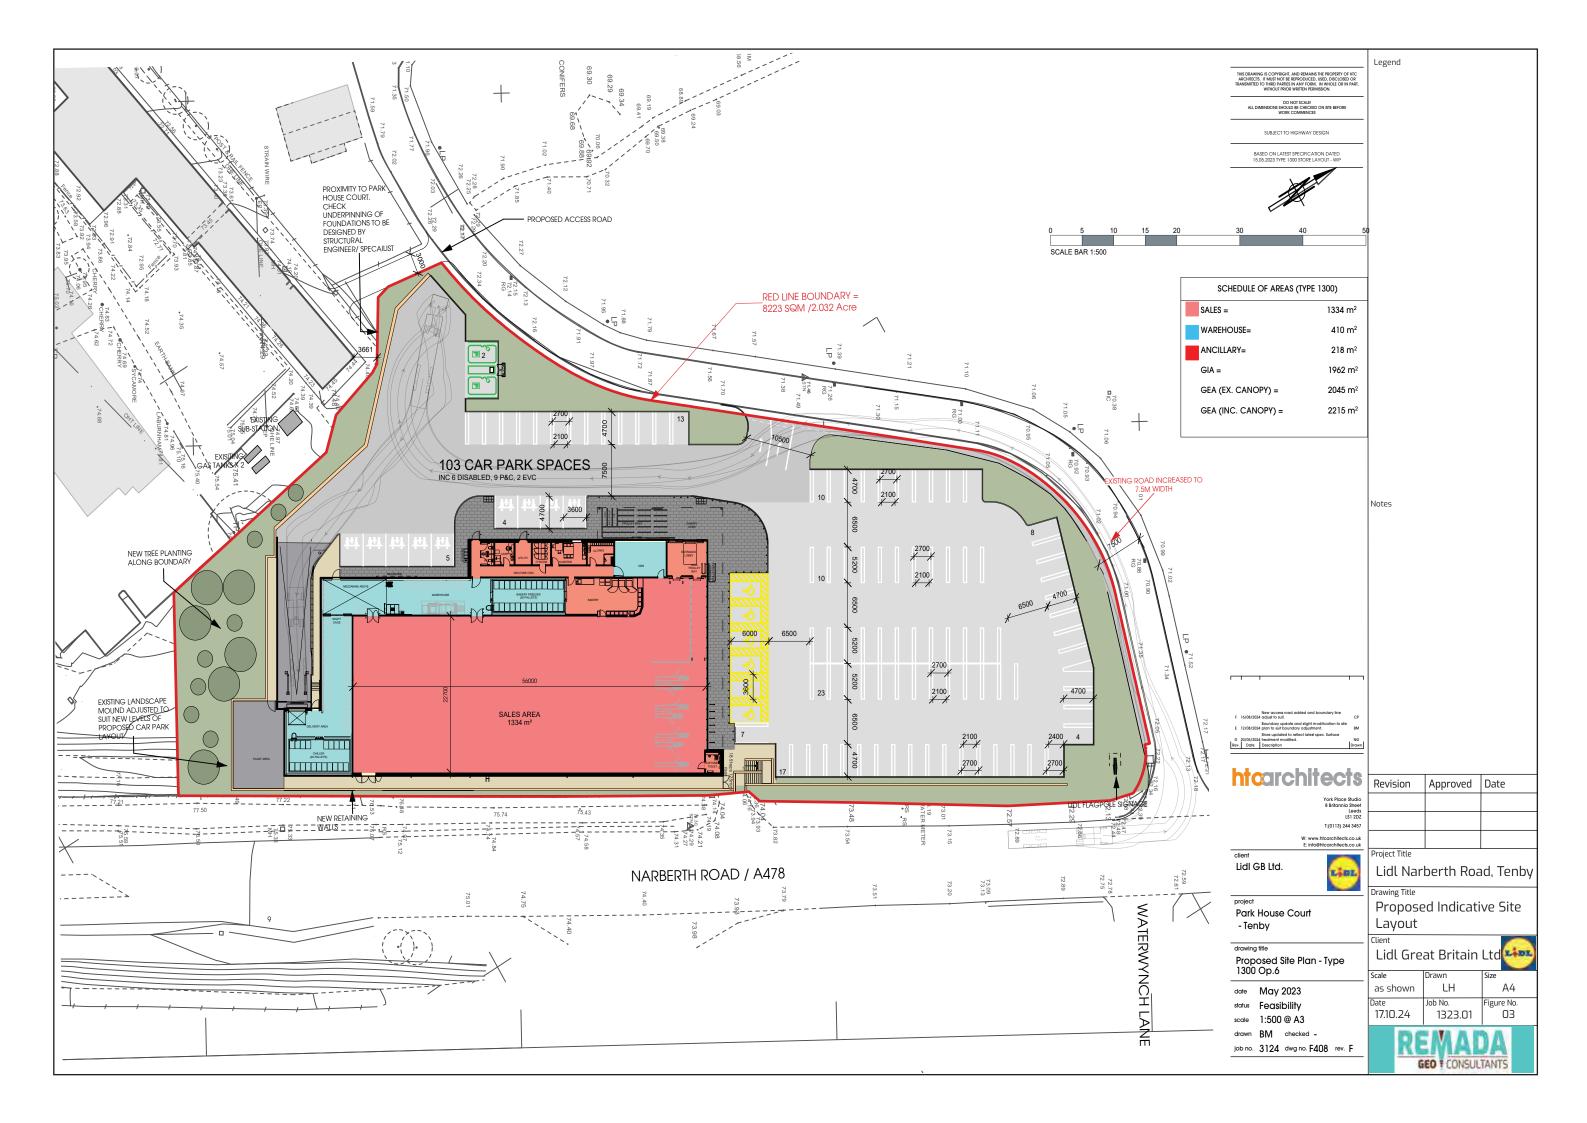
Figure 3 Proposed Indicative Site Layout

It is understood that the proposed use for the site will be a Lidl retail store with associated car park and soft landscaping. A proposed indicative site layout plan is presented as **Figure 3**, with the proposed store footprint located adjacent to A478 Narbeth Road in the southern and south-eastern areas. The remaining areas are proposed to be a combination of car parking, HGV access and soft landscaping.
