# Phase 1 Site Investigation & Preliminary Risk Assessment

Client: Lidl Great Britain  
Ltd

Cymann, Lampeter

Report No: 1304.01.01

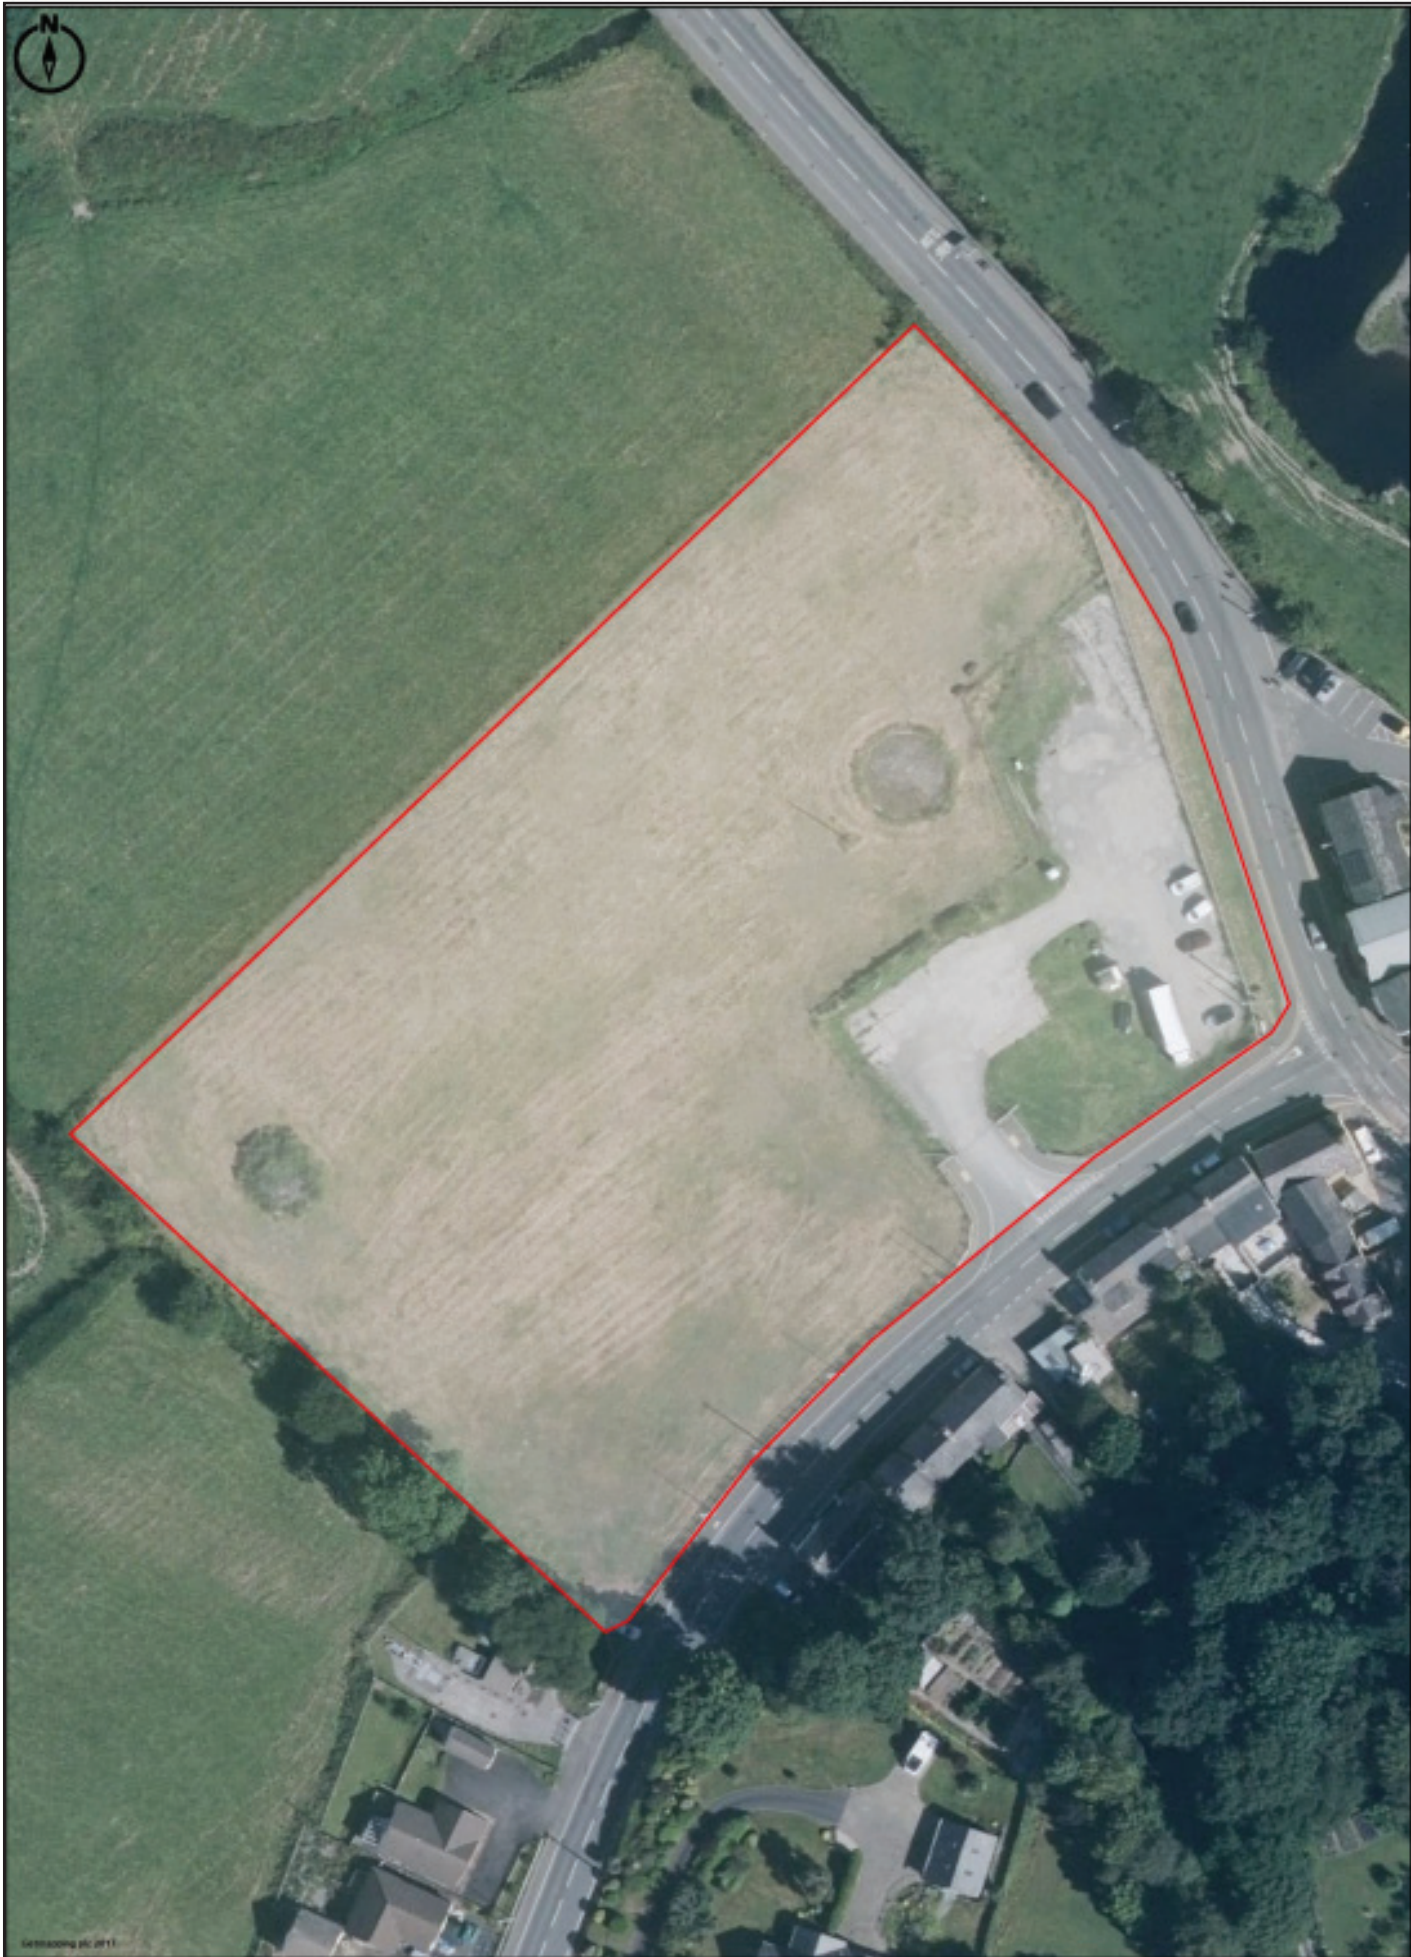
| Figure 2 | Existing Site Layout |

| <b>Site Description</b> | The site occupies a broadly rectangular plot of land to the west side of the junction of the A482 & A485. A wooden post and rail fence appears to separate the pedestrian footpaths to the roads from the site. The site itself is a more or less flat field except for the northeastern corner adjacent to the road junction where a unpaved car park has been constructed from a capping or subbase material. The car park is accessed via a bell mouth on the A485 approximately 50m south the junction. The existing site layout is indicated in <b>Figure 2</b> . |

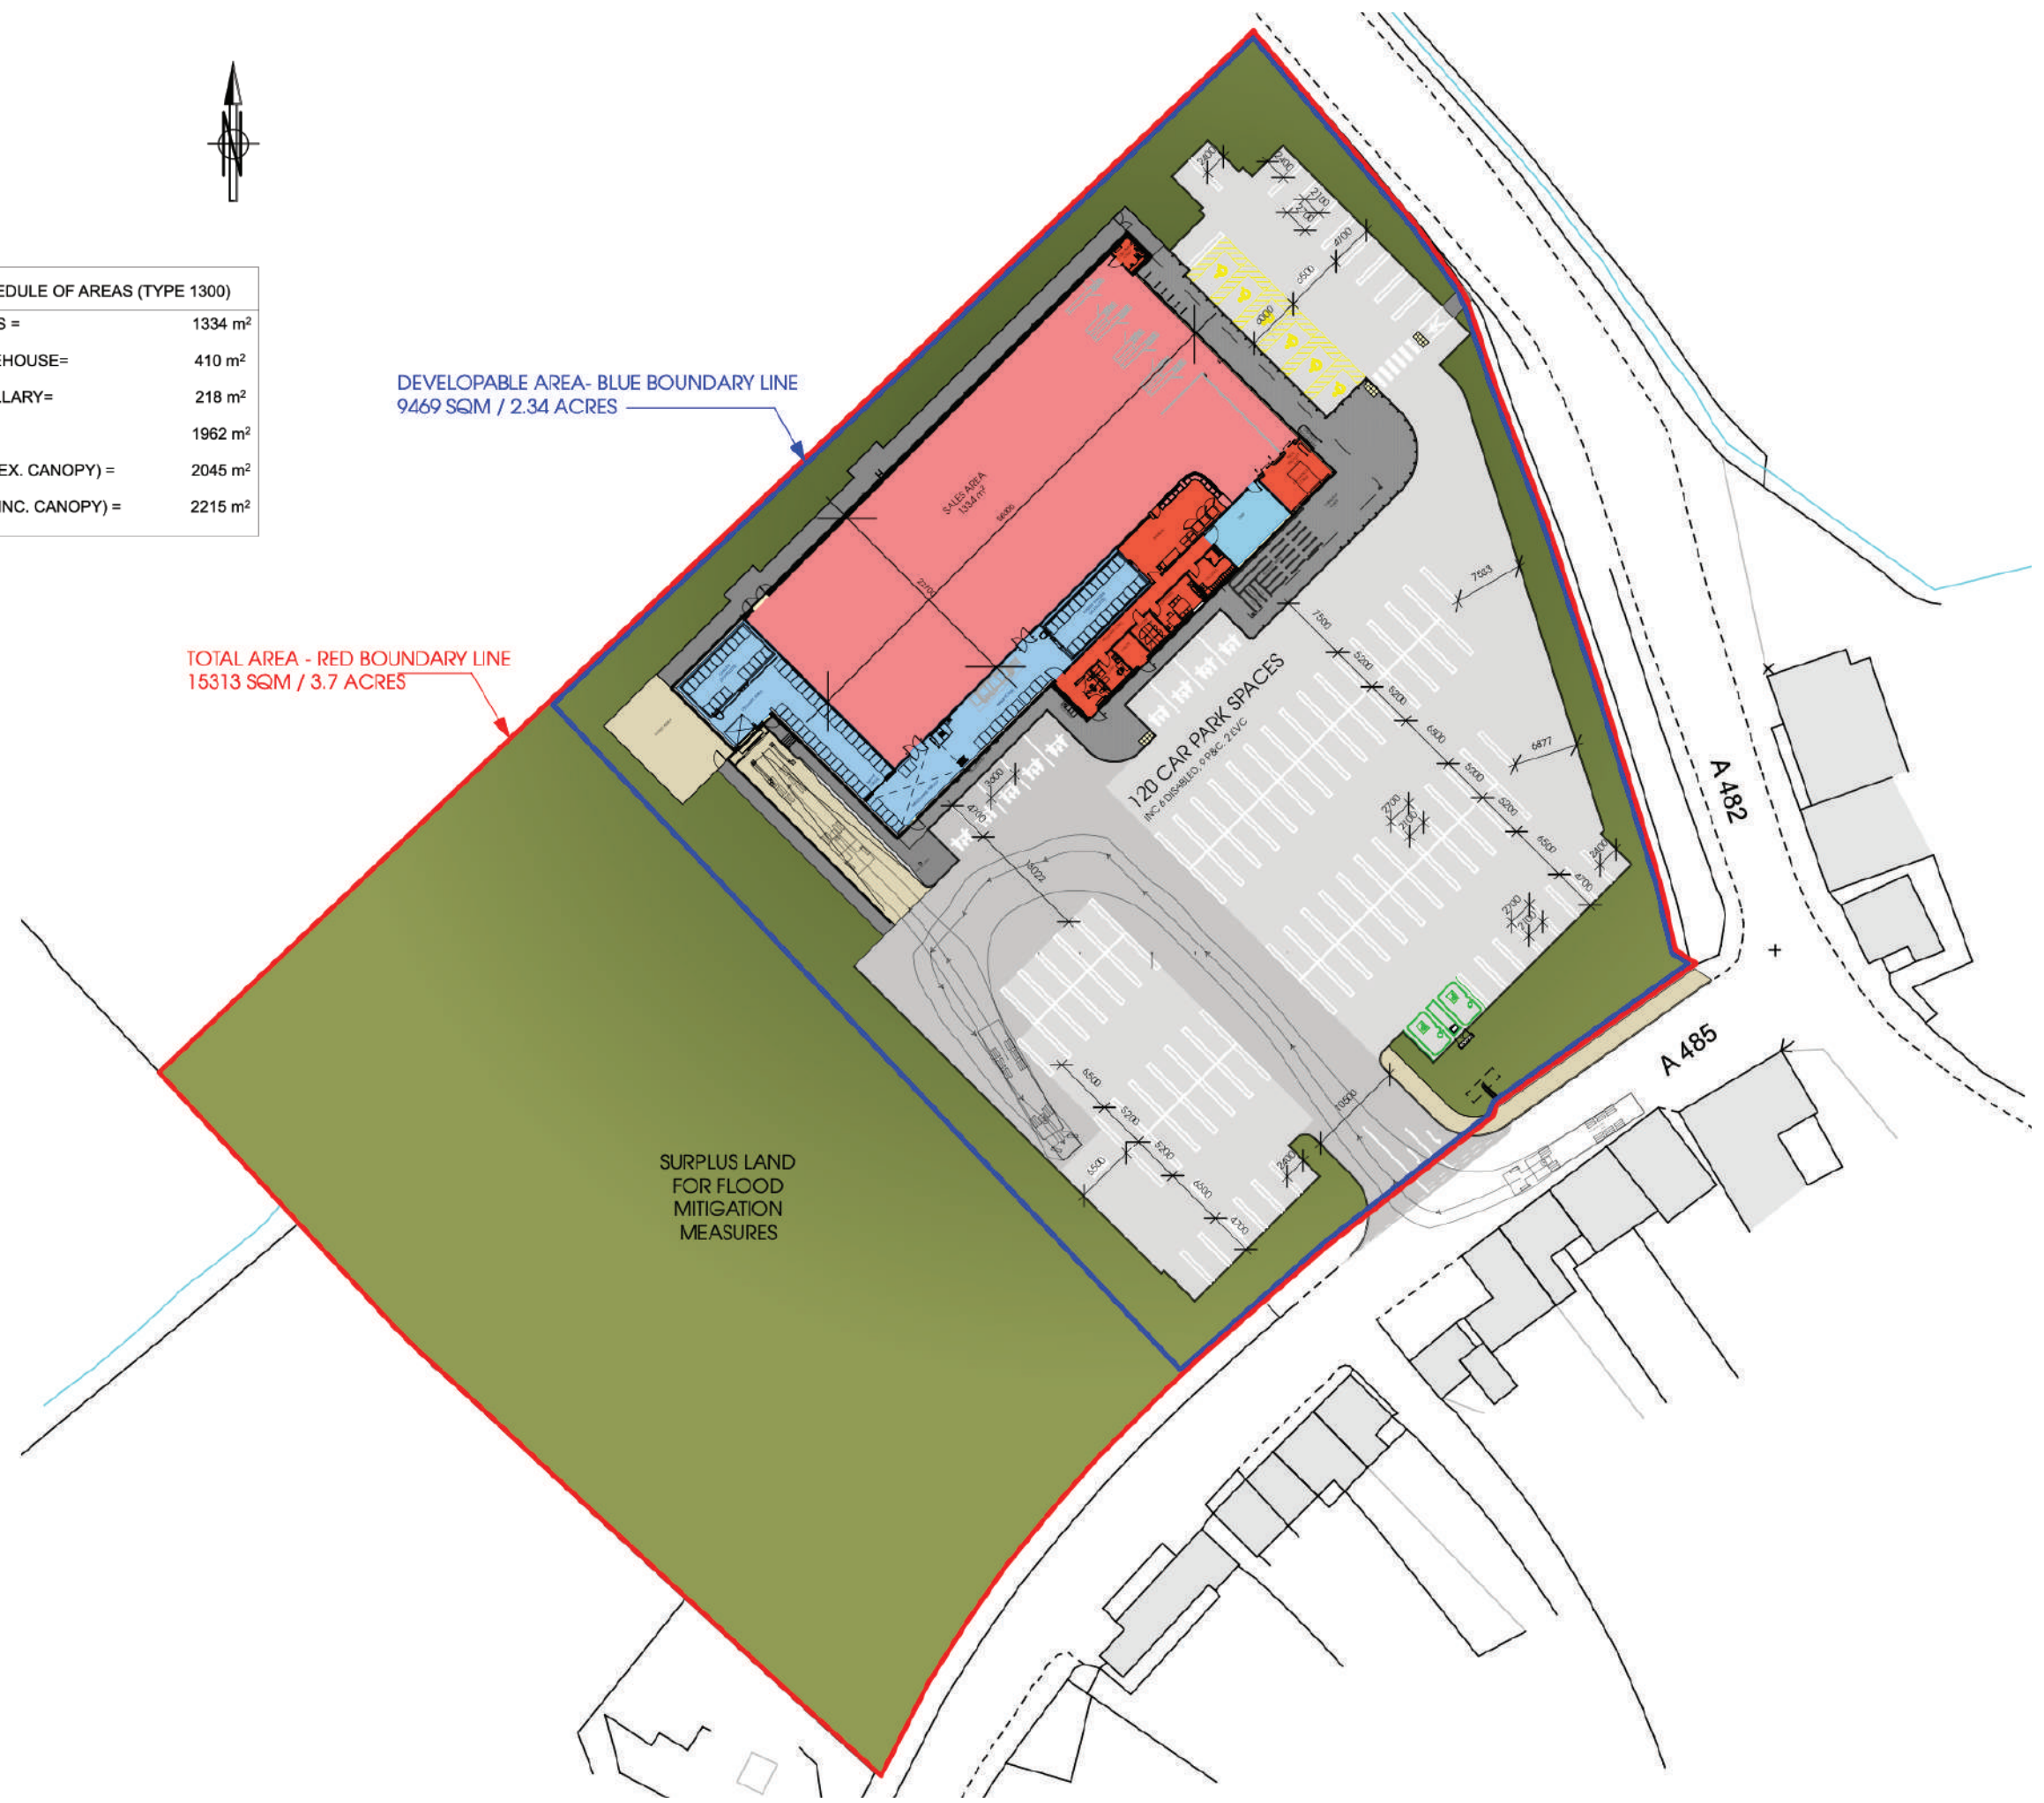
| Figure 3 | Proposed Indicative Site Layout |

It is understood that the proposed site use for the site will be a Lidl retail store with associated car park and soft landscaping. A proposed indicative site layout plan is presented as **Figure 3**, with the site being accessed from the A485 along the south-eastern boundary. The proposed store footprint is indicated to be in the north-western area of the site, with the remaining areas being a combination of car parking, HGV access and soft landscaping. The south-western area of the site is indicated to be 'surplus land for flood mitigation measures'.

| SCHEDULE OF AREAS (TYPE 1300) | |
|---|---|
| GEA (EX. CANOPY) = | 2045 m <sup>2</sup> |
| GEA (INC. CANOPY) = | 2215 m <sup>2</sup> |
