**Phase 2  
Ground Investigation**

**Client: Lidl Great Britain Ltd  
Aberystwyth Road, Cardigan**

**Report No: 941.02.01**

**December 2025**

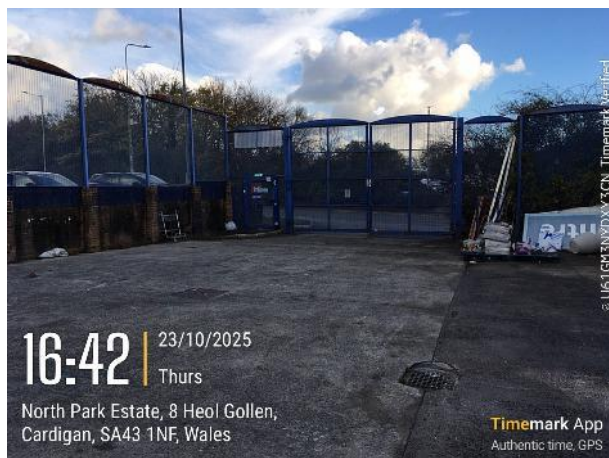
**Photo 1:** The southwestern site boundary with a gated entrance to the courtyard and storage area of the B&M store and Garden Centre.

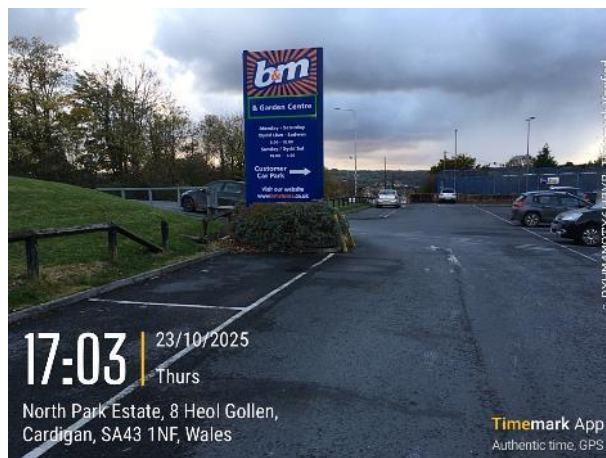
**Photo 2:** A view towards the south of the site, showing the carpark entrance from B4548 Aberystwyth Road and showing the height difference between the car park and service yard.

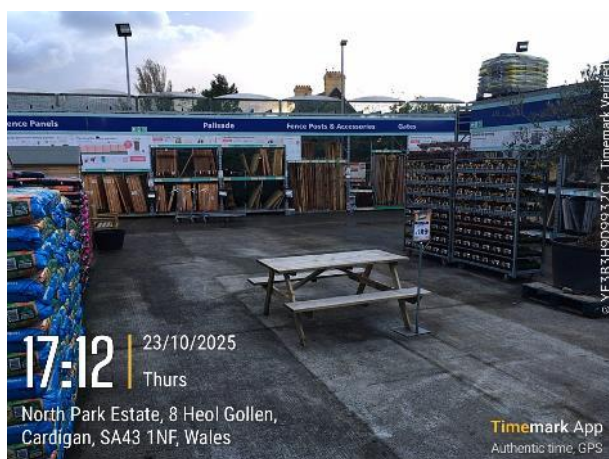
**Photo 3:** A view of the Garden Centre where window sample (WS01) is located.

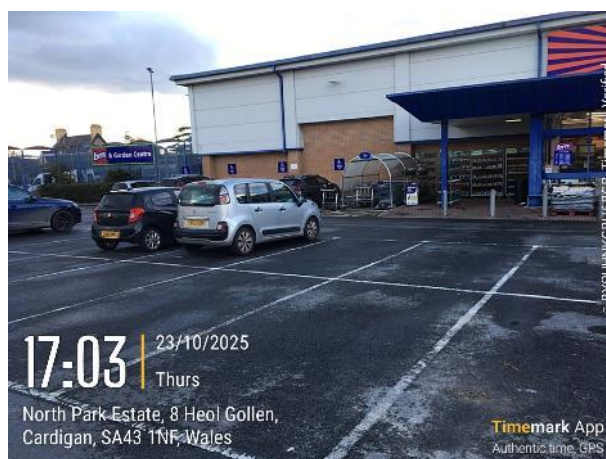
**Photo 4:** A view towards the north showing the existing carpark and B&M store.

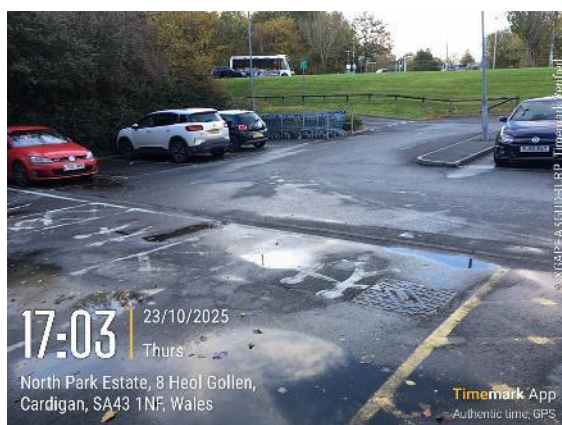
**Photo 5:** A view towards the south-east

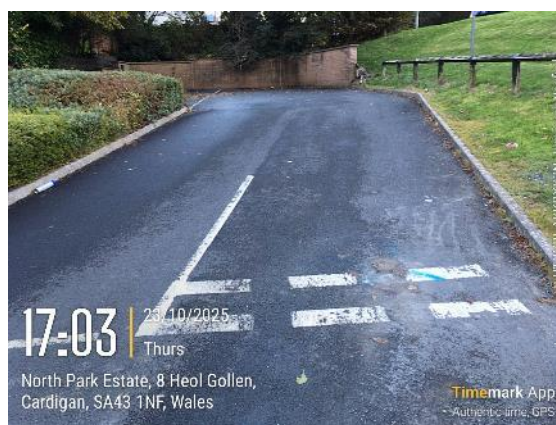
**Photo 6:** A view towards the north-east corner of the site

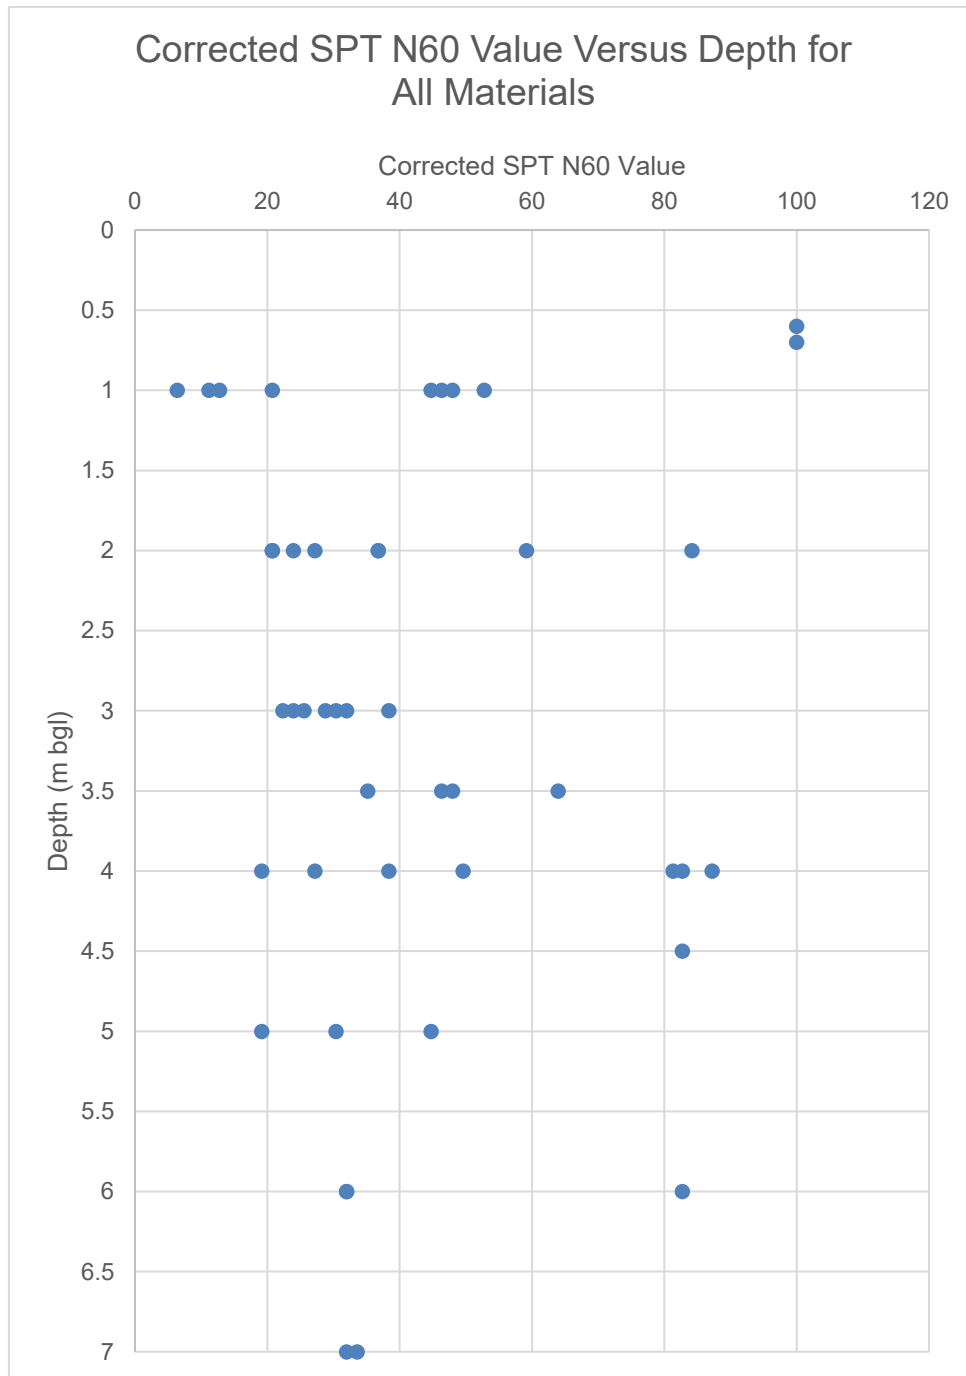
**Graph 1: Plot of Corrected SPT N-Values Versus Depth**

In-situ SPTs were undertaken to assist with the interpretation of strata encountered. The results of corrected N-values versus depth are plotted in the graph below. Where the corrected N-value >100, the plotted value = 100

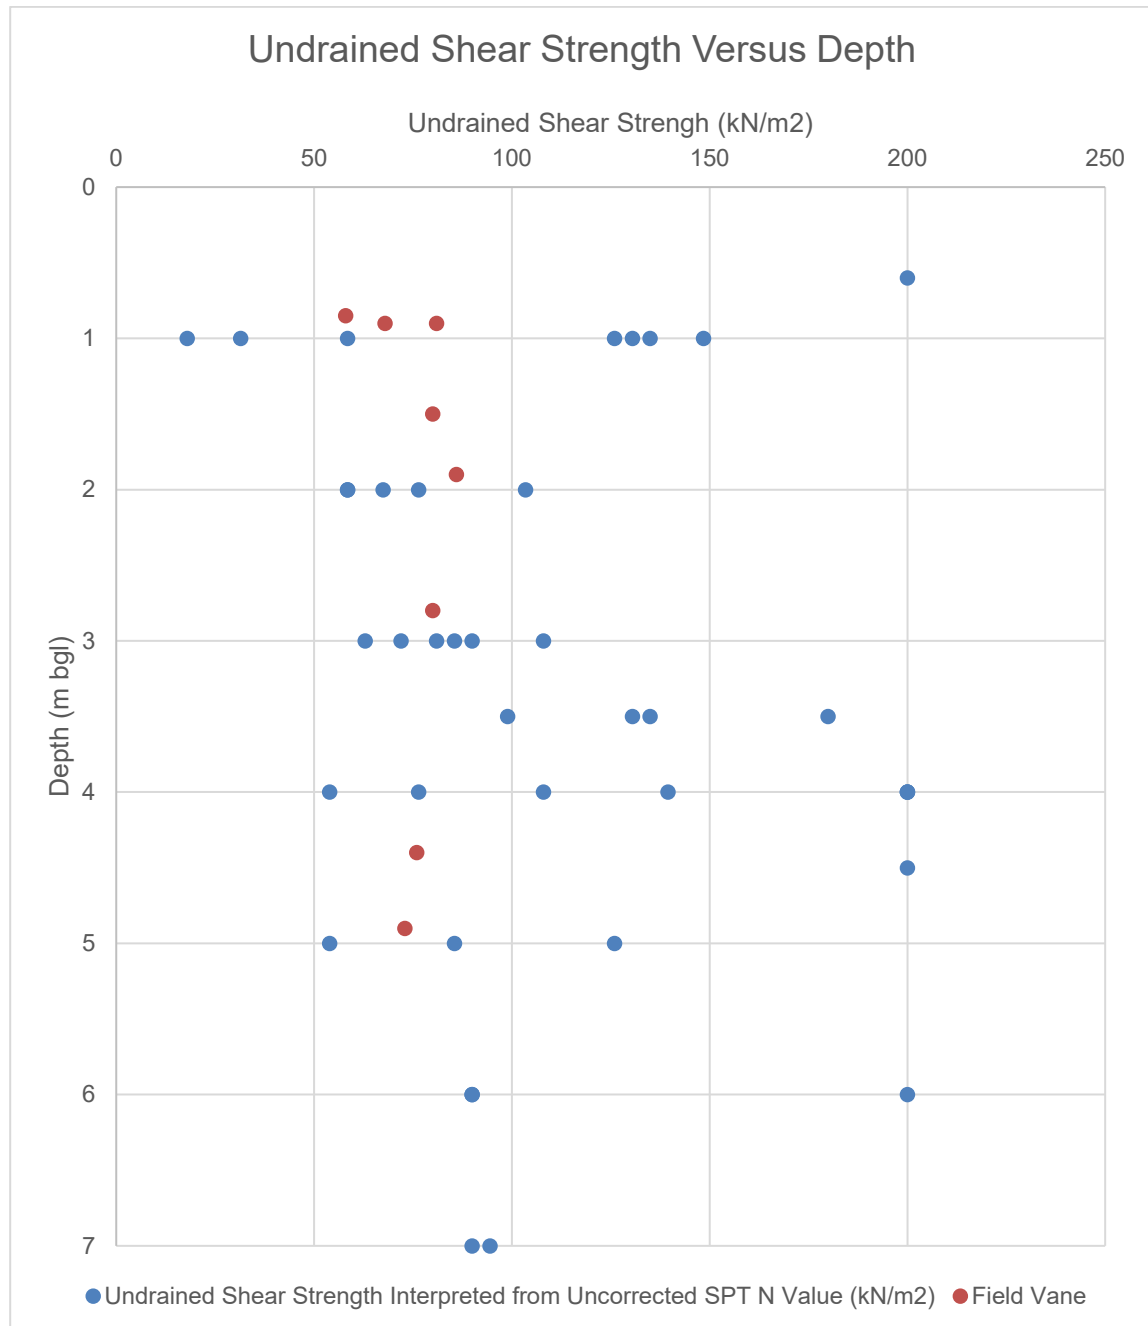
**Graph 2: Plot of Mass Shear Strength Versus Depth With Remada's Design Lines**

Undrained shear strengths have been estimated from SPT N values using the relationship developed by Stroud (*The standard penetration test in incentive clays and soft rocks*) and summarised in Tomlinson where:

A Plasticity Index of 35% has been assumed (based on geotechnical laboratory testing) which equates to an  $f_1$  factor of 4.5. Where the calculated shear strength is  $>200\text{kN/m}^2$  then the plotted number = 200

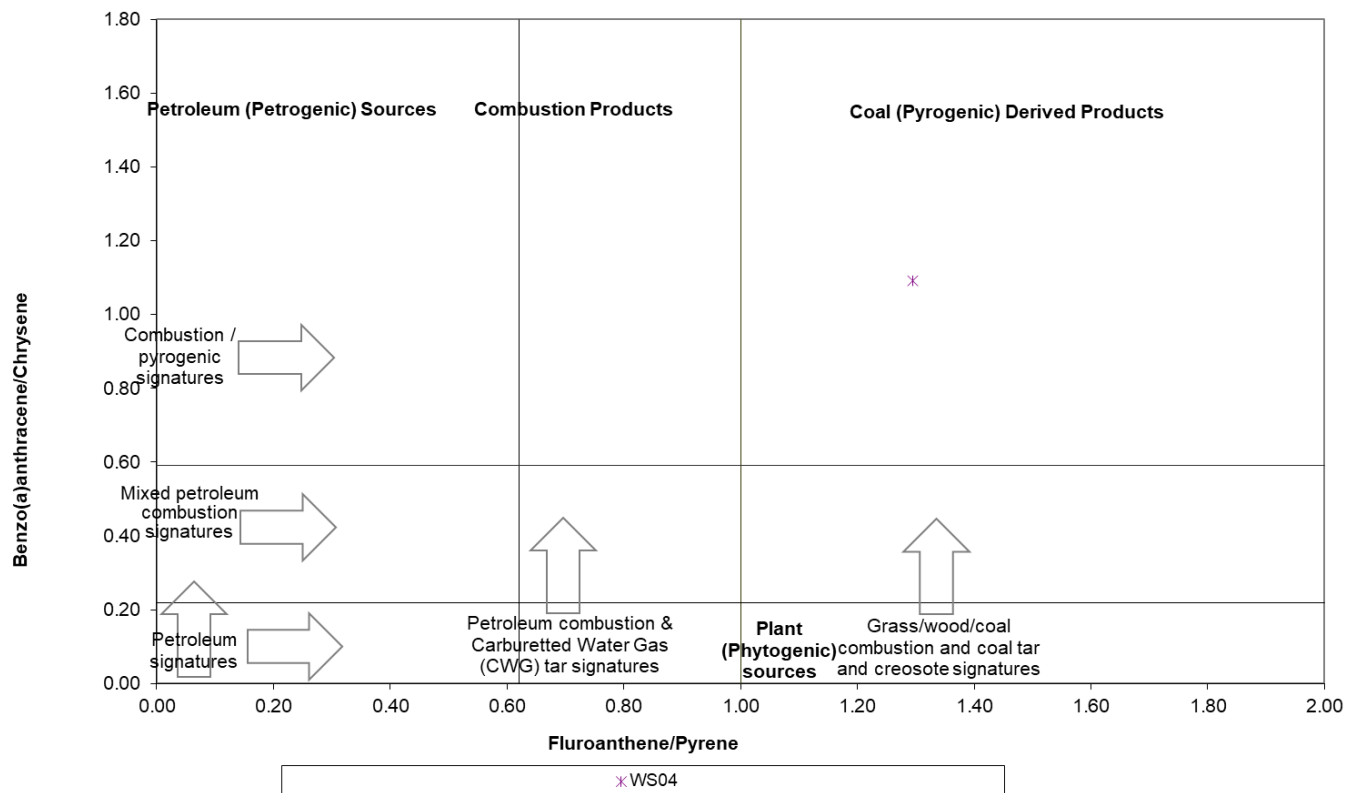
**Graph 4: PAH Double Ratio Plot**

In addition, the PAH concentrations have been plotted on a double ratio plot to provide an indication of the likely source of the PAHs. All of the samples that had detections of the four PAHs used have been plotted and all are indicated to be coal derived product related PAHs which could be associated with urban background sources.

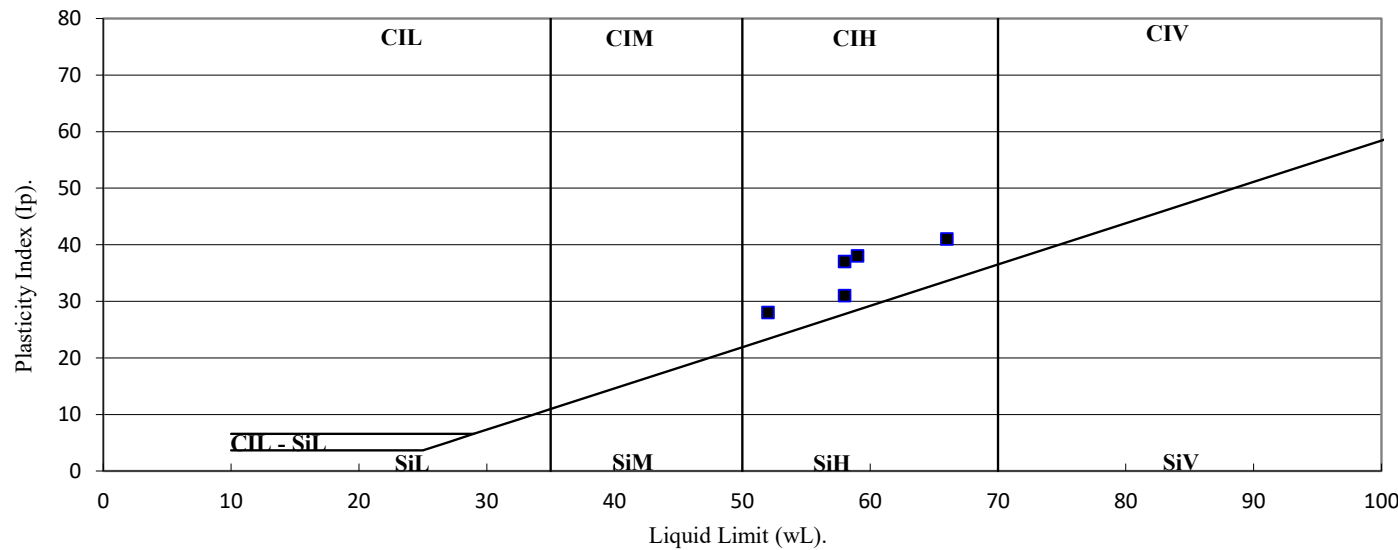
## PLASTICITY CHART

### BS EN ISO 14688-2:2018 Clause 4.4

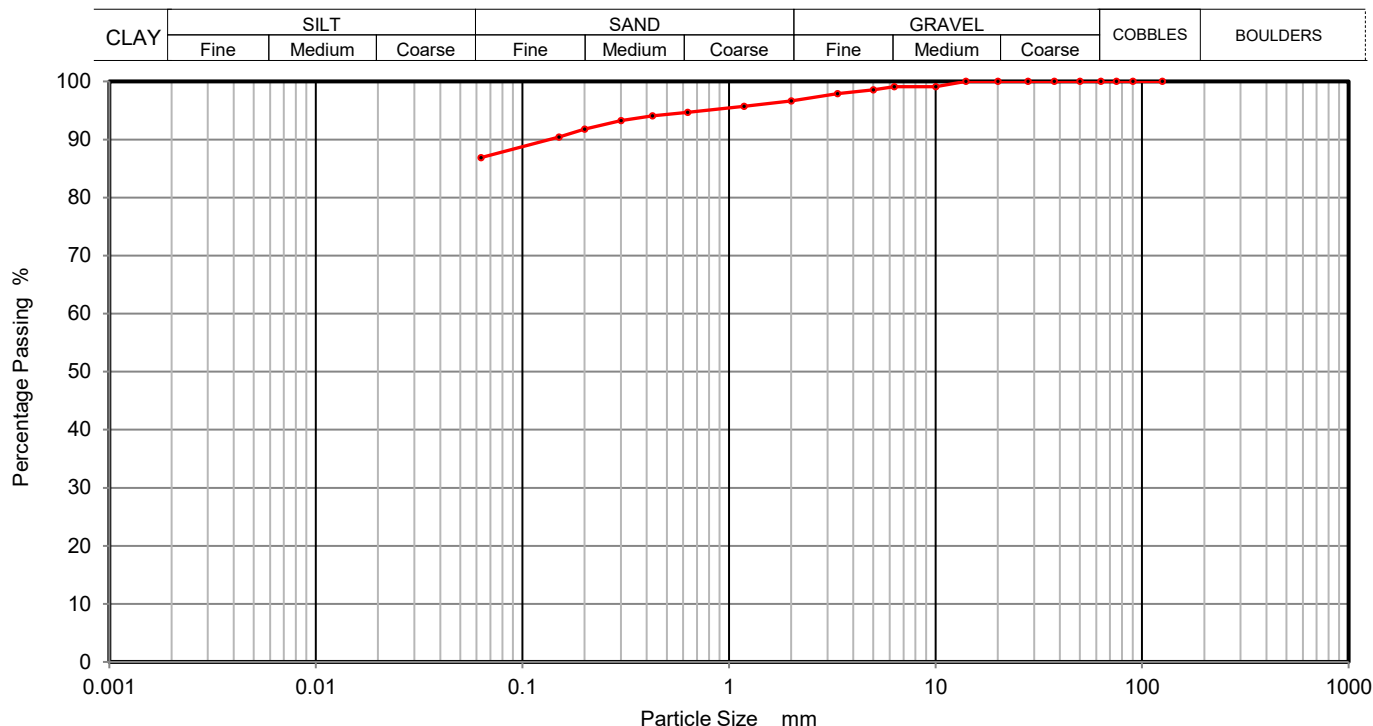
Sieving		Sedimentation	
Particle Size mm	% Passing	Particle Size mm	% Passing
125	100		
90	100		
75	100		
63	100		
50	100		
37.5	100		
28	100		
20	100		
14	100		
10	99		
6.3	99		
5	99		
3.35	98		
2	97		
1.18	96		
0.63	95		
0.425	94		
0.30	93		
0.20	92		
0.15	90		
0.063	87

Sample Proportions	% dry mass
Cobbles	0
Gravel	3
Sand	10
Silt and Clay	87

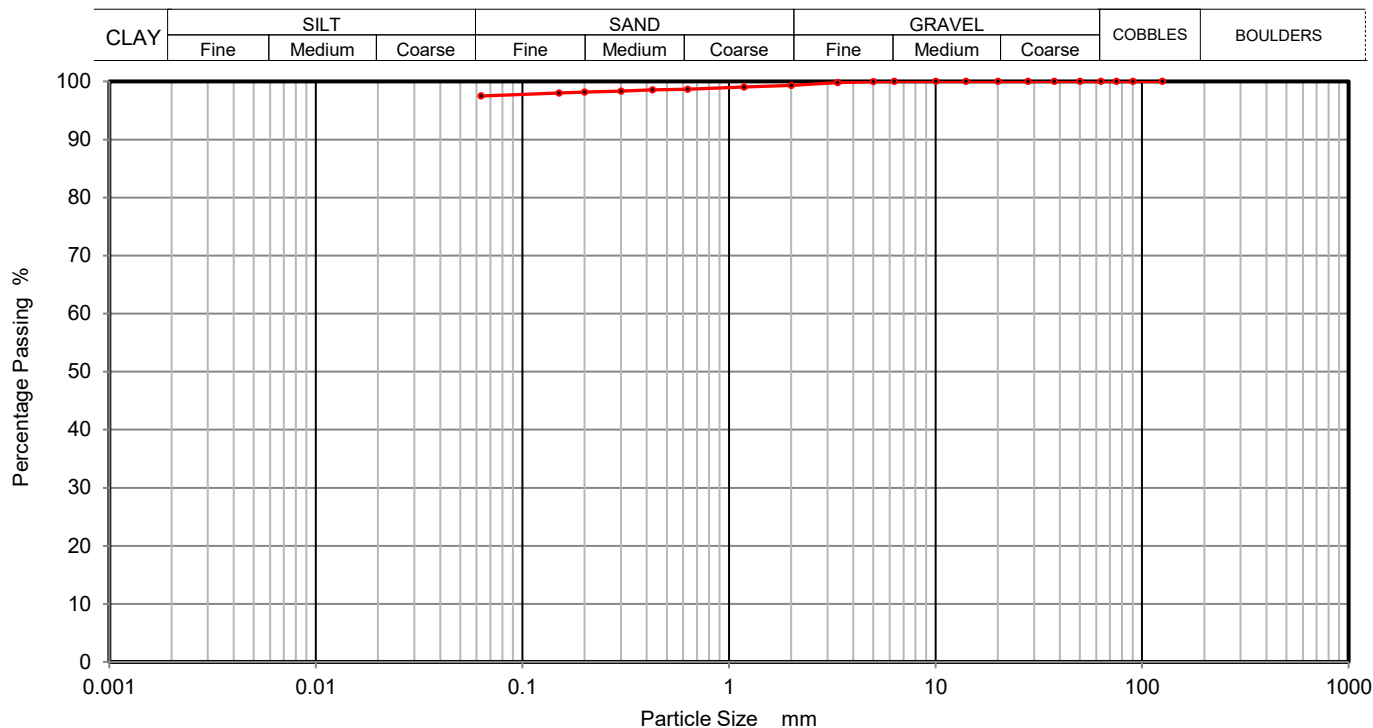
Sieving		Sedimentation	
Particle Size mm	% Passing	Particle Size mm	% Passing
125	100		
90	100		
75	100		
63	100		
50	100		
37.5	100		
28	100		
20	100		
14	100		
10	100		
6.3	100		
5	100		
3.35	100		
2	99		
1.18	99		
0.63	99		
0.425	99		
0.30	98		
0.20	98		
0.15	98		
0.063	97

Sample Proportions	% dry mass
Cobbles	0
Gravel	1
Sand	2
Silt and Clay	97

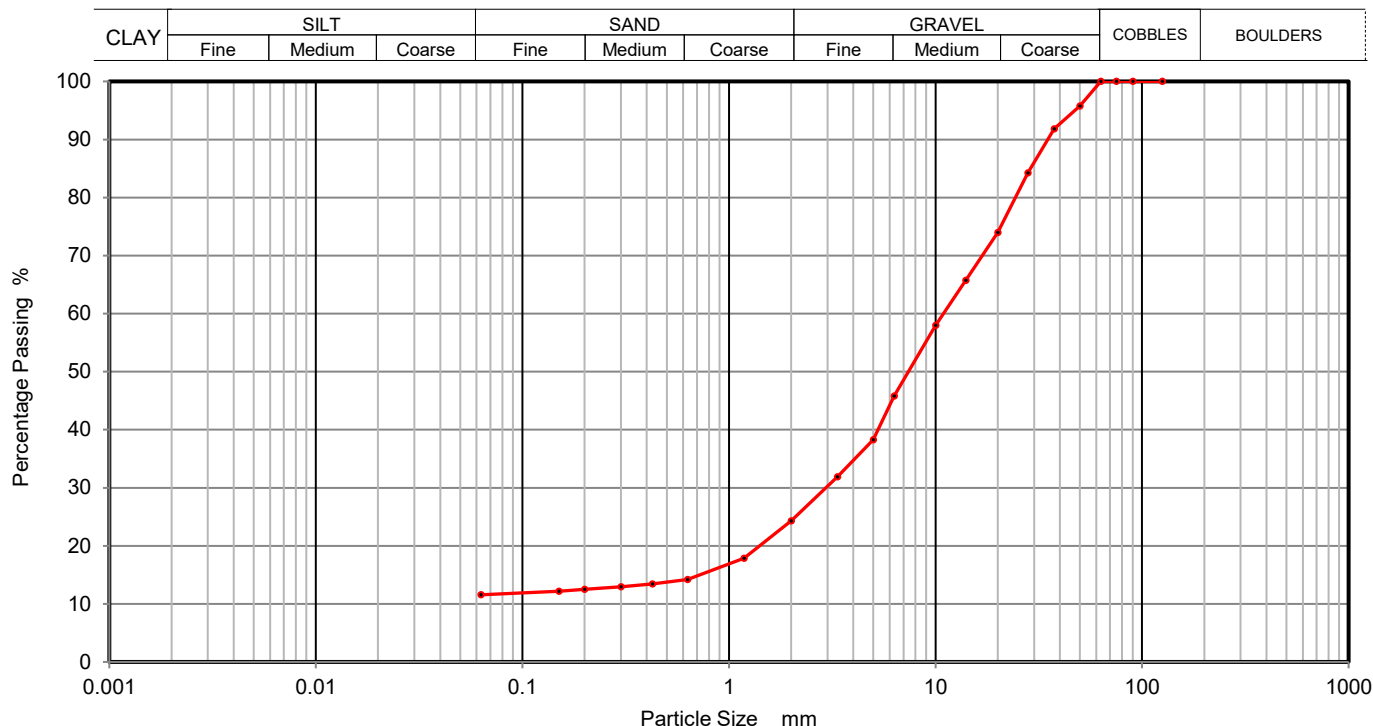
Sieving		Sedimentation	
Particle Size mm	% Passing	Particle Size mm	% Passing
125	100		
90	100		
75	100		
63	100		
50	96		
37.5	92		
28	84		
20	74		
14	66		
10	58		
6.3	46		
5	38		
3.35	32		
2	24		
1.18	18		
0.63	14		
0.425	13		
0.30	13		
0.20	12		
0.15	12		
0.063	12

Sample Proportions	% dry mass
Cobbles	0
Gravel	76
Sand	12
Silt and Clay	12
