Phase 2 Ground Investigation

Client: Lidl Great Britain
Ltd

London Road, Pembroke
Dock

Report No: 1360.02.01

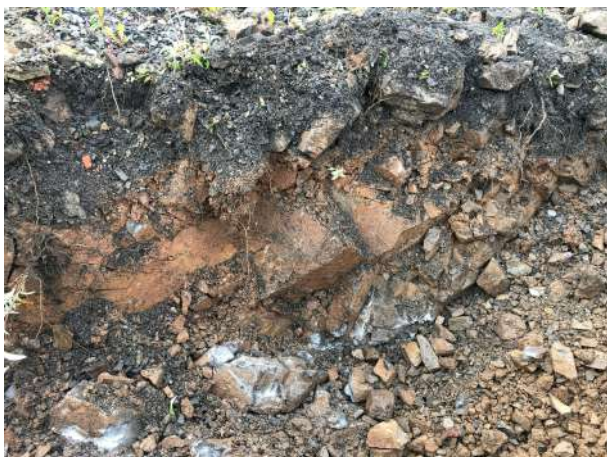
Photo 3: A view of the sidewall from SA02 showing minimal Made Ground overlying very shallow limestone bedrock fractured and locally oxidised.

WS01, WS02, WS04, WS07 & WS08 were located within the proposed store footprint. The depth to bedrock (SPT N = 50) was 2m at WS01 in the north-west of the proposed store footprint, but elsewhere less than 1m bgl. Due to shallow depth of SPT refusals, WS06 was replaced with trial pit (TP01) and similarly to the trial pits for soakaway tests SA01 and SA02 (Photo 3), limestone was exposed at less than 0.5m bgl.

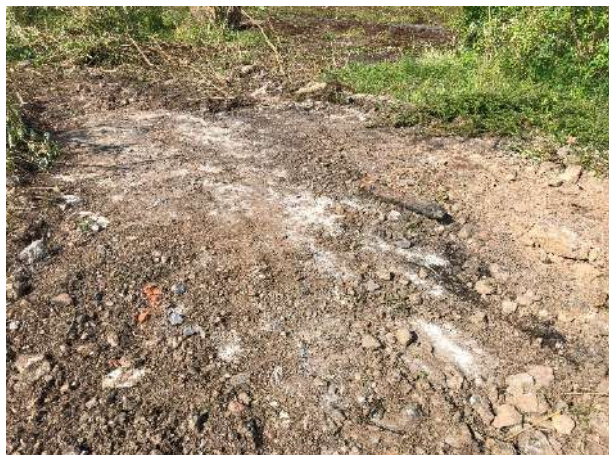
In situ concrete foundations are still present, which will require breaking out and removing prior to the development, see Photos 5 and 6 below.

Photo 5: A view approximately west from the west of the site where the concrete slab of the former building is still present.

In situ concrete foundations are still present locally within the site.

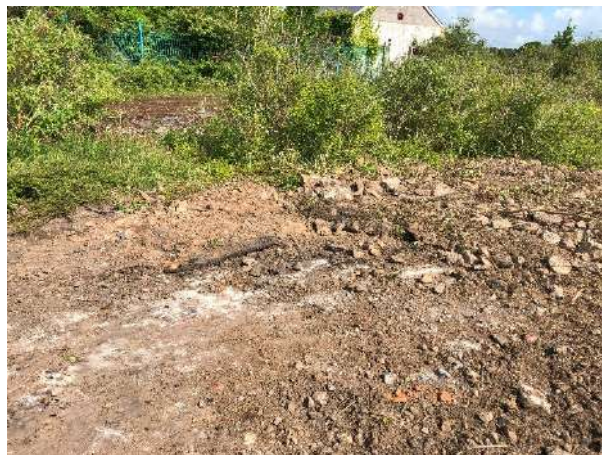
Photo 6: A view of the concrete slab from Photo 5 looking north-west.

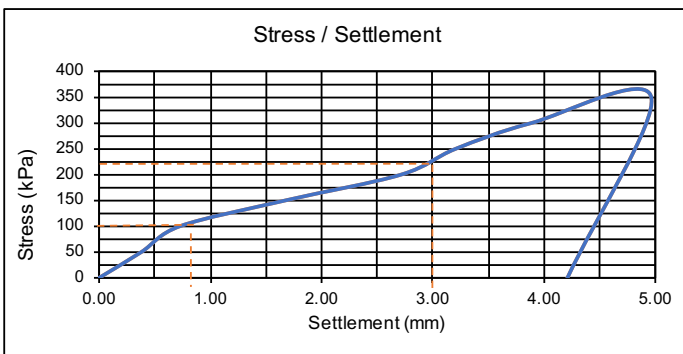
Time (s)	Stress (kPa)	Settlement (mm)
0	0	0.00
60	50	0.38
120	100	0.73
240	150	1.68
330	200	2.72
450	250	3.21
630	300	3.89
810	350	4.96
1140	0	4.21

Plate Diameter (mm)	Maximum σ [kN/m ²]	0.3 σ [kN/m ²]	0.7 σ [kN/m ²]	s1 (mm)	s2 (mm)	Ev [MN/m ²]
450	350.0	105.00	245.00	0.82	3.16	20.23
