# Phase 2 Ground Investigation

Client: Lidl Great Britain  
Ltd

Cwmann, Lampeter

Report No: 1304.02.03

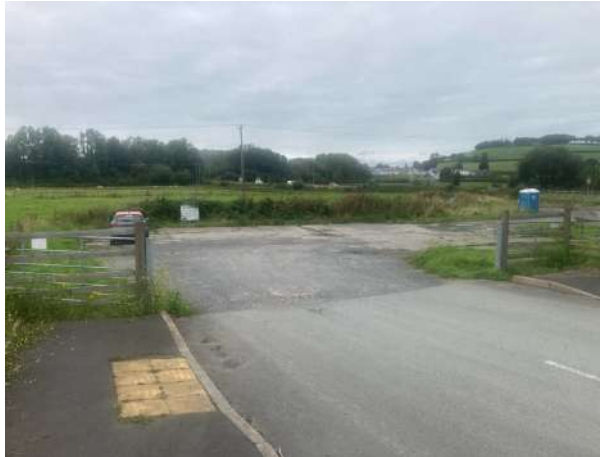
**Photo 1:** The southern boundary marked by the fencing, view showing the existing car park on site.

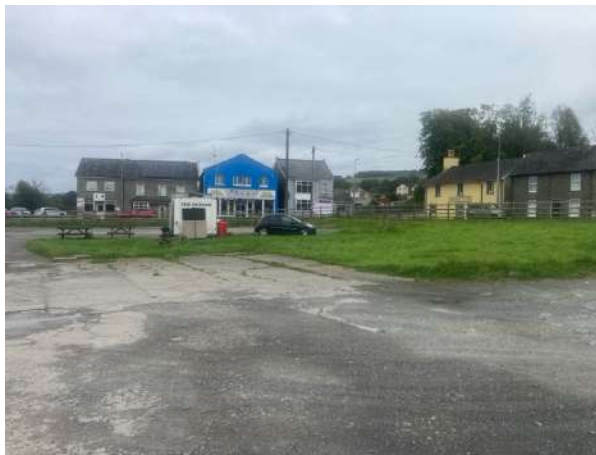
**Photo 5:** Detail of the car park currently situated on the site, which is located in the southeast of the site, car park is used as a customer parking area for the burger box (white cart shown in photograph).

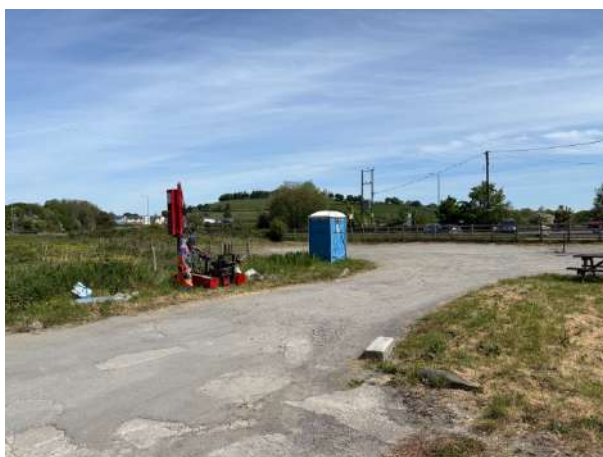
**Photo 11:** Existing portable toilet in the eastern half of the site. The course of the buried electricity cable supplying the Burger Box is roughly marked by the toilet and the picnic bench.

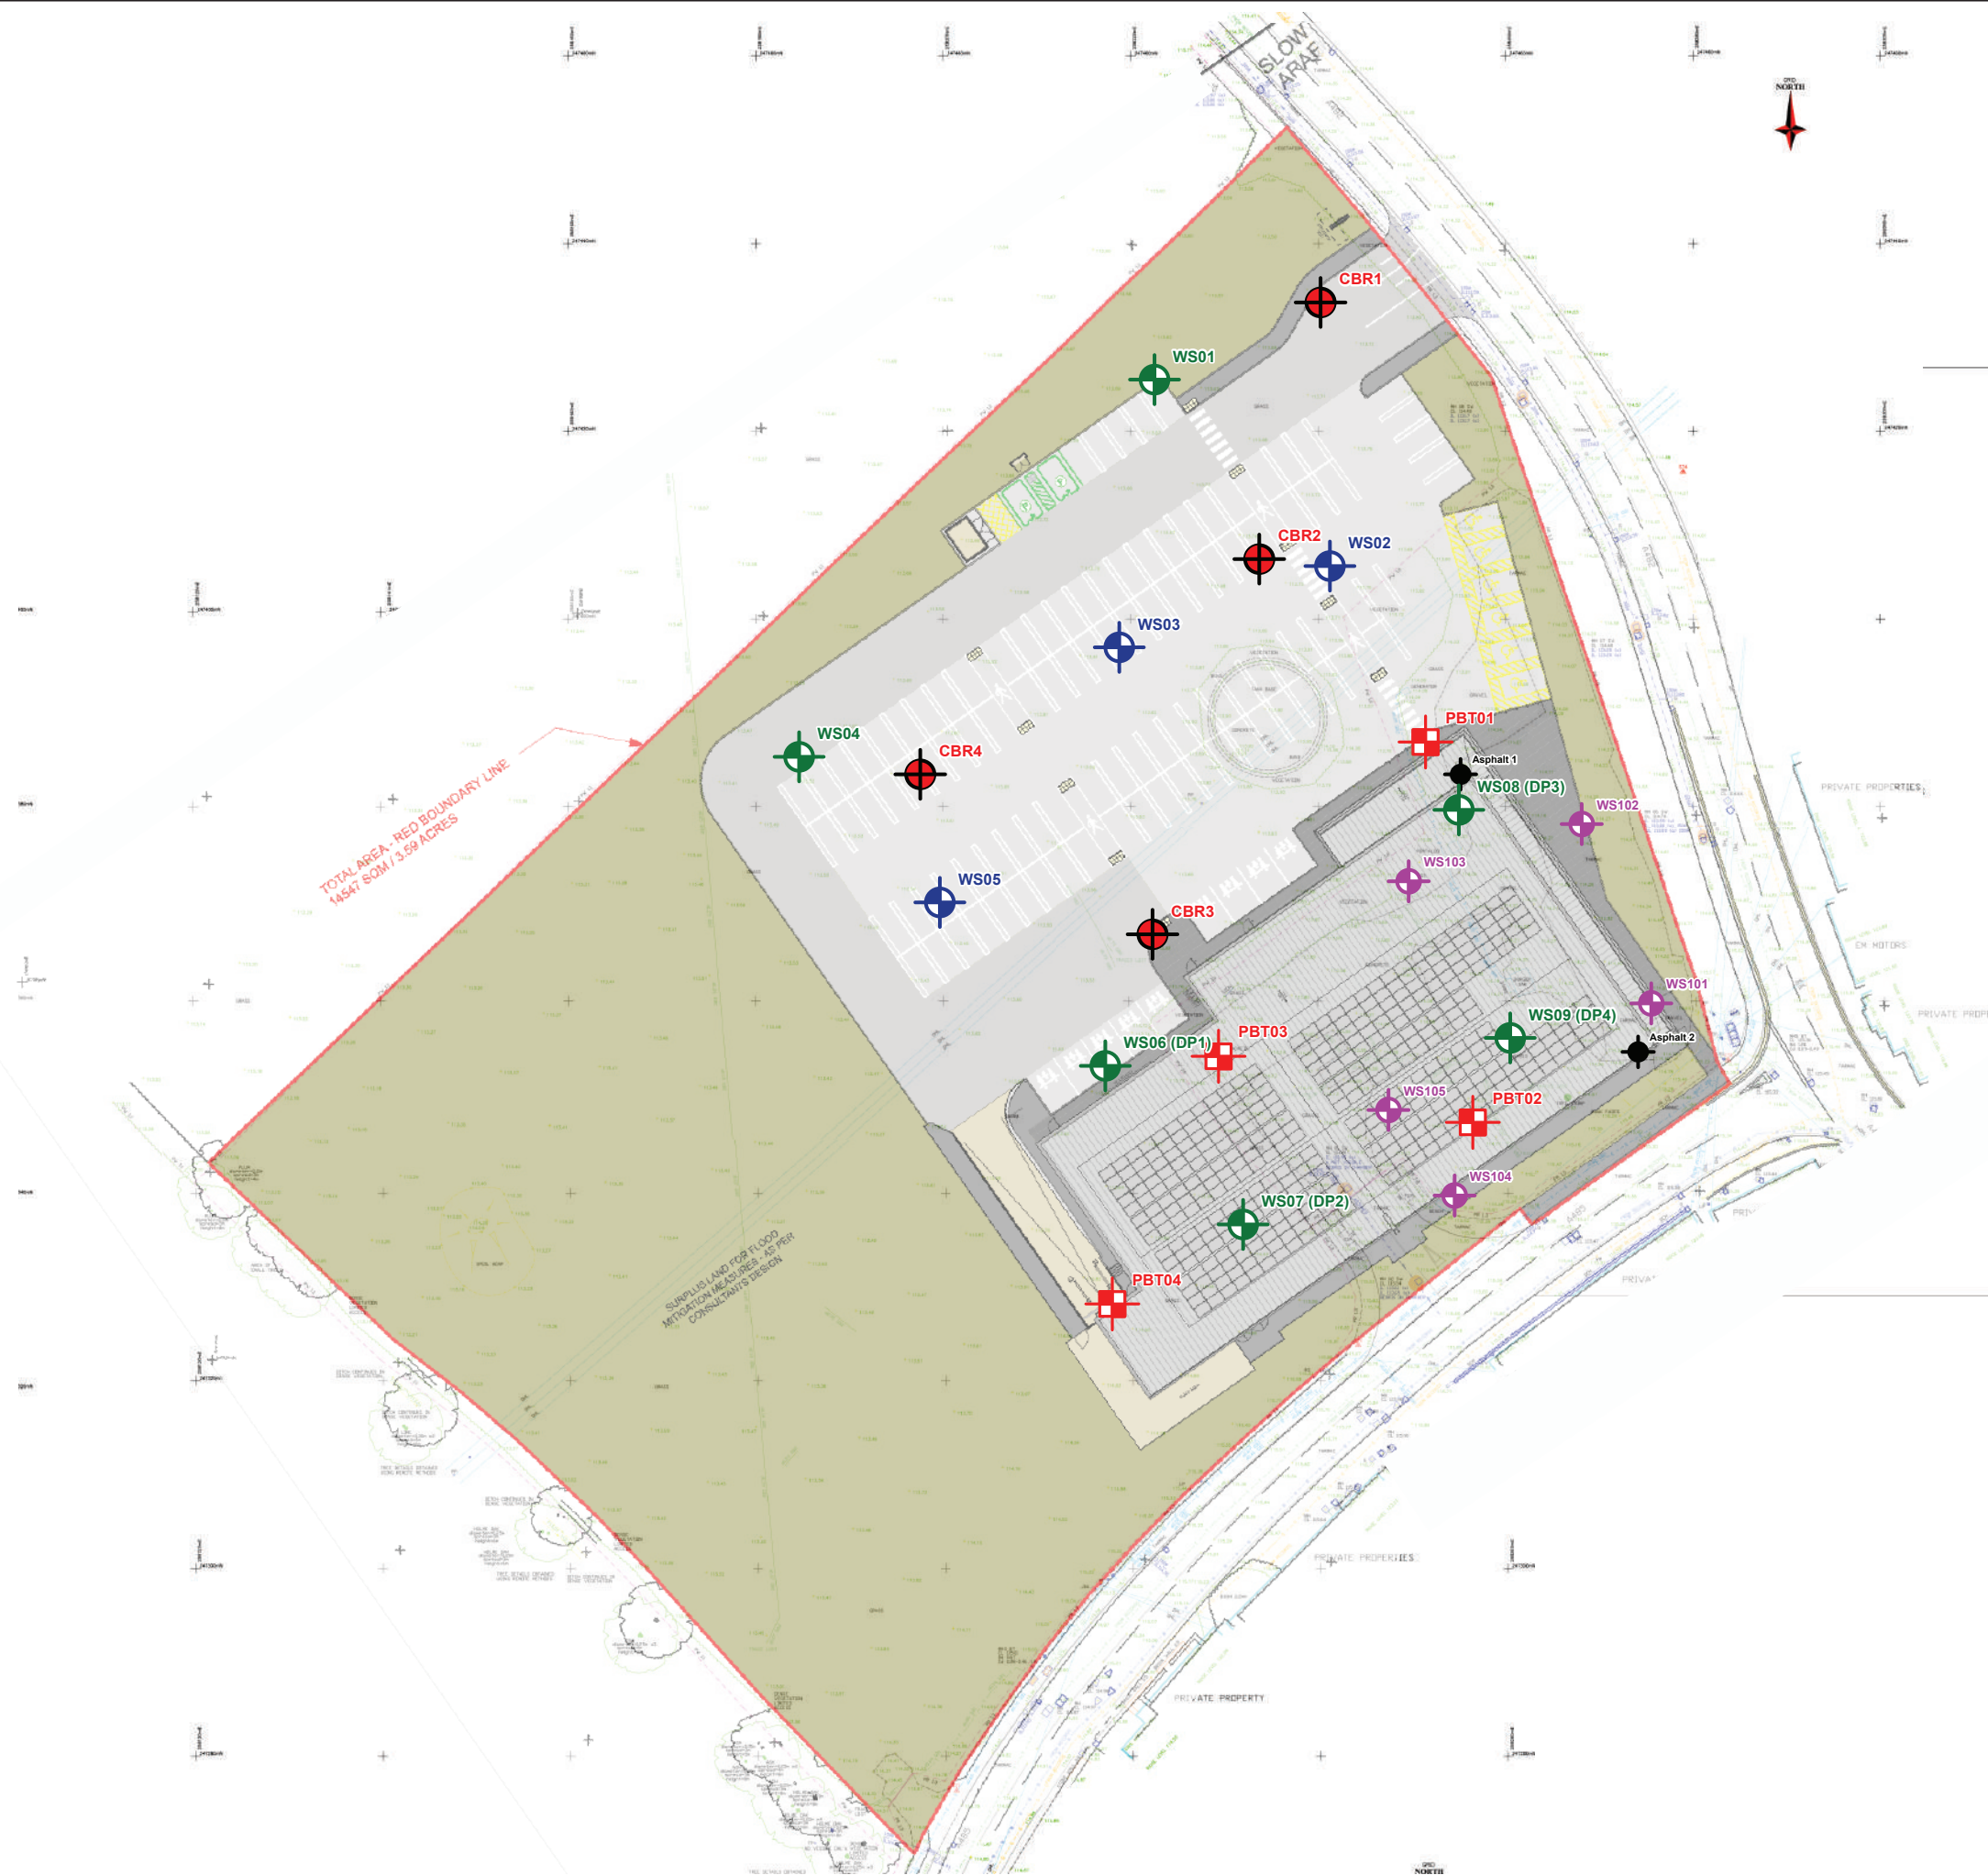
The investigation comprised the drilling of nine (9 No.) window sample boreholes (WS1 – WS9), execution of four (4 No.) plate bearing tests and four (4 No.) CBR tests at locations indicated on **Figure 2** on 4<sup>th</sup> and 19<sup>th</sup> September 2024 and 7<sup>th</sup> October 2024.

Remada's supplementary investigation comprised the drilling of five (5 No.) window sample boreholes (WS101 – WS105) targeting the revised store footprint, at locations indicated on **Figure 2** on 16<sup>th</sup> May 2025.

The positions of all the exploratory hole locations are recorded on **Figure 2** and the results of the DP tests are presented as **Appendix B**.

At the time of Remada's intrusive investigation on-site on 4<sup>th</sup> September 2024, boreholes WS1 to WS5 were positioned within the proposed store footprint. However, on 17<sup>th</sup> September 2024, the client supplied Remada with a revised site layout plan, resulting in boreholes WS6 to WS9 being located within the proposed store footprint. The scheduled timing of the plate load and DCP testing on-site enabled this revised layout to be accommodated, as per **Figure 2**.

A proposed indicative site layout plan is presented as **Figure 2**, with the site being accessed from the A482 to the north. The proposed store footprint is indicated to be located in the eastern area of the site, with the delivery bay located adjacent to the south-western façade. The southern area of the site is indicated to be *'surplus land for flood mitigation measures'* whilst the remaining areas are a combination of car parking, HGV access and soft landscaping.

At the time of Remada's intrusive investigation on-site on 4<sup>th</sup> September, boreholes WS1 to WS5 were positioned within the proposed store footprint. However, on 17<sup>th</sup> September 2024, the client supplied Remada with a revised site layout plan, resulting in boreholes WS6 to WS9 being located within the proposed store footprint. The scheduled timing of the plate load and DCP testing on-site enabled this revised layout to be accommodated, as per **Figure 2**. Boreholes WS101 to WS105 were also positioned targeting the proposed store footprint during Remada's supplementary investigation in May 2025.

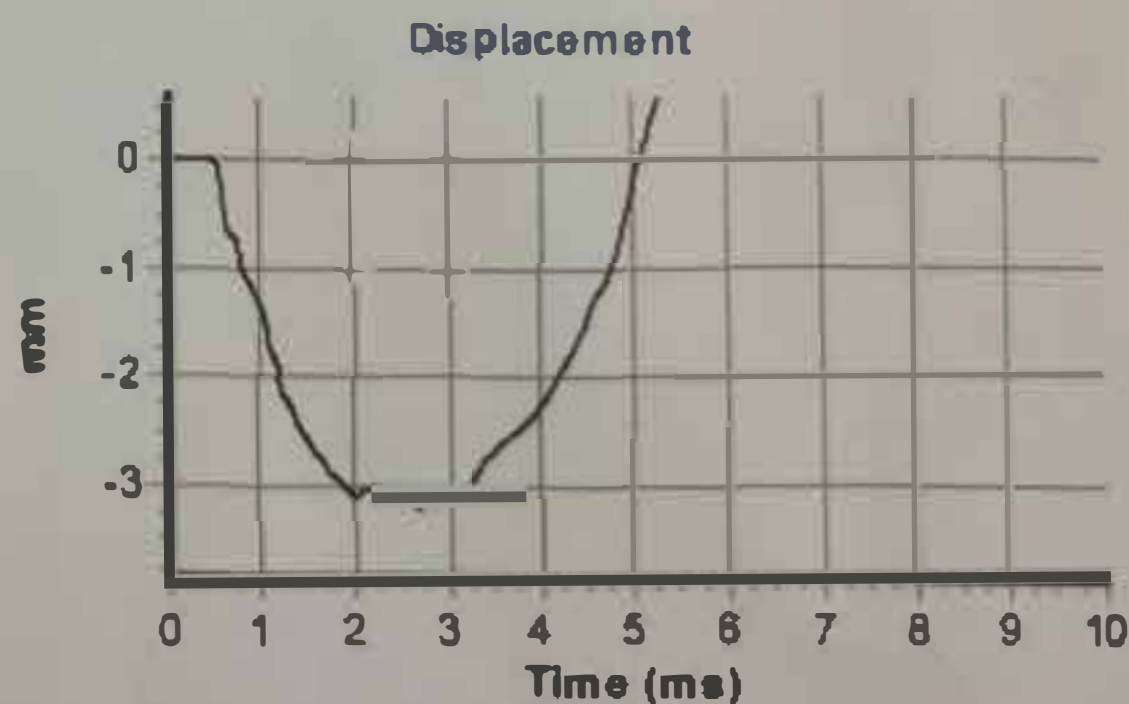
Area of Rod  $A$  (mm<sup>2</sup>): 905  
Theoretical Energy  $E_{theor}$  (J): 473  
Measured Energy  $E_{meas}$  (J): 325
