**Land off A473 & A4222, Talbot Green
Proposed Residential Development
Supplementary Coal Mining Risk Assessment (CMRA)**

Report Reference: ESP.9211.02b.4473.Rev1

Land off A473 & A4222, Talbot Green Proposed Residential Development Supplementary Coal Mining Risk Assessment (CMRA)

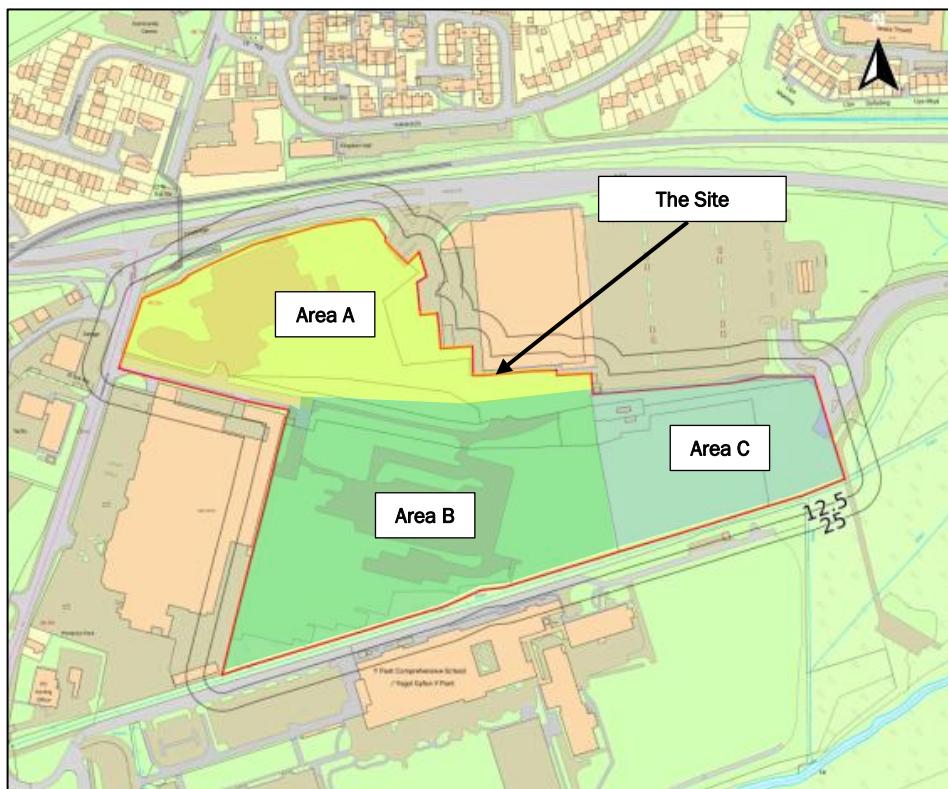
Insert 4 – OS Mapping Site Plan from data report (Appendix C) – See Below Site Descriptions

To aid in the description of the site in this section, the site has been separated into three areas (Area A, B and C) as shown on Insert 4 below. Area C is not included within the proposed residential development and is therefore not included in this assessment.

Area A

This comprises a large area of former hardstanding, located in the central and west, with the remainder being open grass/scrub. In the northwest, a former possible pumping station associated with former water mains remains.

Area B

This comprises the former entrance to the site and a localised area of tarmacadam. The central area is occupied by a large concrete slab, with further areas of concrete and tarmacadam in the south and southwest. Steel runs were identified within the concrete in the central area, possibly associated with former crane/lifting runs or reinforcement to the slabs. Several drain covers were also identified but could not be lifted.
