**Land off A473 & A4222, Talbot Green
Proposed Residential & Retail/Commercial Development
Exploratory Investigation
Report Reference: ESP.9211.4278**

Land off A473 & A4222, Talbot Green Proposed Residential & Retail/Commercial Development Exploratory Investigation

Report Reference: **ESP.9211.4278**

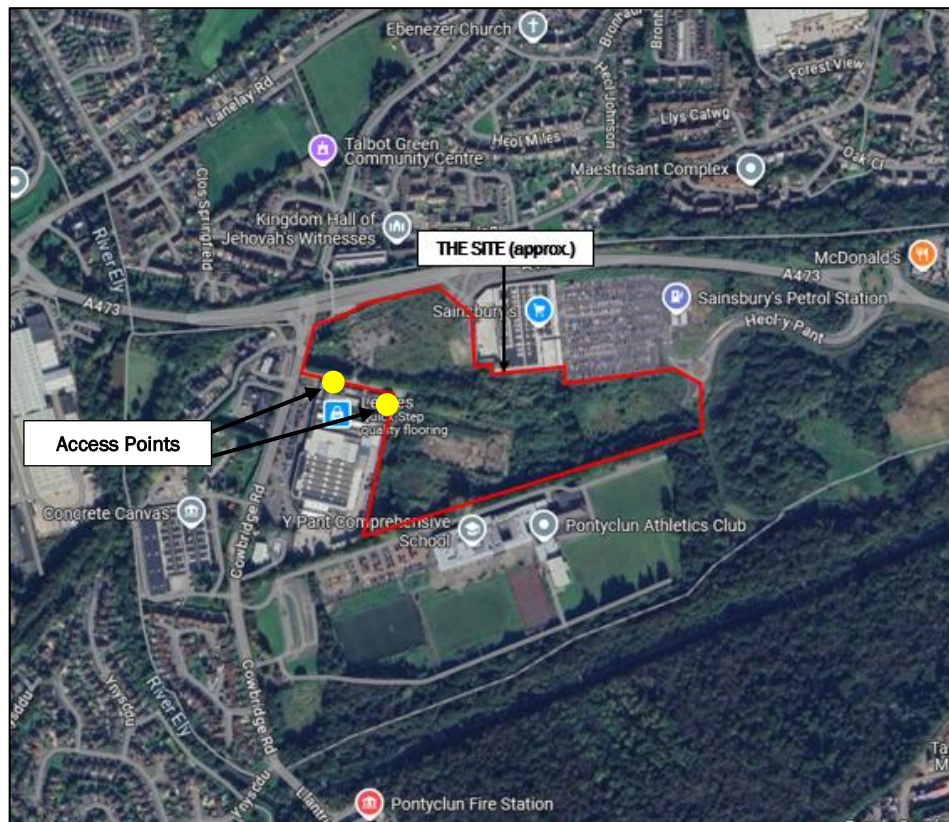
Insert 2 - Site Plan from Google Maps (Image taken May 2023)

To show the current status of the site, an aerial image of the current site status is shown as Insert 2 below, followed by an OS site plan from the data report in Appendix C as Insert 3. for reference.

Vehicular access to the site is currently gained via a gate north of the existing Leekes department store. Access can also be gained through large concrete bollards via the former entrance in the west of the site (see insert 2). The site boundaries generally comprise post and wire fences to the west, south and north. The east of the site is open to the new road layout constructed as part of the adjacent Sainsburys development.

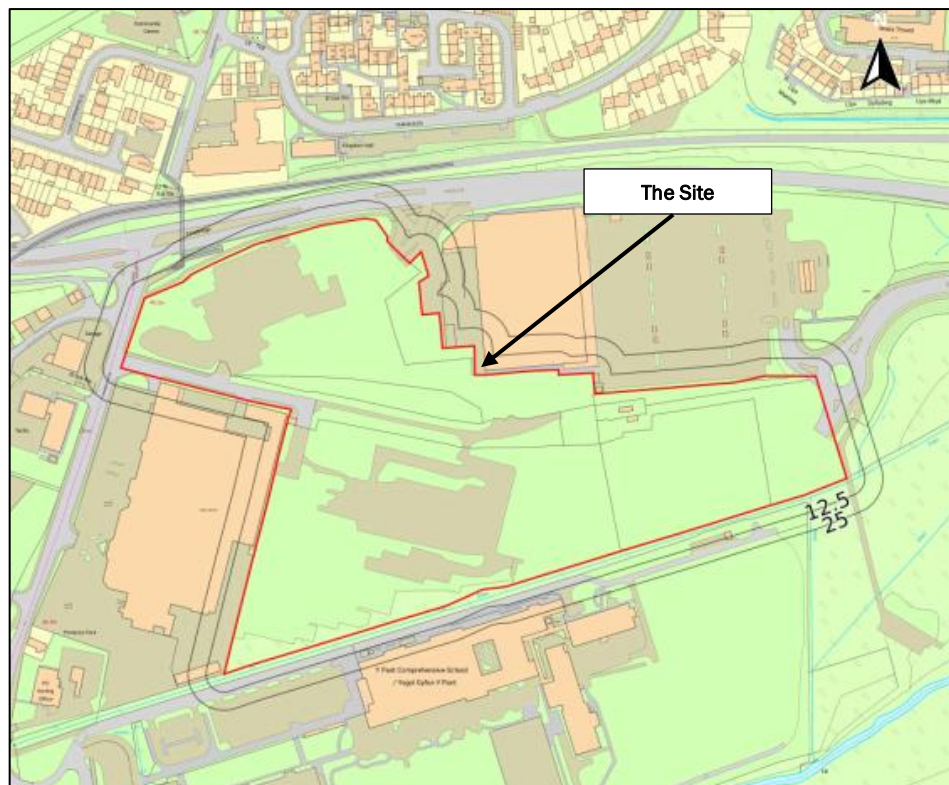
Insert 3 – OS Mapping Site Plan from data report (Appendix C)
