Arboricultural Report

To the British Standard 5837:2012
*(Trees in relation to design, demolition
and construction. Recommendations)*

Site – Pembroke Dock

Project Reference – ArbTS_2099.2_Pembroke Dock

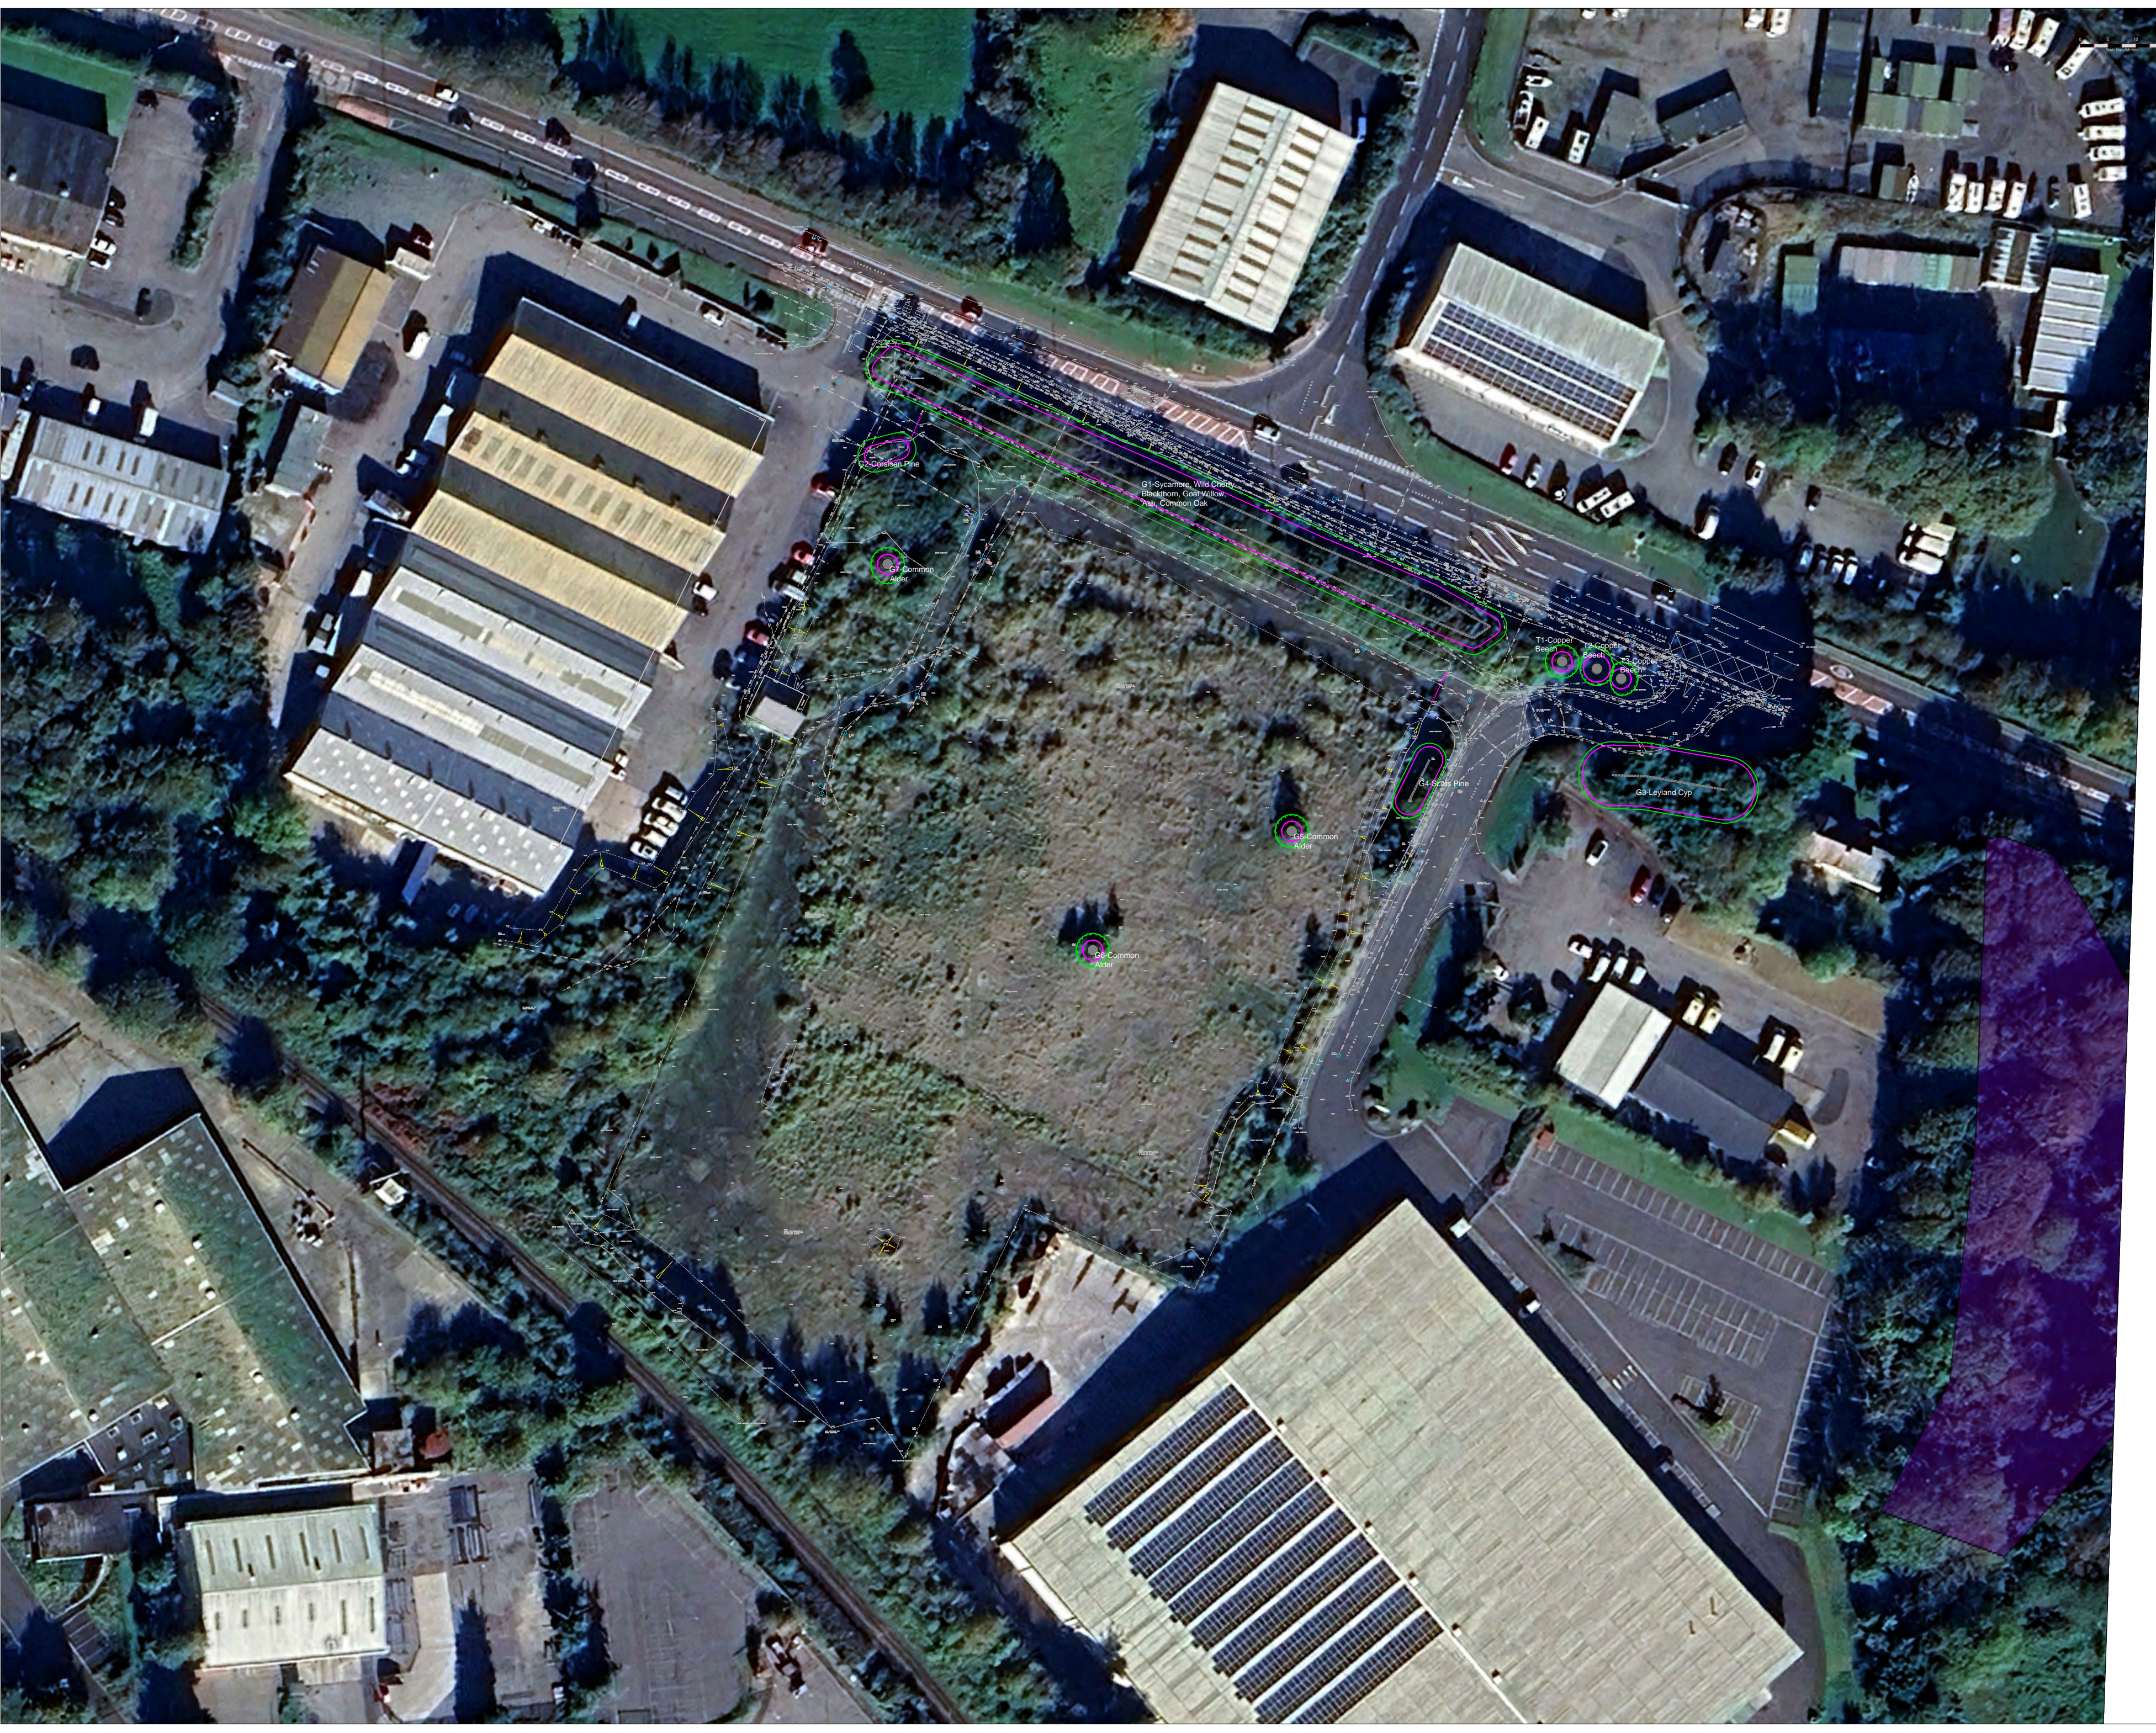
Tree Constraints Plan

- **Tree Quality** - The TCP highlights the above and below-ground constraints each tree poses to design future development schemes. Further, the BS5837 tree quality category (A - High, B - Moderate, C - Low and U- Unsuitable for retention) are coloured coded as solid circles at the centre of the tree's position.

- **Root Protection Area** – The magenta circle on the TCP sets out the root protection area (RPA). No construction work in this area, ground-level alteration or site traffic (machinery or persons) should occur. This prevents damage to tree roots and soil compaction. (Where possible, an Arboriculturist can design suitable tree protection methods to facilitate construction work/site traffic within these areas).

- **Tree Canopy** - The green circle/oval on the TCP sets out the above-ground constraints of tree canopy spread. Within this area, no construction work or site traffic (machinery or persons) should occur if the tree is to be retained. This prevents damage to the tree branches and trunk. (Where possible, an Arboriculturist can design suitable tree protection methods to facilitate construction work/site traffic within these areas).

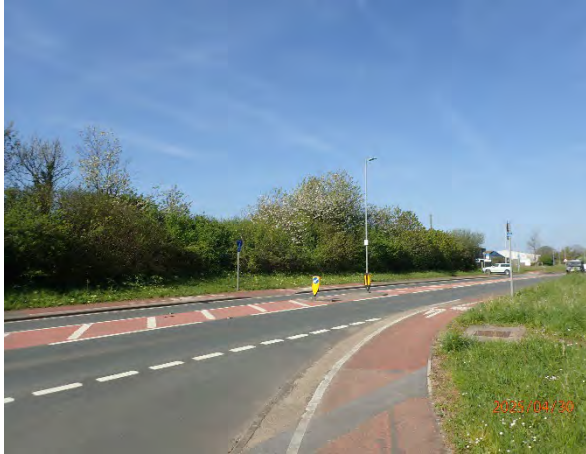
Tree ID#G1

- Tree Group – G7 – Small group of a few Alder trees of Low quality (C category)
- Tree Group – G6 – Small group of a few Alder trees of Low quality (C category)
- Tree Group – G1 – Two small areas (total 250m²) of overgrown scrub and small trees of Low quality (C category)

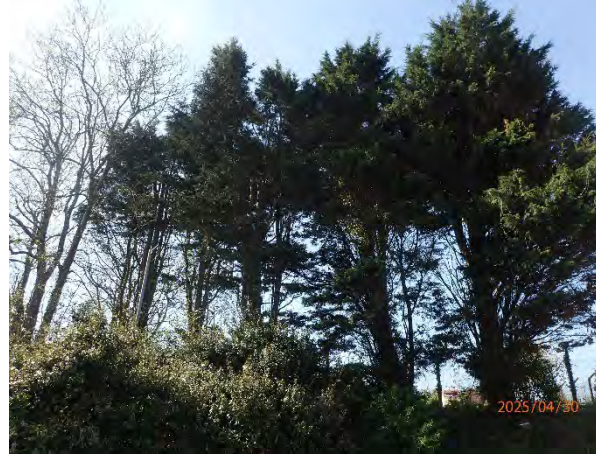
Tree ID#G3

G3	X Cupressocyparis leylandii (Leyland Cyp)	M	1	450	C2	15(4)	6	6	6	6	F	N/A	10+	Located on private land preventing a close inspection of the tree therefore all observations and measurements are estimated.	off site group of over grown conifers		5.4	91.62
G4	Pinus sylvestris (Scots Pine)	SM	1	200	C2	5(2)	3	3	3	3	G/F	F	10+		group of trees small scots pine		2.4	18.1
G5	Alnus glutinosa (Common Alder)	SM	1	150	C2	5(0)	3	3	3	3	F	F	10+		multistemmed alder		1.8	10.18
G6	Alnus glutinosa (Common Alder)	SM	1	150	C2	4(0)	3	3	3	3	F	F	10+		multistemmed alder		1.8	10.18
G7	Alnus glutinosa (Common Alder)	SM	1	150	C2	4(0)	3	3	3.5	3	F	F	10+		multistemmed alder		1.8	10.18
T1	Fagus sylvatica 'Purpurea' (Copper Beech)	SM	1	150	C2	5(2)	3	3	3	3	G/F	N/A	10+	Surrounding vegetation prevented close inspection of the tree therefore all observations and measurements are estimated.	small tree, one of group of beech		1.8	10.18
